Peter Palček – Mária Chalupová *

BREAKDOWN OF THE IMPELLER WHEEL OF A TG2 KAPLAN TURBINE

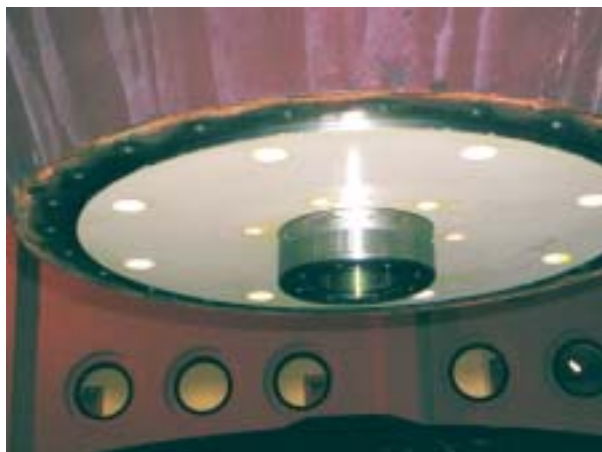
After extracting the turbine impeller wheel from the chamber and dismantling its bottom it was found out that the rod of the servomotor was extruded downwards by about 4.2 cm (Fig. 1). On its upper part it can be seen that there is a fracture of the whole rod cross-section just under its flange (Fig. 2). The fracture has a fatigue character in the constitutive part of its cross-section (Fig. 3), while the initiation of the fracture was from the gasket and slot from

Fig. 1 The rod extrusion from bottom bearing

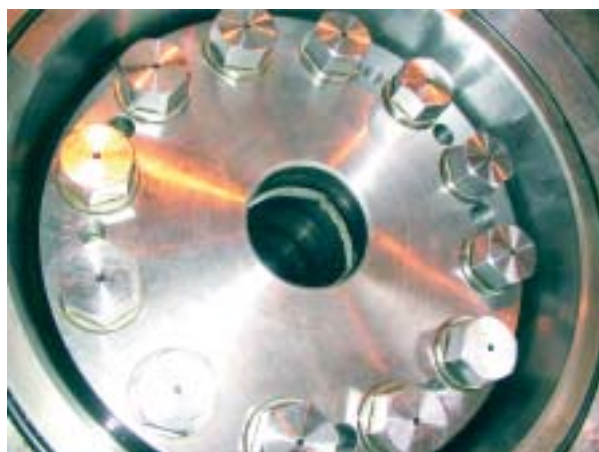
Fig. 2 The fracture of the rod under its flange

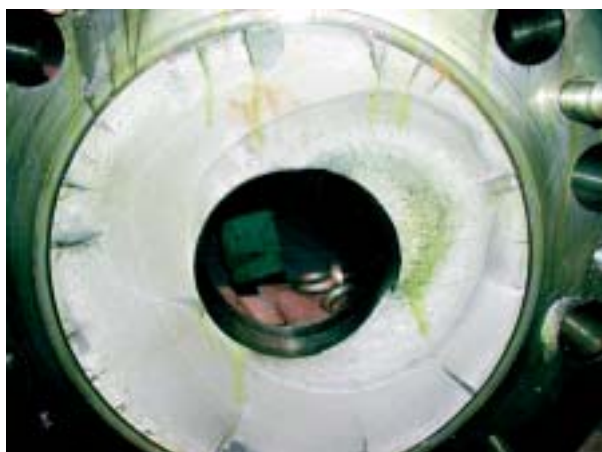
Fig. 3 The fracture of the rod

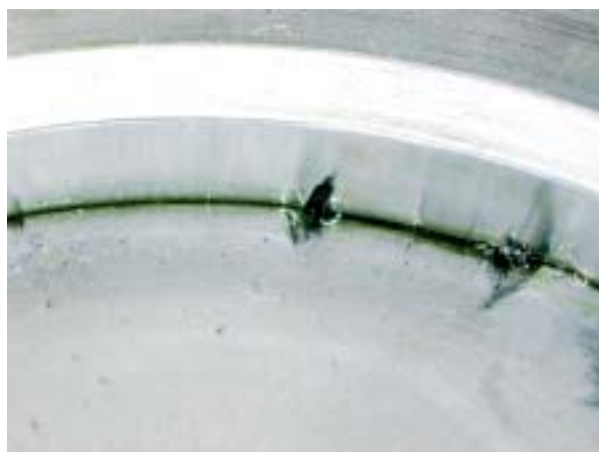
various parts over the whole perimeter of the crossing area. The parts of the damaged gasket (Fig. 4) and forged pieces of metal

Fig. 4 The parts of gasket between the rod and the body of the turbine rotor

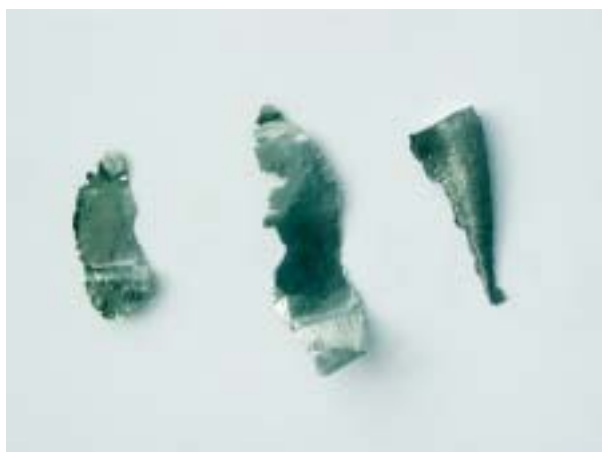
caused by the crack growth were on the surface of the fracture. The thickness of these pieces ranged from 5 to 14 μm (Fig. 5).

Fig. 5 Forged pieces of the rod

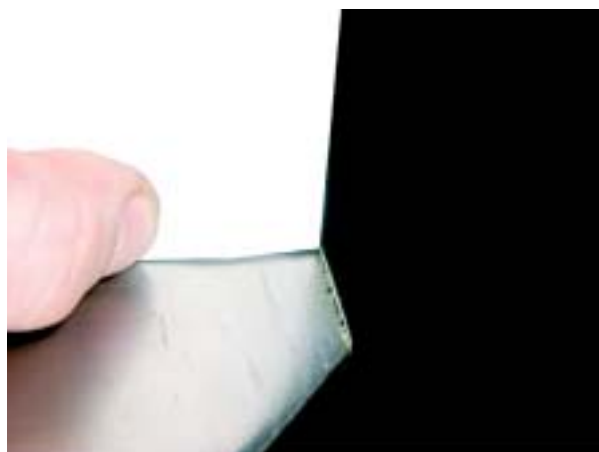
Fig. 6 Extruded material on the edge of the vane

By inspecting the impeller wheel we found out that there are areas without biological corrosion on the external circumference of the vanes. It means that the vanes had a direct contact with the turbine chamber when moving. This presumption is confirmed by the extrusion of material on the whole circumference of the vanes (Fig. 6) and by a continuous glossy track created by a mechanic contact with the vanes (Fig. 7).

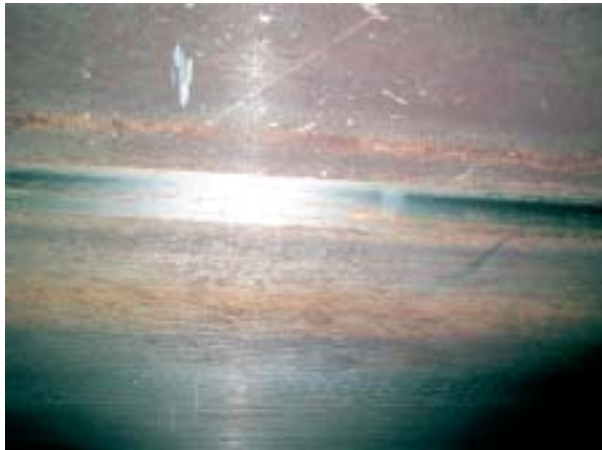
Fig. 7 The failure of the chamber surface of the turbine by wear from vanes

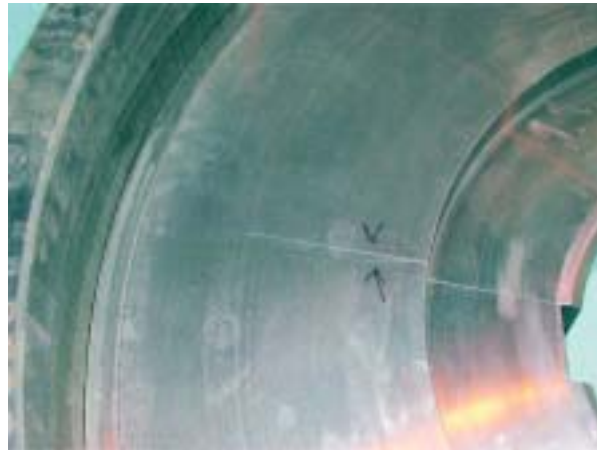
Fig. 8 The crack in the piston of the servomotor

By dismantling the servomotor cylinder it was found out that there is a crack on the piston. The crack is growing in the direction to the external diameter approximately to the two thirds of the diameter (Fig. 8). On the crack tip it is visible that the material of the piston is plastic (Fig. 9). This is typical for crack growing. On the contact area of the matrix that secures the position of the piston on the rod and transmits the forces from the piston to the rod,

The failure of the piston by the crack could be caused by concentration of tensions in the slot for spring, by a directed structure after rolling or by a structural non-homogeneity of the piston material. The contact fatigue on the rod matrix verifies a mutual micro motion between the piston and matrix (pulsating tension) that could contribute to the origin of additional loading of the piston.

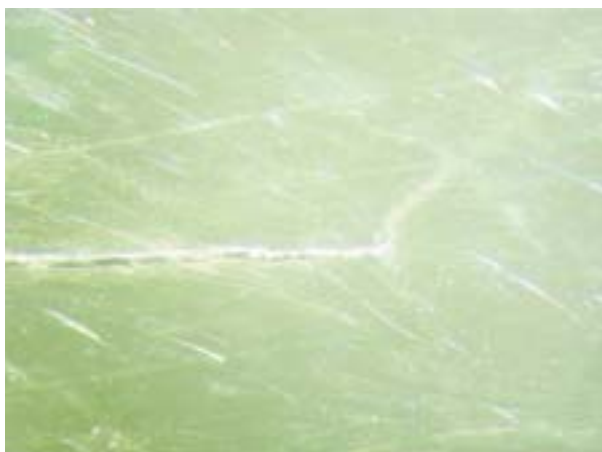
Fig. 9 The detail of the crack end on the piston

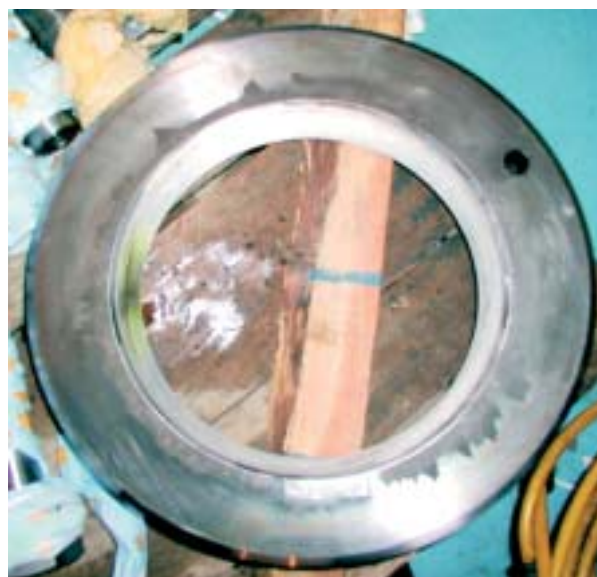
the maps with a changed surface quality were found out (Fig. 10). It is typical for contact fatigue.

Fig. 10 Pressing of the matrix surface

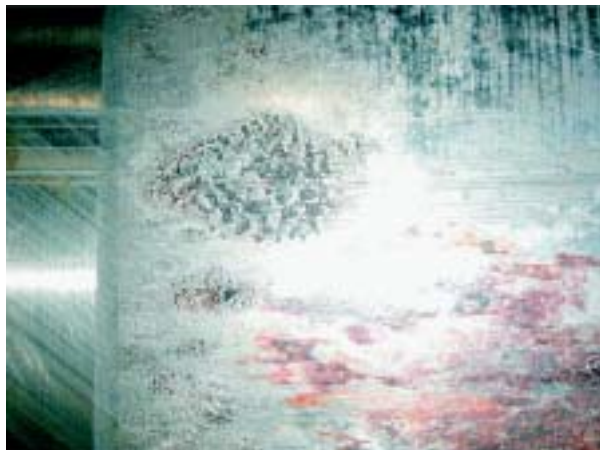
After complete dismantling of the impeller wheel it was found out that the rod is damaged by longitudinal lines and there is a large failure by contact fatigue – pitting (Figs. 11 and 12) on the functional areas of the rod.

Fig. 11 Deep pittings on the functional surface of the rod

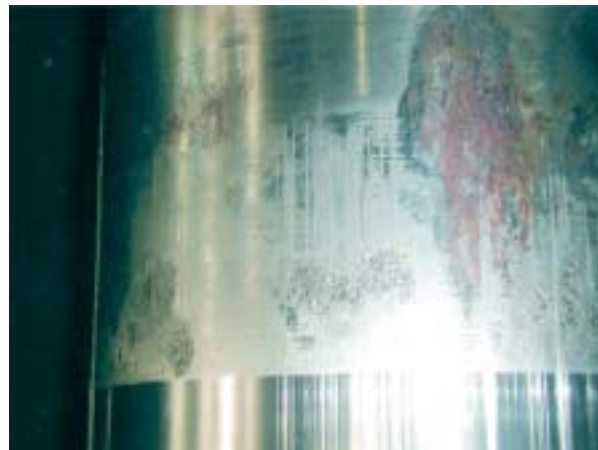
Fig. 12 Deep and shallow pittings on the functional surface of the rod

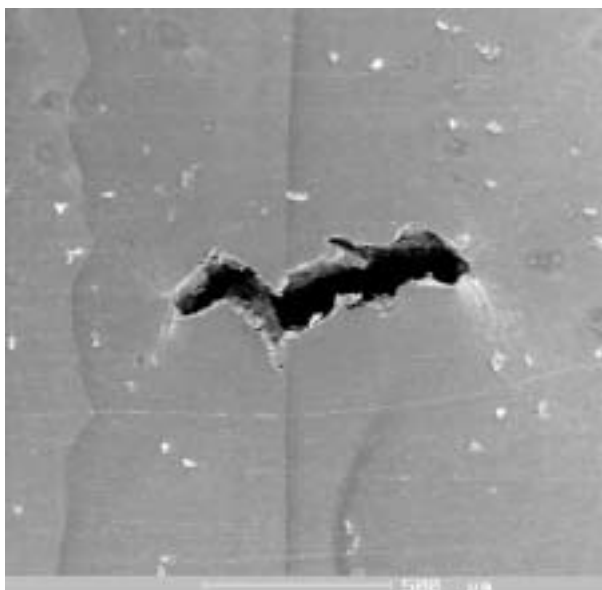
In the area of larger cracks (Figs. 13 and 14) a creation of slip lines – plastic deformation on the crack tip is observed. The creation of cracks is probably conditioned by presence of inclusions in the material structure. These inclusions are non-coherent and hard. They cracked by loading and they got separated from the basic material (Figs. 15 and 16) and it means that they served as micro cracks nuclei.

Fig. 13 A crack on the surface of the testing rod, REM

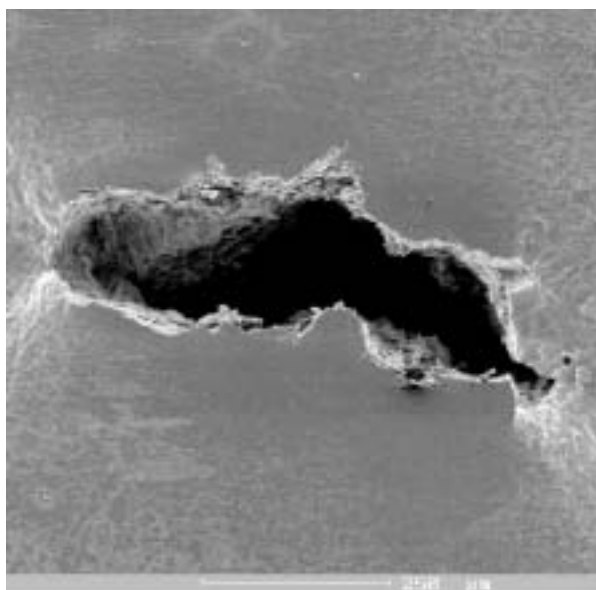
Fig. 14 A different crack, plastic deformation on the crack tip, REM

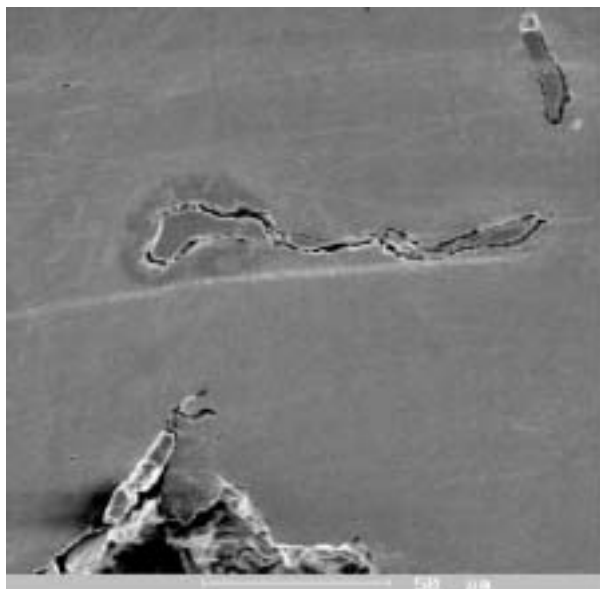
Fig. 15 The separation of an inclusion from basic material, REM

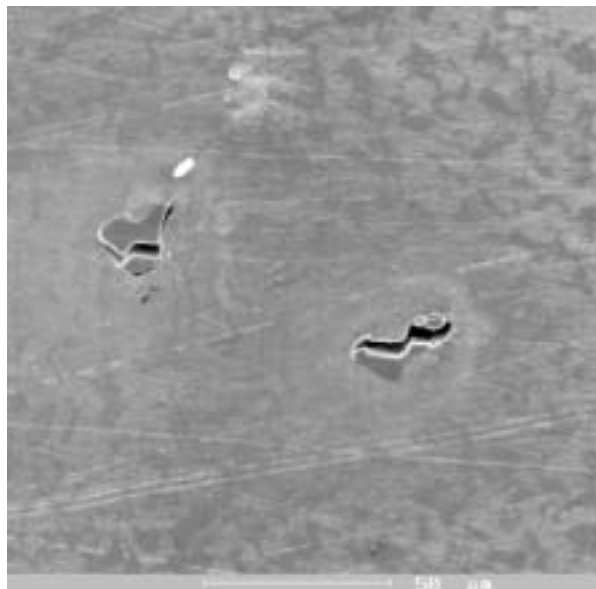
Fig. 16 Cracked inclusions on the surface of the testing rod, REM

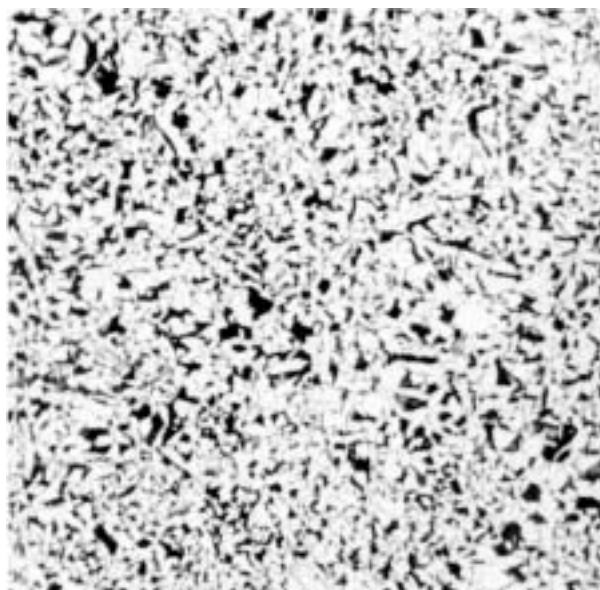
Steel structure is irregular, ferritic-pearlitic, created by grains of different sizes. Pearlite is lamellar in many cases, but it also exists in a spheroidic shape that corresponds to soft annealing. The size of ferritic grains is also very different. Moreover, it exists in the shape of Widmannstätten structure in many cases. Spheroidic pearlite is created by soft annealing that is realized at heating of material just under AC1 and leaving it at this temperature for some hours. In the case of the evaluated rod, a partial spheroidization occurred by slow cooling of the rod after forging. On the other hand, ferrite in the shape of Widmannstätten structure is created by rapid cooling

Fig. 17 Ferritic-pearlitic structure, a longitudinal section, 100x, etch. 3% NITAL

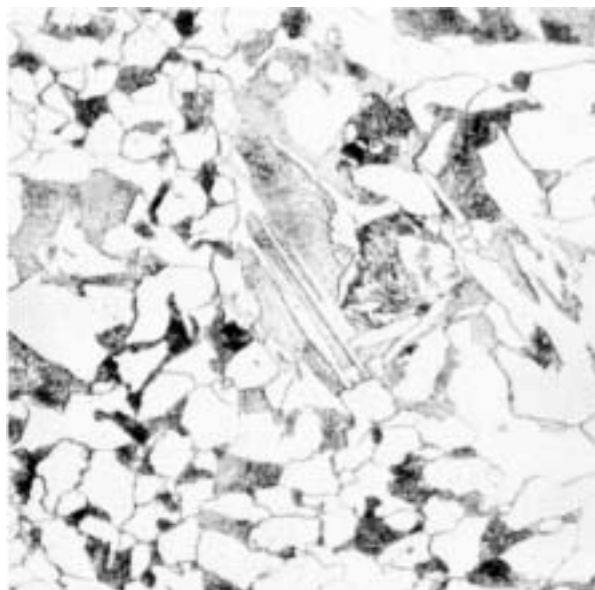
Fig. 18 Ferritic-pearlitic structure, a diagonal section, 400x, etch. 3% NITAL

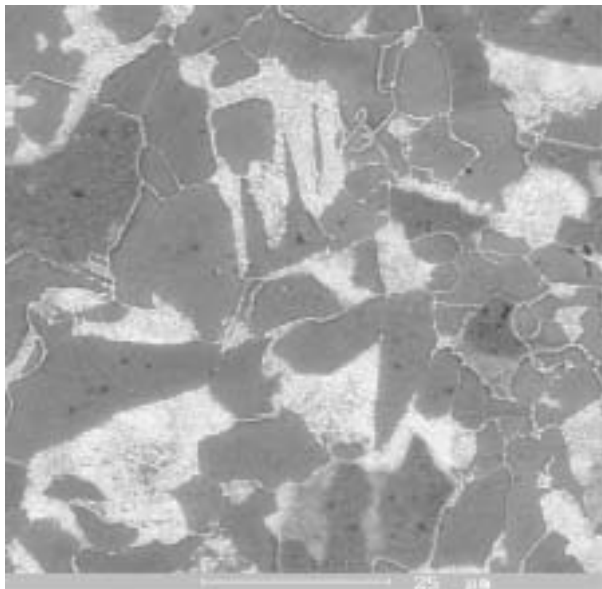
(Figs. 19 and 20) and there are grains of a very small ($6\ \mu\text{m}$) size and of very large sizes ($45\ \mu\text{m}$).

Fig. 19 Ferritic-pearlitic structure, a longitudinal section , REM

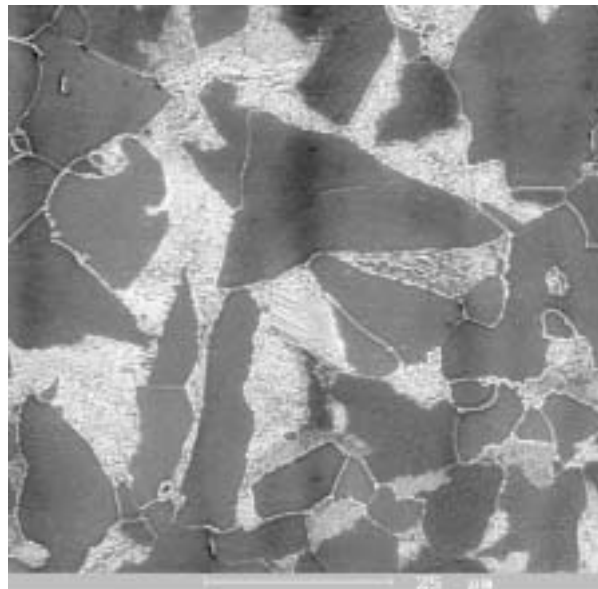
Fig. 20 Ferritic-pearlitic structure, a diagonal section , REM

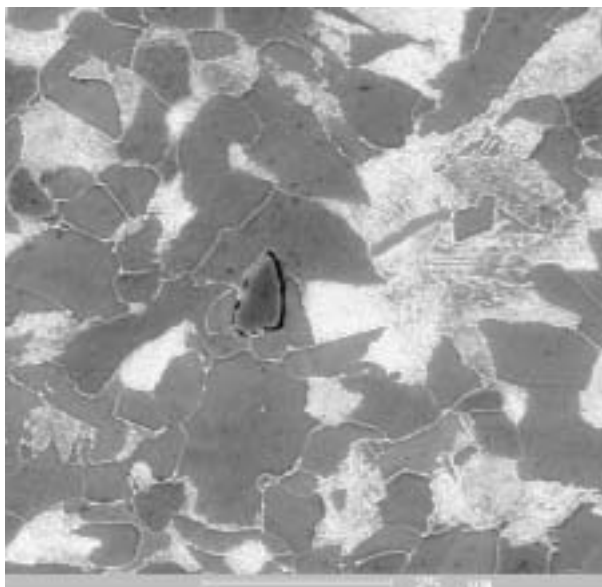
Pearlite is of a lamellar character in some grains and globular in others. Sporadically, Widmannstättenic ferrite was observed in the areas with near by big grains. Except for very irregular grains, inclusions of various shapes and parameters occurred in the structure (Figs. 21 and 22), while they nearly always had a non-coherent interface. The separation of inclusions from the matrix is probably caused by a long-term dynamic loading with a relatively high amplitude (in the relation to fatigue properties of the evaluated steel).

Fig. 21 The presence of an inclusion in the material structure, irregular size of grain, REM

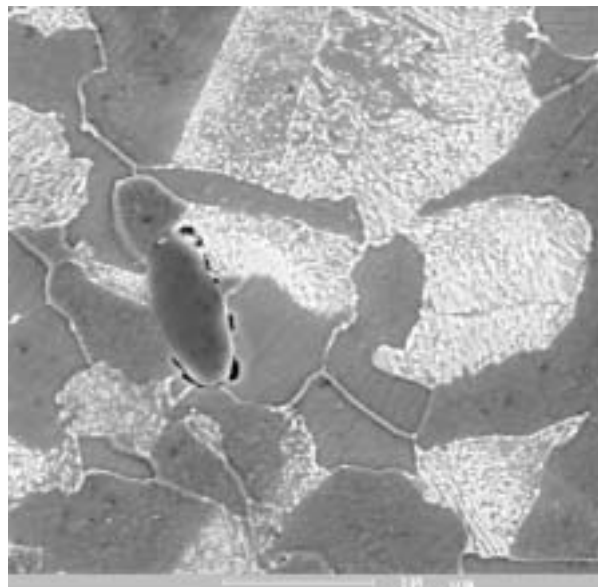
Fig. 22 The detail of ferritic-pearlitic structure with occurrence of an inclusion, REM

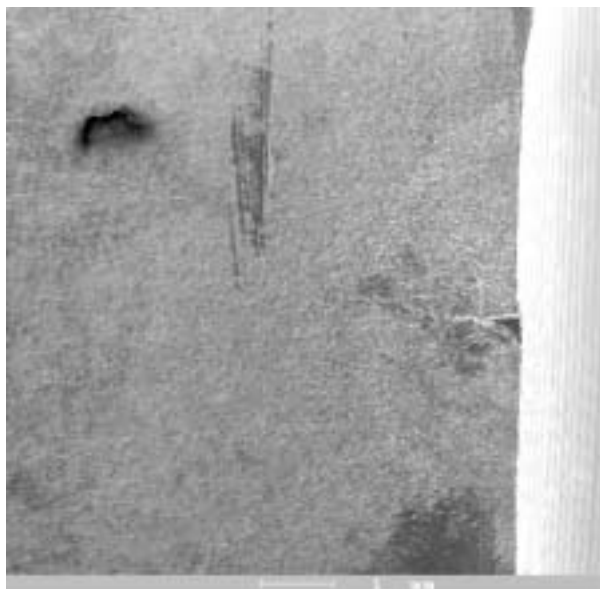
The specimen for the fractographic evaluation was extracted in the way to record the place of a supposed beginning of the crack growth, its gradual progress to the final fracture (Figs. 23 to 28). There were two sources on the evaluated fracture area (Fig. 23) from where the crack began to grow. In Fig. 23 the source is on the surface, the second source is superficial (Fig. 24). Most probably there was a bigger inclusion that served as a crack nucleus. But we cannot confirm this as the fracture area is damaged by

Fig. 23 The beginning of the crack growth – one of the sources, REM

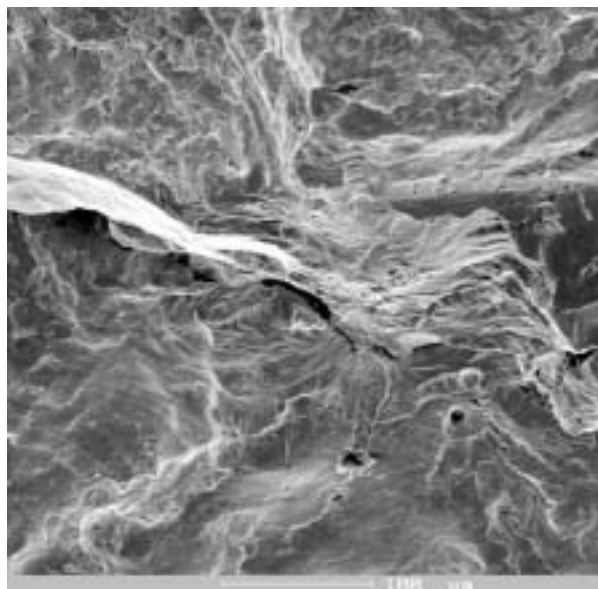
Fig. 24 The detail of a sub-surface source, REM

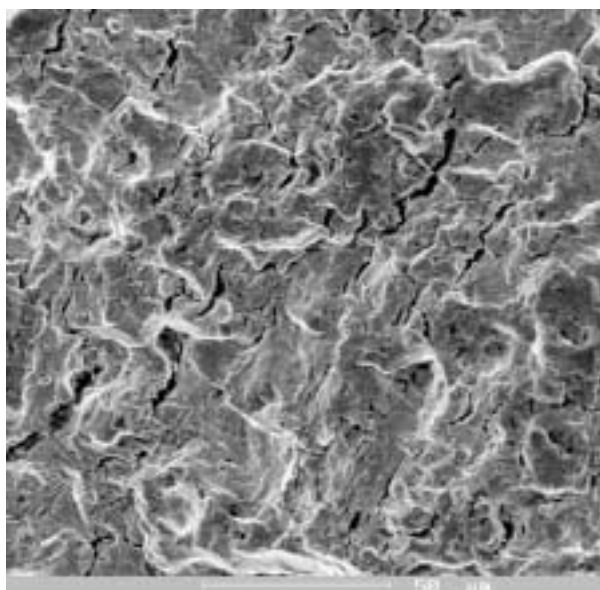
The character of the fatigue fracture area in the direction from the source to the force fracture is shown in Figs. 25 and 26. The whole fatigue fracture is characteristics by a transcrystalline fatigue failure with the occurrence of relatively deep secondary cracks (Fig. 25). At bigger magnifications typical fatigue signs – striations were observed (Fig. 26).

Fig. 25 The character of fatigue fracture area further from the source, REM

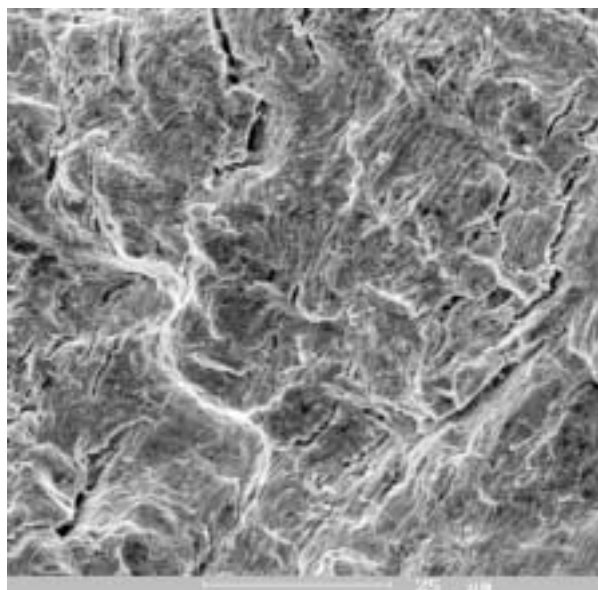
Fig. 26 A transcrystalline fatigue failure with the occurrence of striations and cracks, REM

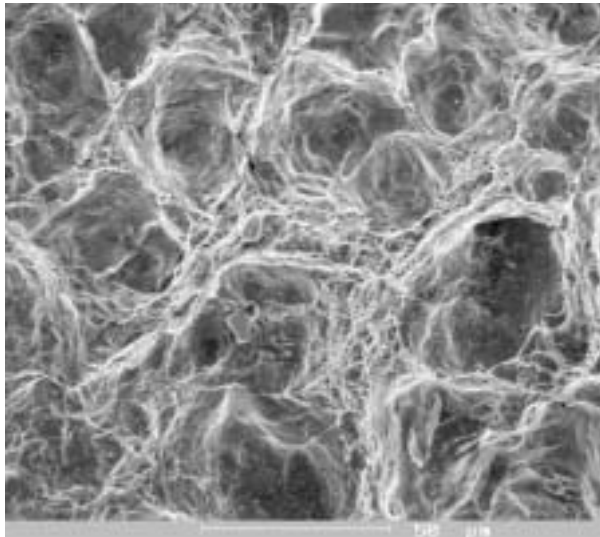
The area of fracture is characteristic with a transcrystalline ductile failure with dimple morphology (Figs. 27 and 28), while the dimples were very heterogeneous which is related to the material heterogeneity. Big dimples correspond to ferrite, small dimples are pearlitic.

Fig. 27 The area of fracture, a transcrystalline ductile failure with dimple morphology, REM

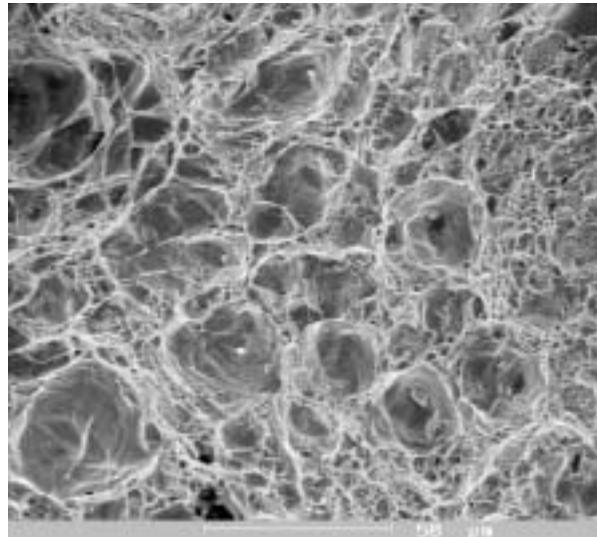
Fig. 28 The area of fracture - big dimples are ferritic, small are pearlitic, REM
