Vincent Kvocak – Renata Vargova – Pavol Beke – Eva Terpakova *

EFFECTS OF ATMOSPHERIC CORROSION ON THE CAR PARK ROOF STRUCTURE

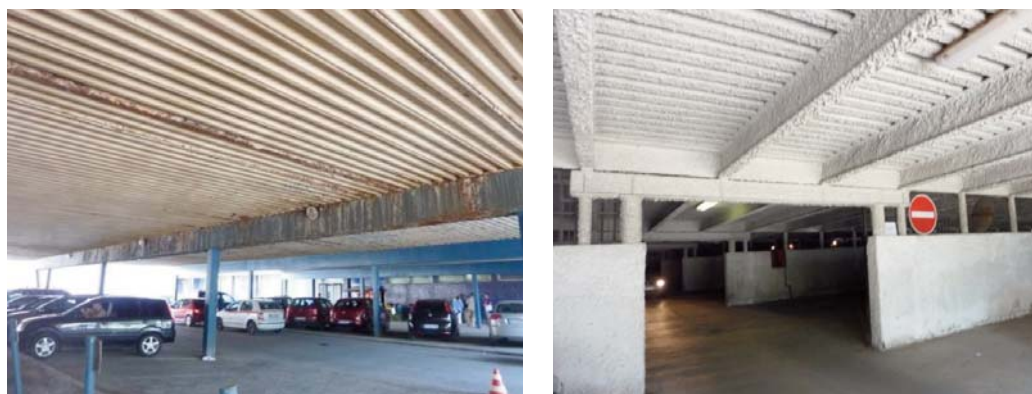
Fig. 1 The external (left) and the internal (right) roof structures of the University Hospital car park, Kosice, Trieda SNP 1

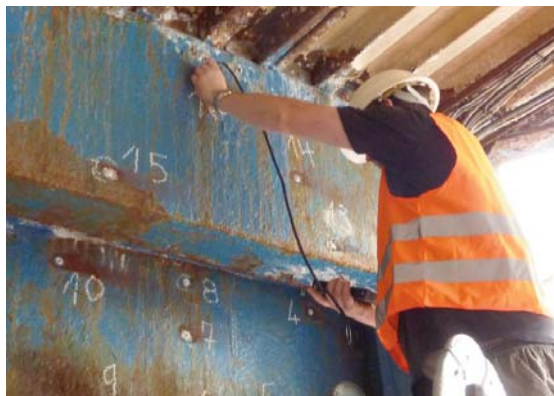
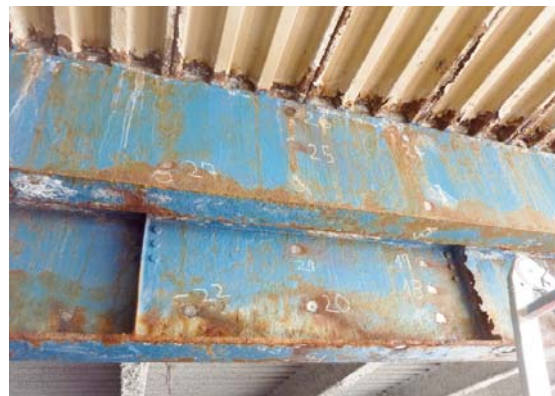
Fig. 2 Experimental measurements of the section thickness of Beam 6 in the most exposed locations

As expected, the most substantial deviations were detected in Beam 6. Degradation of its braces was evident, the flange and web thicknesses in the indicated locations remarkably reduced. The corrosion losses in the thickness of the lower flange were most dramatic – up to 6 mm. Similarly, serious losses occurred in the web, namely in the first field, from the original 8 mm to barely 5 mm. Due to the degradation effects of the environment most of the braces (the shear reinforcement) in the beam were damaged leading to a significant decrease in its shear resistance.

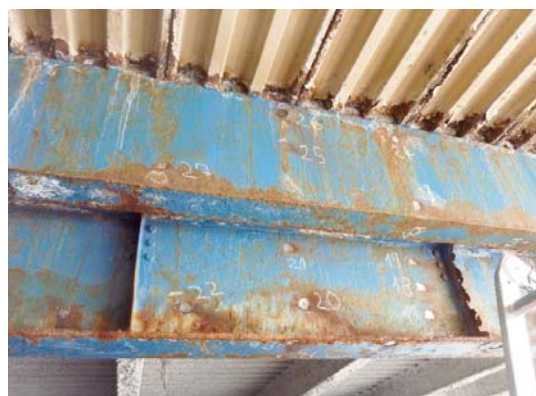
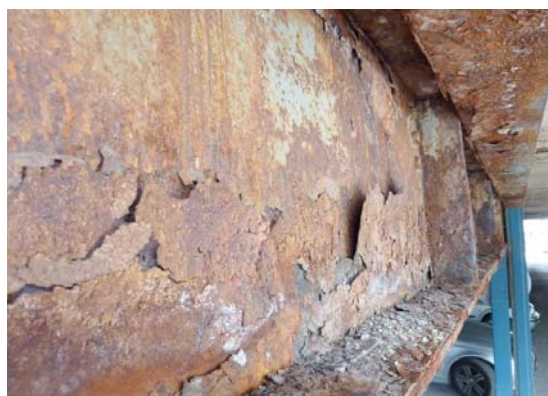
On visual on-site inspection of the existing structures it was concluded that Beams 1, 2 and 4 did not exhibit any signs of damage. It was further concluded that they were reliable and safe. The reason for their well-preserved condition might be their original good quality. On the contrary, Beams 3, 5 and 6 were greatly affected by corrosion, so it was essential to assess their real state, determine the actual corrosion losses in the individual fields of the examined beams as well as to examine the effects of external factors. The condition of the above-mentioned beams is shown in Figs. 2 and 3.

Fig. 3 Views of the steel frame details of the external car park roof structure (the condition before the renovation)

dized the safety of the building as a whole. By their nature and geometry, the examined beams did not meet the requirements for safe and reliable occupancy of the building any longer; therefore, measures for its renovation were inevitably proposed and implemented.

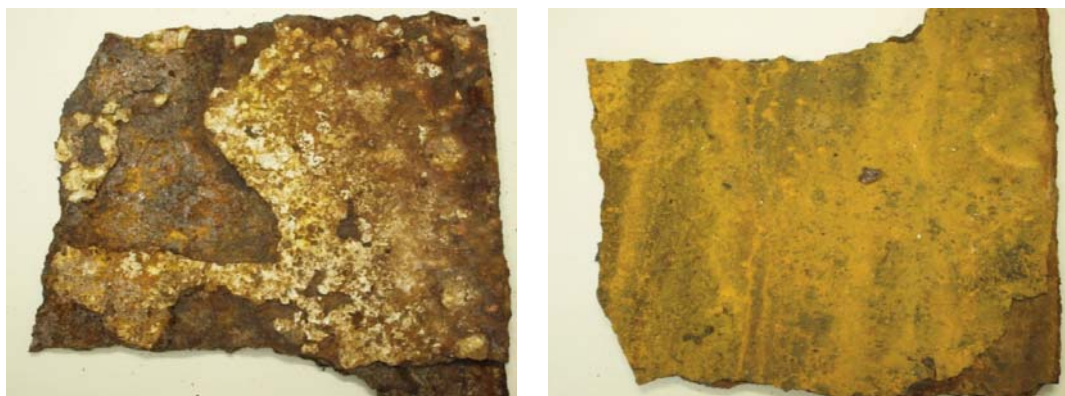
The rate of degradation of steel members was determined on mechanically removed rust samples from Beam 6 whose material was badly corroded, flaky, non-compact. The details of the sample surface are documented in Fig. 4. An optical microscope BRESSER was used to assess corrosive changes in the samples in great detail. At only the magnification of 20 (Fig. 5 left), both pitting and surface corrosion was indicated resulting in the separation of layers of rust. In Fig. 5 on the right, there is a detail of the same surface magnified 80× where a deep microcrack can be seen with evident surface corrosion.

Fig. 4 Appearance of the external part of the sample (on the left) and of the reverse side of the sample (on the right) with the residues of coating

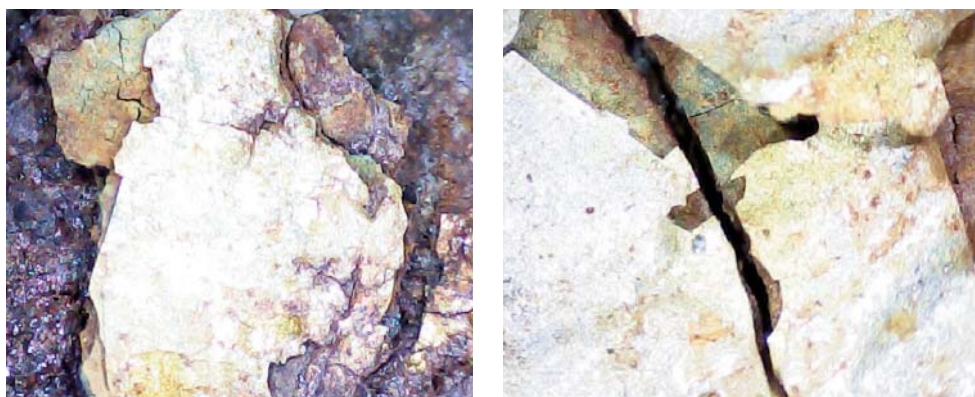
Fig. 5 Micrograph of the sample surface - magnified 20x (on the left), serious surface corrosion evident under a microcrack -at the magnification of 80 (on the right)
