Martin Moravcik - Peter Kotes - Miroslav Brodnan - Patrik Kotula *

SOME EXPERIENCE FROM THE ANALYSIS OF EXISTING 40 YEARS OLD PRESTRESSED BRIDGES IN THE NORTH OF SLOVAKIA

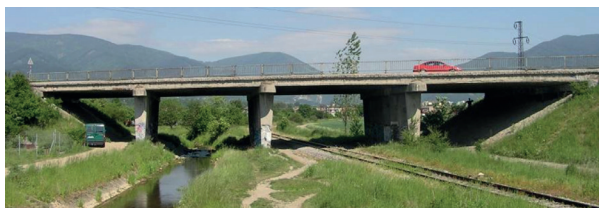
Fig. 1 The view of bridge No. 018-293 near the town of Martin on I/18 road

Failures, which have been observed on bridge 018-293, result both from the state of knowledge about bridge building accessible at the time when the bridge was built and also from insufficient maintenance at present. Outer girders, connection joints between the girders and over-supporting parts of the beams are the mostly damaged parts of the superstructure. On outer girders we can see uncovered, exposed, corroded tendons with some ruptured wires. Similar situation can be seen also in Figs. 4 and 5. Loss of cement mortar can be seen mainly in the peripheral connection joints and in over-supporting areas as a result of water leakage through these joints. Precast girders carry all typical features of the first prestressed concrete bridges built in Slovakia. The areas and the edges are rough and broken, the visible surfaces are marked with water leaking through the carriageway and insulation on the superstructure.

It was found out that the strength of concrete on bridge No. 018-293 corresponds to concrete class C25/30 according to [10], or to concrete class B 330 according to the previous Slovak standard. Strength of concrete was tested in a non-destructive way with the Schmidt hammer type L. Content of chloride ions, especially in the concrete cover, was determined by the tests of RCT instrument. The carbonation depth was determined by a simple indication method by spreading the concrete with phenolphthalein. On the exposed areas of reinforcement incurred by the fall of the concrete cover, the corrosion of prestressed reinforcement was found leading to the rupture of some wires.

On the basis of inspections, the bridge classification according to [11] was replaced by [12] as follows: - The bridge top cover condition: V. = bad, the substructure condition: IV. = satisfactory, the superstructure condition: VI. = very bad, complex bridge condition: V. = bad.

In the case of bridge No. 018-293 it is expected that the reconstruction work will be done with traffic moved over one lane of the bridge. Due to corrosion and subsequent rupture of prestressing tendons of outer girders it was proposed to remove them and replace them with new ones. Increasing the load carrying capacity should be achieved also by new composite slab concreting. The corroded caps have to be strengthened also in several possible ways, for example, by additional prestressing, or by other new reinforcement on the metallic or non-metallic base (FRP materials).

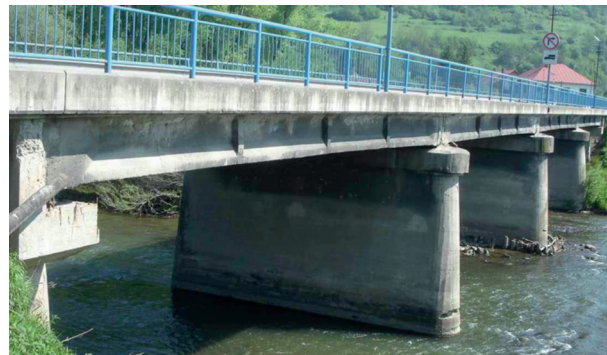
Fig. 2 The view of bridge No. 059-091 in Nizna over the river Orava

The precast superstructure of bridge No. 059-091 carries all the signs of such bridges from the 1st generation of prestressed structures in Slovakia. Consequences of water leakage through the carriageway and insulation can be seen on the superstructure. Anchored areas of the superstructure cross prestressing, particularly in over-supporting sections carry the signs of failures

due to leakage as, for example, removed concrete cover, and corroded anchors. However, the structural system realized in this way is still relatively solid. The girders in the longitudinal direction have still sufficient pressure reserve, which is noticeable in the overhanging. There are some major defects due to technical difficulties connected with cross prestressing and separate spans without linking the neighboring spans by a composite slab.

Despite the high age of the bridge and history of the Orava river bridged in this place, it was recommended to repair this bridge in order to increase its lifetime, and, at the same time, to maintain such capacity which corresponds to the current trends in designing new bridges. We suggest to repair the bridge superstructure by new external prestressing and new composite concrete slab.

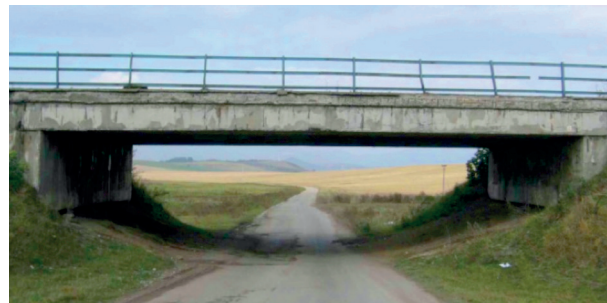
Fig. 3 The view of bridge No. 065-086 near the village Mosovce

One of the main deficiencies of the precast superstructure of bridge No. 065-086 from the KA-61 girders is a box shape of the designed girder. The closed shape of the girder cross-section causes the wet environment inside the girder, which affects the rapid reinforcement corrosion. That effect can be seen on many bridges constructed from the KA-61 girders.

In the case of bridge No. 065-086, the numerical model of the “curtain” slab was taken into account. The combination of the strengthening method was used due to the insufficient load carrying capacity. At first, all existing deteriorated elements will be removed from the top of the bridge. The new external prestressing (2 Monostrand tendons on 1 girder) was designed. Then new 150mm depth of the composite slab concreting on the top of the girders is assumed to be applied. That kind of the structural invasion completely changes behavior of the superstructure from a “curtain” slab to the solid orthotropic slab (Fig. 9). The superstructure being strengthened, similar repair work will be conducted as in the above mentioned cases.

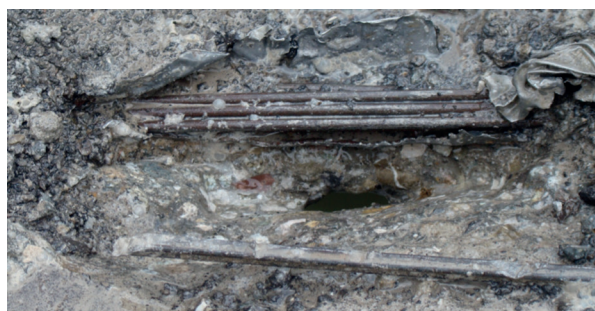
Fig. 4 The partial rupture of wires of the prestressing tendon - bridge No. 059-091

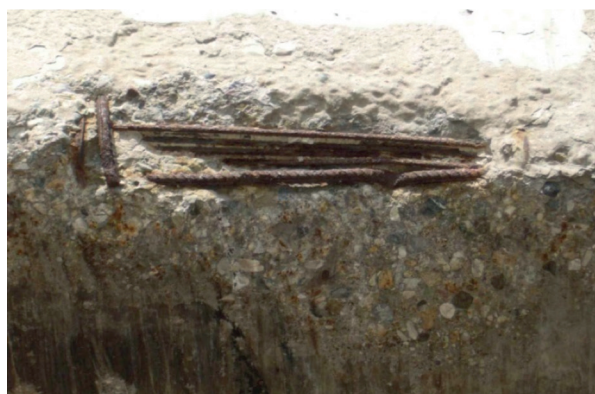
Fig. 5 The partial rupture of wires of the prestressing tendon - bridge No. 065-086

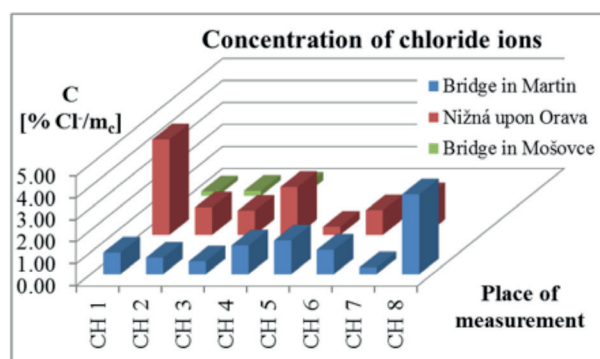
It was found out that the strength of concrete of the precast beams on bridge No. 059-091 was C30/37 (B 400), which corresponds to the designed value. Content of chloride ions Cl^-/mc was above the critical value (Fig. 6). The carbonation depth was lower than the concrete cover (Fig. 7). Technical condition

Fig. 6 The concentration of chloride ions- overview

It was found out that the strength of concrete of the precast beams on bridge No. 065-086 was C35/45 (B 500), which corresponds to the designed value similarly as with the above mentioned bridges. Content of chloride ions Cl^-/mc exceeds the critical value of content of chloride ions Cl^- (Fig. 6). The carbonation depth did not reach the value of the concrete cover

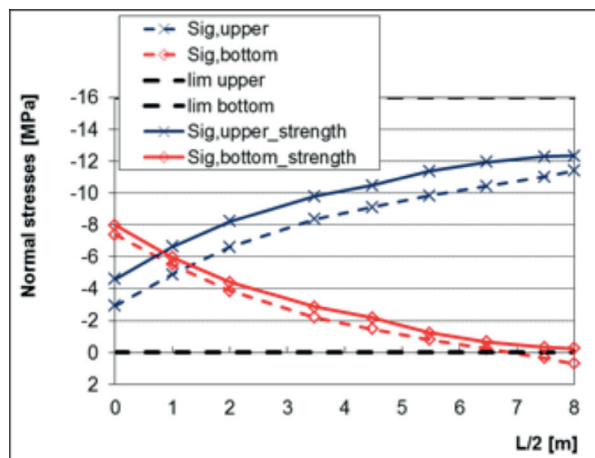
Fig. 8 The normal stresses course along the half span of bridge No. 065-086

- The bridge top cover condition: V. = bad, the substructure condition: IV. = satisfactory, the superstructure condition: V. = bad, complex bridge condition: V. = bad. The load carrying capacity calculation showed the following results: $V_n = 25$ tons, $V_r = 59$ tons, $V_e = 183$ tons, which again indicates the insufficient structural capacity, see Fig. 8.

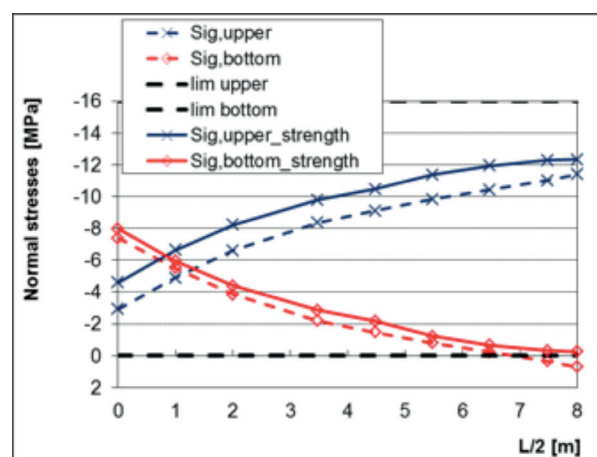
Fig. 9 The course of normal stresses along the half span on strengthened structure of bridge No. 065-086

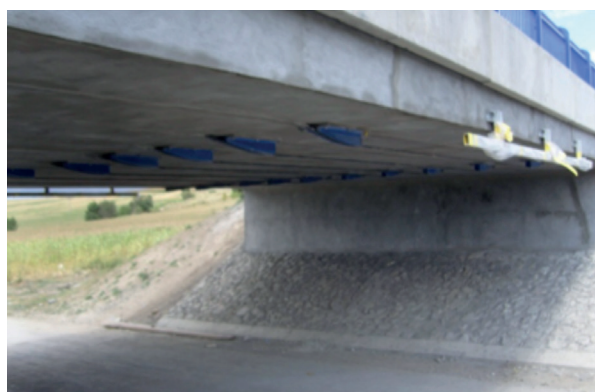
Fig. 10 Bridge No. 065-086 after strengthening by external prestressing

This is demonstrated by the example of bridge No. 065-086 where repair work has been successfully done recently. Composite slab concreting and the external prestressing combination method were used for the structural strengthening, as shown in Fig. 10.
