MATERIAL ANALYSIS OF DEGRADED STEAM TURBINE ROTOR

This article deals with structural, fractographic and non-destructive analysis of a defective rotor made of 26NiCrMoV14-5 steel and assessment of possible technological failures resulting in the occurrence of cracking and subsequent defects. Metallographic analysis of the microstructure and evaluation of the steel metallographic purity were executed, including analysis of inclusions present and ultrasonic testing. Attention was paid to fractographic analysis of fracture areas. Degradation possibilities were monitored in relation to technological failures. The aim was to elucidate the cause of the rotor defect hindering its operational use.

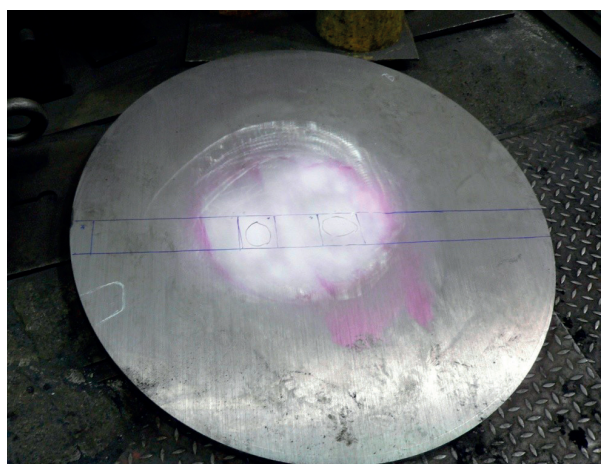
Fig. 1 Experimental plate

the rotor body over the area with the defects indicated (Fig. 1). The actual experimental samples were prepared from it.

During the ultrasonic test, inadmissibly large indications, bigger than 2 mm, were detected in the rotor examined around the forging axis on the head side of the ingot. The defective areas are encircled on the experimental plate (Fig. 1). In sum, 35 inadmissibly large indications of Dn 2.1 to 2.6 mm were found. Most of them were of Dn 2.1-2.2 mm, three of the indications had the dimension of Dn = 2.4 mm, one of them had the dimension of Dn = 2.6 mm. All indications were located at the depth of 427 – 558 mm below the surface of the rotor body. Almost the entire half of the rotor on the ground side of the ingot was without any inadmissible defects.

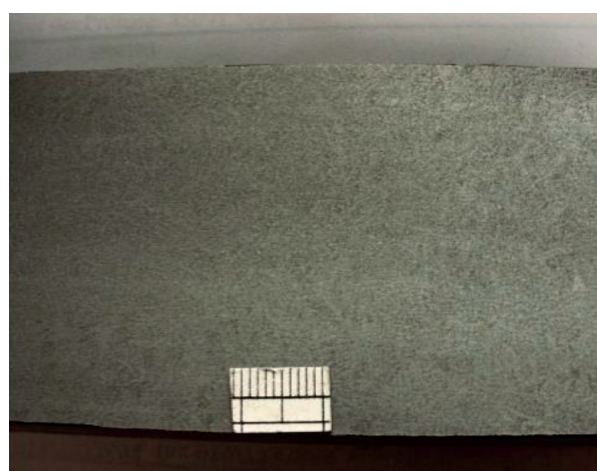
Fig. 2 Macrostructure below the surface

individual dendrites were relatively fine; their size ranged about 1 mm and their arrangement was chaotic. To the depth of approx. 200 mm below the surface, the dendritic segregation was manifested less intensively than in the other parts of the forging cross section (Fig. 2). It was the areas of more evident segregations in which the above mentioned defects were detected. Moreover, a distinctive phenomenon in these areas was the spots of existence of stem segregates. The chaotically arranged dendrites and cross sections of stem segregations, not exceeding the size of 2 mm, are then presented in Fig. 3.

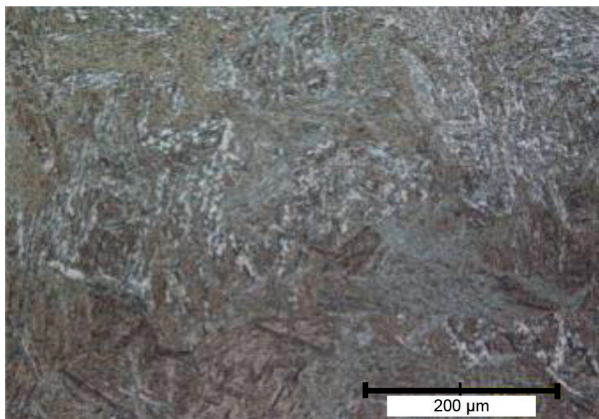
Fig. 4 Microstructure of the basic metal matrix

Throughout the entire volume, the analyzed steel had a fine-grained microstructure made of tempered heterogeneous bainite, which shows evidence of both high hardenability of the steel used for the rotor manufacture and the optimum hardening mode. The microstructure of the basic metal matrix was mostly of the acicular character (Fig. 4). More distinctive

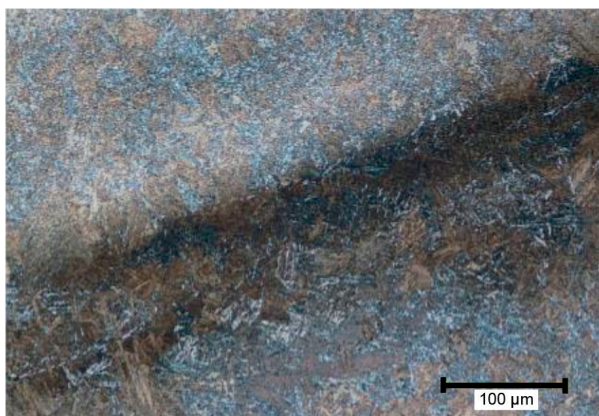
Fig. 5 Macrostructure with segregates

dendritic segregations in higher depths below the rotor surface are presented in Fig. 5.

In addition to bainite, these areas, characterized by lower carbon content, probably contain probainitic acicular ferrite. The occurrence of carbides of globulitic morphology bears evidence of high tempering temperature after hardening [7].

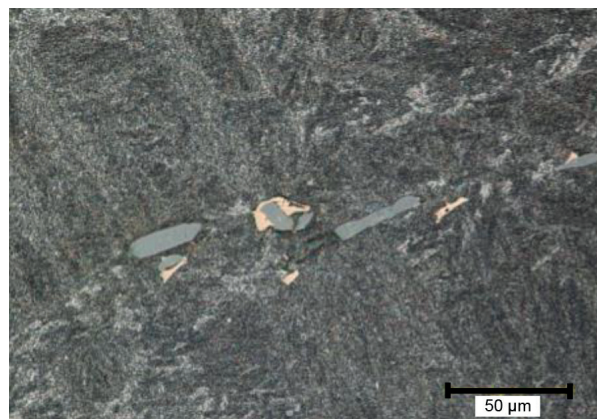
Fig. 6 Microstructure with inclusions

At the points of inadmissible ultrasonic findings around the forging axis, discontinuities were detected in the form of coarse inclusions, rounded elongated cavities and coarse inclusions situated inside the cavities. The length of the largest of these discontinuities at the metallographic samples exceeded 2mm, as indicated above. The coarse inclusions formed conglomerates of non-metallic particles

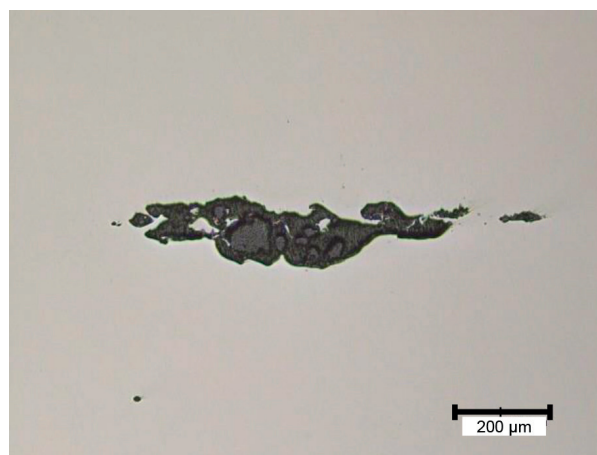
Fig. 7 Complex inclusion

the dominant constituent of which was brittle sharp-edged complex oxides on the basis of $\text{MgO} \cdot \text{Al}_2\text{O}_3 \cdot \text{CaO}$. An example of a complex inclusion at the place of ultrasonic indication is presented in Fig. 7. Besides these inadmissible discontinuities, tiny oxidic and oxysulphidic inclusions of micrometric dimensions as well as titan nitrides or carbonitrides were analyzed (Fig. 8).

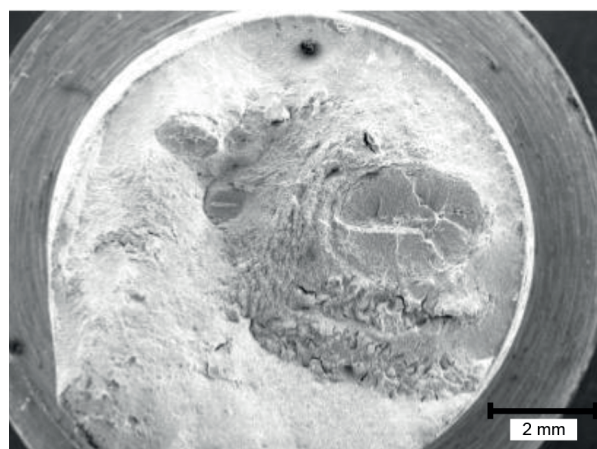
Fig. 11 Defective area with intercrystalline failure

significant fact is the presence of intercrystalline failure on the fracture area in the vicinity of the fish eyes, as apparent in Fig. 11.

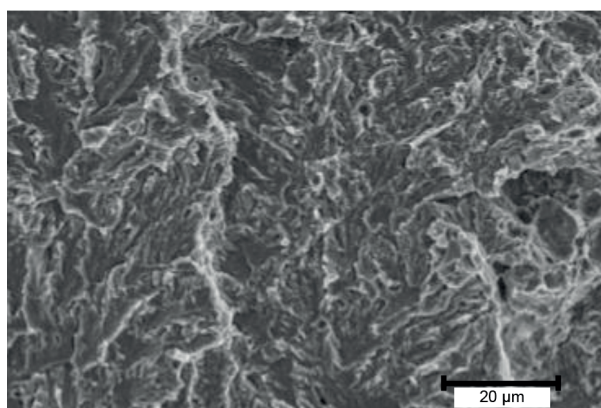
Fig. 9 Brittle transcrystalline cleavage

The following Fig. 9 presents the morphology of brittle transcrystalline cleavage. This was typical of substantial part of the fracture area. The fine cleavage facets are characteristic of the bainitic structure detected earlier by the metallographic analysis.

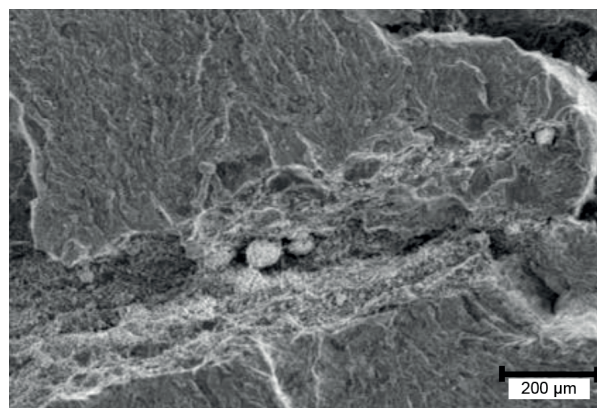
Fig. 12 Inclusions in rows

Figures 12 and 13 present inclusions in these defective zones of fracture areas. Figure 12 documents oxidic and oxysulphidic inclusions arranged in lines in the centre of the defective zone of the fracture area, Fig. 13 then shows these inclusions in detail.

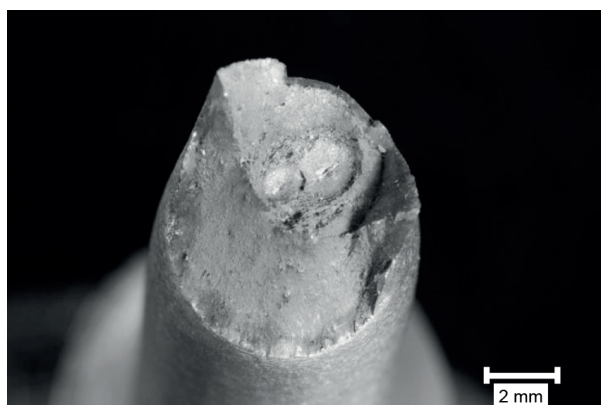
Fig. 10 Fish eyes in the fracture area

The fracture area of tensile tests featured defective zones which are typical as the so-called “fish eyes” (Fig. 10). The fish eye morphology is characteristic of defects resulting from hydrogen action [9]. This proposition is supported by the analysis of chemical composition. Apparently, the hydrogen content reached the value of 1.2 ppm, as opposed to the maximum admissible 0.8 ppm (see Table 1). Another

Therefore, one can state that the defect in the technological process, which was the broken porous block, hindered proper flushing and movement of the melt, which was degassed insufficiently at the same time. This resulted in both a substantial increase in the hydrogen content as well as increased content of oxygen. The increase in the hydrogen content by approx. 50% above the maximum admissible level led to hydrogen embrittlement taking effect in typical fish eyes and intercrystalline steel failure. The increased oxygen content resulted in substantial increase of the steel inclusion rate, which led to significant deterioration of its micropurity.
