# MONITORING OF SHALLOW-GROOVED TRAMWAY CROSSINGS

Magdalena Křečková\*, Hana Krejčířiková

Faculty of Civil Engineering, CTU in Prague, Prague, Czech Republic

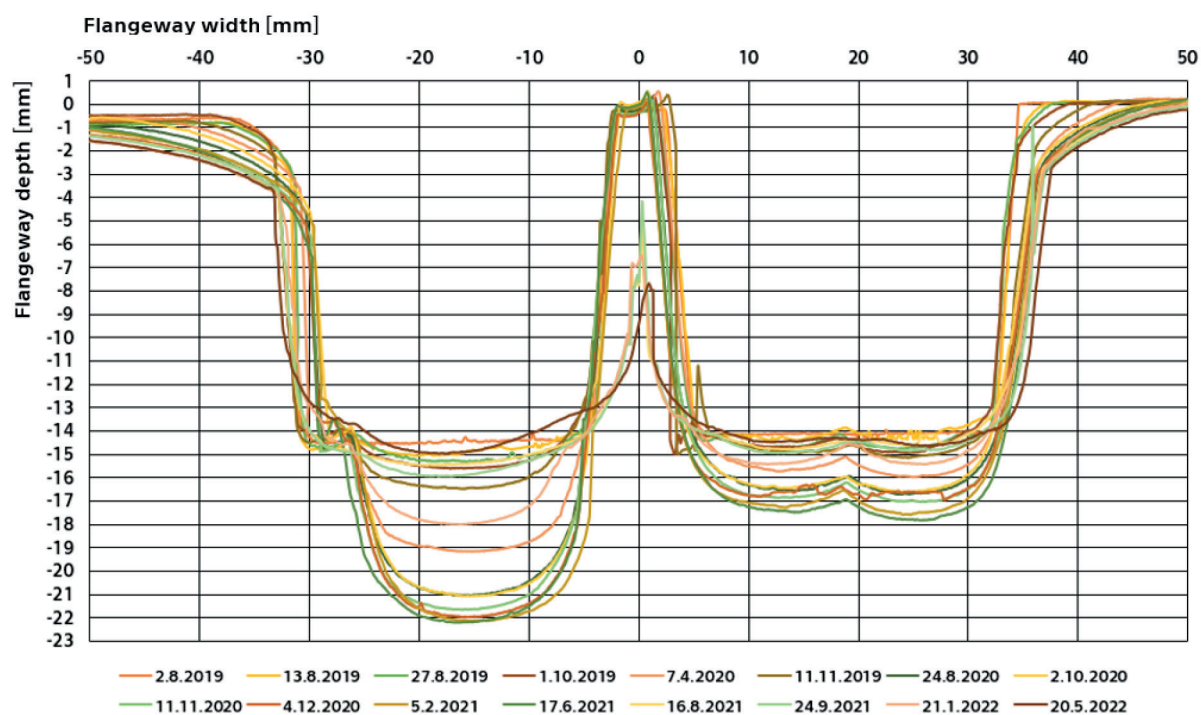
**Figure 3** Example of an evaluated profile of the exit nose of a crossing from the rail structure situated at the Rasin Embankment - Svobodova Street junction (Vyton Locality)

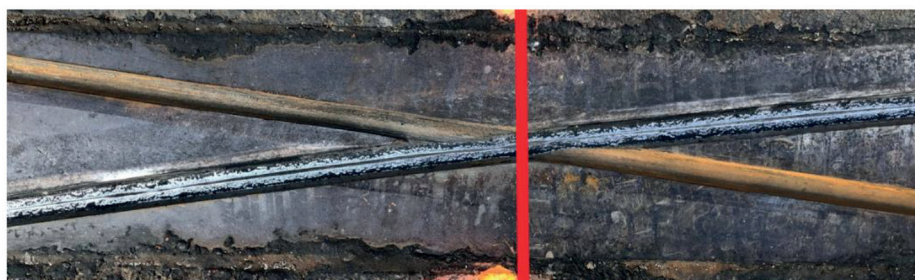
The wear and deformation development pattern at the crossing in the "Vyton" Locality has been chosen as an example (as shown in Figure 5). In particular, the figure displays the profile in the middle of the crossing

**Figure 4** Marked (with a red line) monitored transverse profile of the crossing presented in the article for illustration

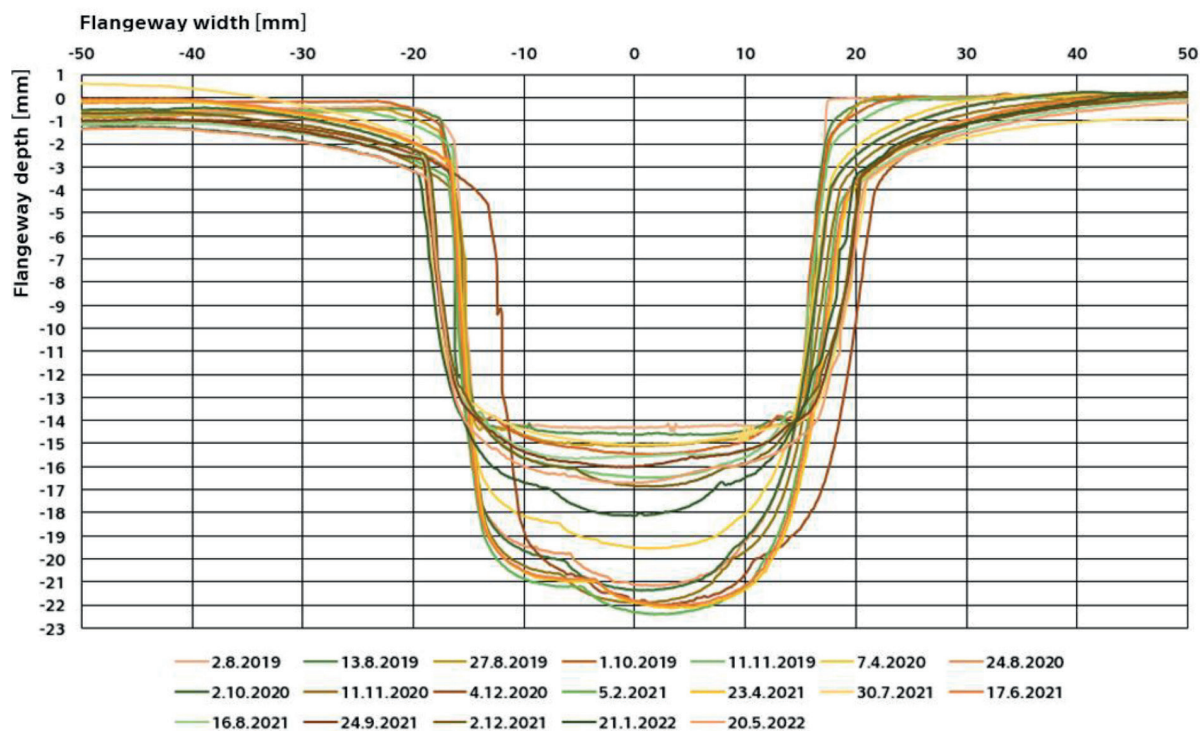
Figure 5 clearly shows that a vertical flangeway wear from a depth of 14 mm to a flangeway depth of 21.6 mm occurred from the installation of a new crossing (curve of 2.8.2019) to the condition before the crossing maintenance by welding on new material (curve of 17.6.2021). Successively, the flangeway bottom was welded (curve of 30.7.2021) and the flangeway depth was 15 mm. For illustration, see the diagram presenting the respective selected values, Figure 6.

From the above results, it can be concluded that the vertical wear of the crossing over a period of 22 months (from 2.8.2019 to 17.6.2021) was 7.6 mm. On closer examination of the measured results (as seen in Figure 5), it is evident that the wear is slower at the beginning of the crossing's life cycle. Subsequently, the flangeway is deepened more dramatically to a value of approximately 20.5 mm, at which the wear development pattern slows down again. The stabilization of the wear at the end of one life cycle of the crossing (before the flangeway bottom of the crossing is welded) is caused by a change in the contact interfaces between the wheel and the crossing. At the beginning of the life cycle, the crossing is travelled over by the wheel flange. However, the deepening of the flangeway results in the wheel being guided over the crossing on the wheel running surface. Subsequently, the lateral wear, in particular, increases and the vertical wear gradually stabilizes. At this point, the crossing is welded, as the shallow-grooved crossing has become a deep-grooved one, to which the crossing's geometry is not adapted.

Figure 5 Wear and deformation development pattern of the centre of the crossing in the "Vyton" Locality

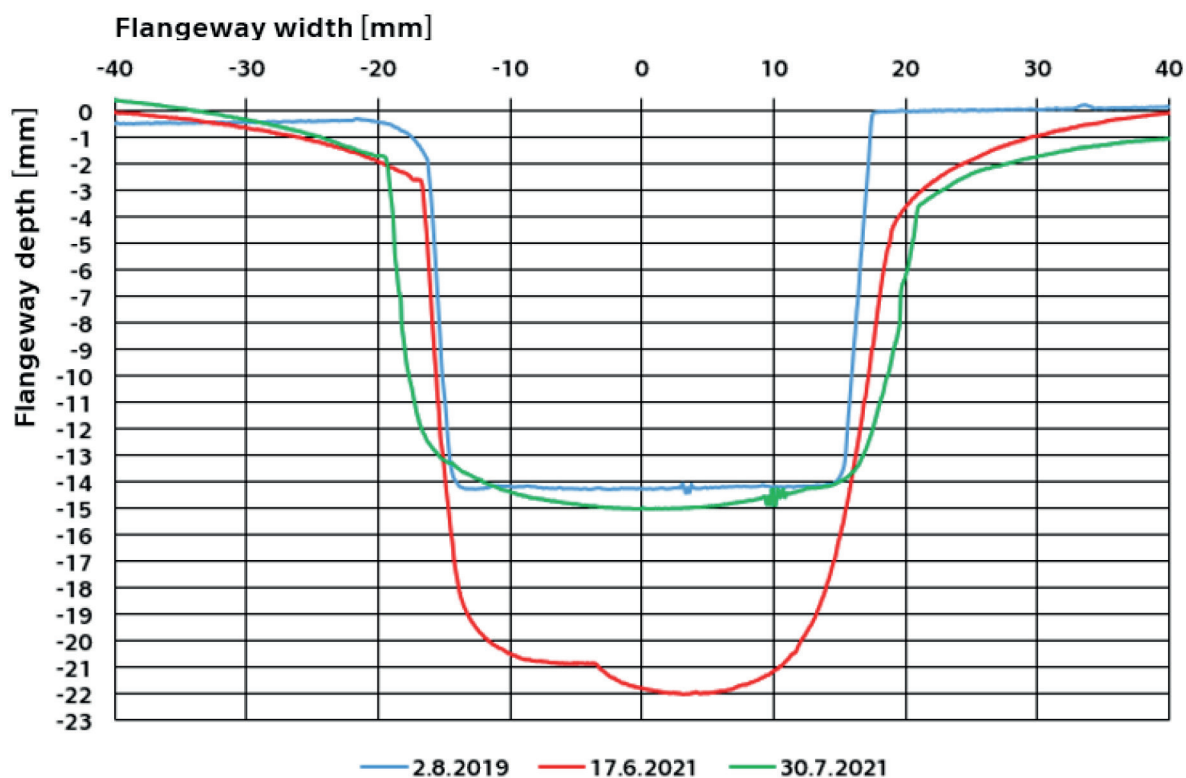
Figure 6 Selected data from measurements in the "Vyton" Locality.
