Libor Izvolt - Janka Sestakova - Michal Smalo*

ANALYSIS OF RESULTS OF MONITORING AND PREDICTION OF QUALITY DEVELOPMENT OF BALLASTED AND BALLASTLESS TRACK SUPERSTRUCTURE AND ITS TRANSITION AREAS

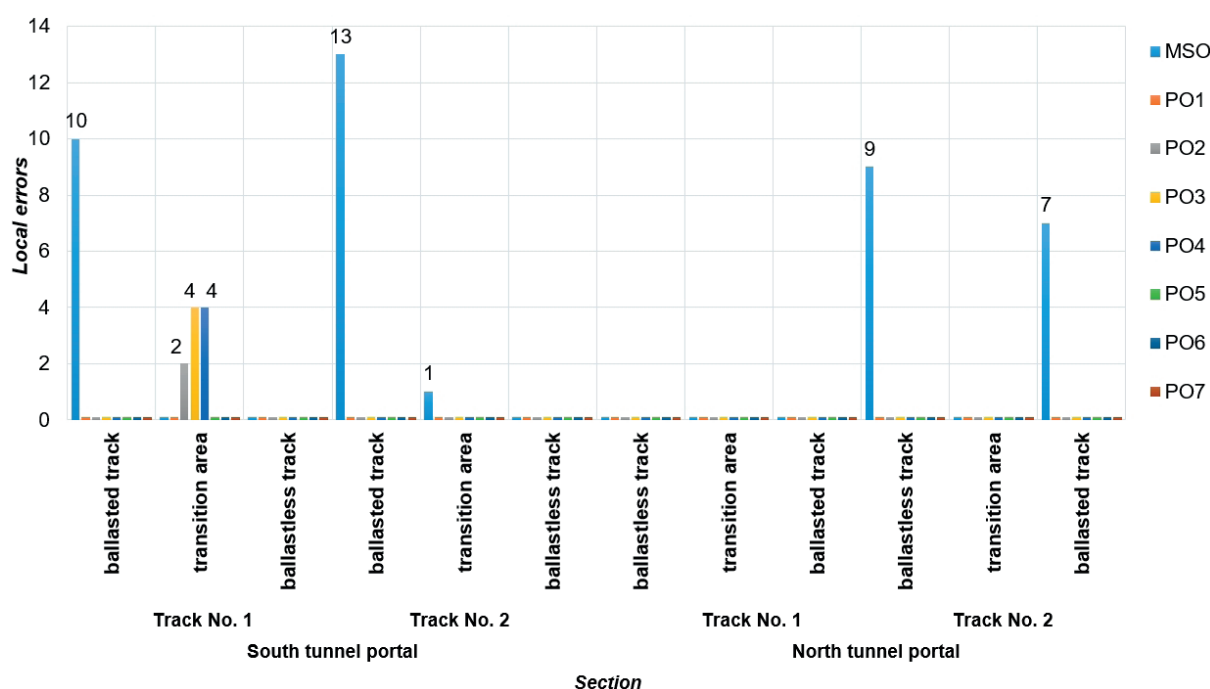
Fig. 2 Incidence of local errors in the monitored section- measurements carried out using measuring trolley KRABTM-Light

The overview of quality development of the track geometry of the monitored section is shown in Figs. 2 - 7. The incidence of local errors of measured parameters is stated separately for ballasted track sections, transition areas and for ballastless track sections (Fig. 2).

The experimental section monitoring has been carried out since July 2012, with six-month periodicity. The input measurement (MSO) was carried out 2 days before putting the track in operation. Within the input measurement, 40 local errors were recorded, out of them 30 in sections with ballasted track, 9 in sections with ballastless track and 1 local error was diagnosed in the transition area of the section 2.1. After this measurement, the supplier carried out the repair of track geometry and microgeometry of rail heads by grinding in the transition areas and in the sections with gravel superstructure (unfortunately, the supplier did not provide the details of repair works). The operational diagnostics has been applied seven times (PO1 to PO7).

In the second operational measurement (PO2), the local errors of the rail top level of the right rail (*VP*) and the top level of left rail (*VL*) were for the first time recorded in the transition area of the section 1.1, confirmed by the track geometry car of ZSR (Železnice Slovenskej republiky – the Railways of the

Slovak Republic). In the following measurements – PO3 and PO4 – further quality degradation of the section 1.1 was diagnosed, confirmed by the increased number of local errors (Fig. 2) as well as worsening value (increase) of the overall number of quality (Fig. 7). In November 2014, the railway infrastructure manager carried out repair interventions in the transition areas of the sections 1.1 and 2.1. In this way the diagnosed local errors were removed. The complex continuous diagnostics, carried out by the measuring trolley *KRABTM Light*, and monitoring by the railway infrastructure manager applying the levelling method from December 2014 to August 2015 in the sections 1.1 and 1.2 confirm further lowering of the track. Their values cannot at present be considered local errors as the operational tolerances were not exceeded. However, due to further degradation of particular parameters of the sections in question, incidence of local errors is expected in the near future. The sections 1.2 and 2.2 in the transition areas do not show any errors in values. The quality development in the measurements carried out so far do not indicate any probability of their incidence in further measurements [5, 6 and 10].

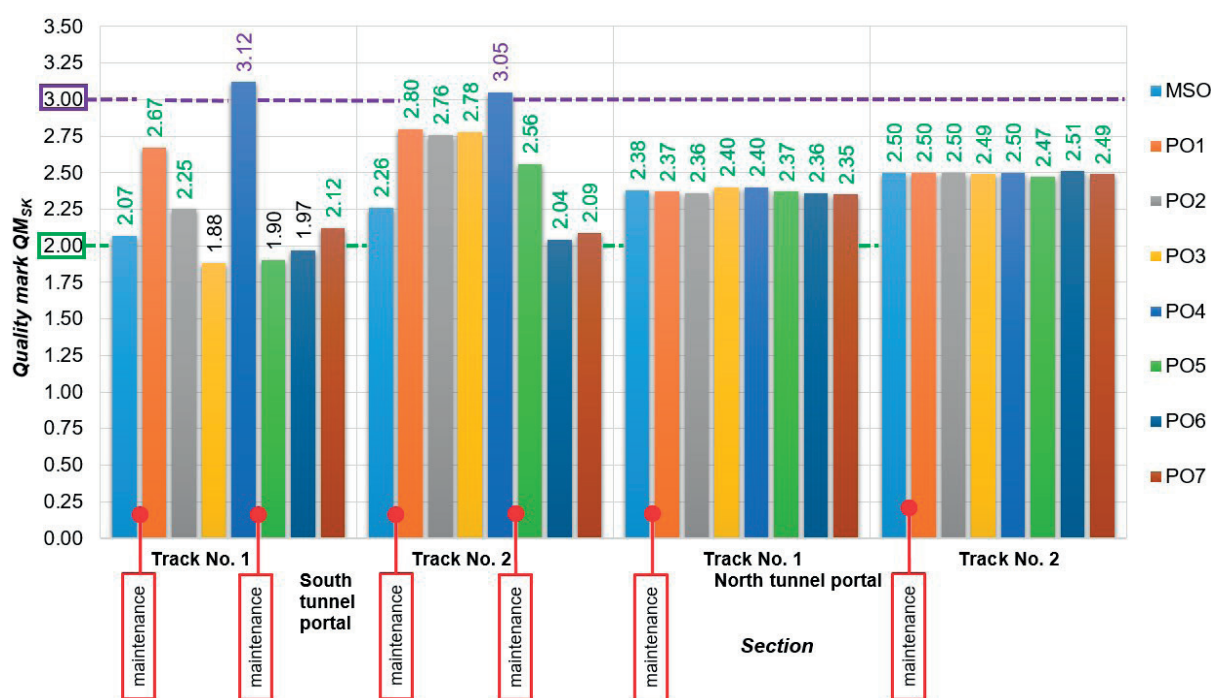
Fig. 3 Quality marks of the geometric quantity alignment of the right rail in respective monitored sections – measurement carried out by measuring trolley *KRABTM Light*

The quality marks of the alignment of the right rail (after calculation also of the left one) QM_{SK} (Fig. 3) were within MSO, PO1, PO2 and PO3 measurements placed in the interval $2 < QM \leq$

3 (recommendation: to design the repair of track geometry in the maintenance work plan) in all the monitored sections. The quality marks in the interval $3 < QM \leq 4$ (recommendation: to carry out the repair of the track geometry until the nearest inspection) were

reached in the sections 1.1 and 2.1 within PO4 measurement. After repair interventions before PO5 measurement, the values of quality marks improved (decreased) to the interval $0 < QM \leq 2$ (the state of the track geometry in the evaluated section is

satisfactory) in the section 1.1 or to $2 < QM \leq 3$ in the section 2.1. In PO7 measurement, slight deterioration of QM_{SK} in the section 1.1 was found out placing it to the interval $2 < QM \leq 3$.

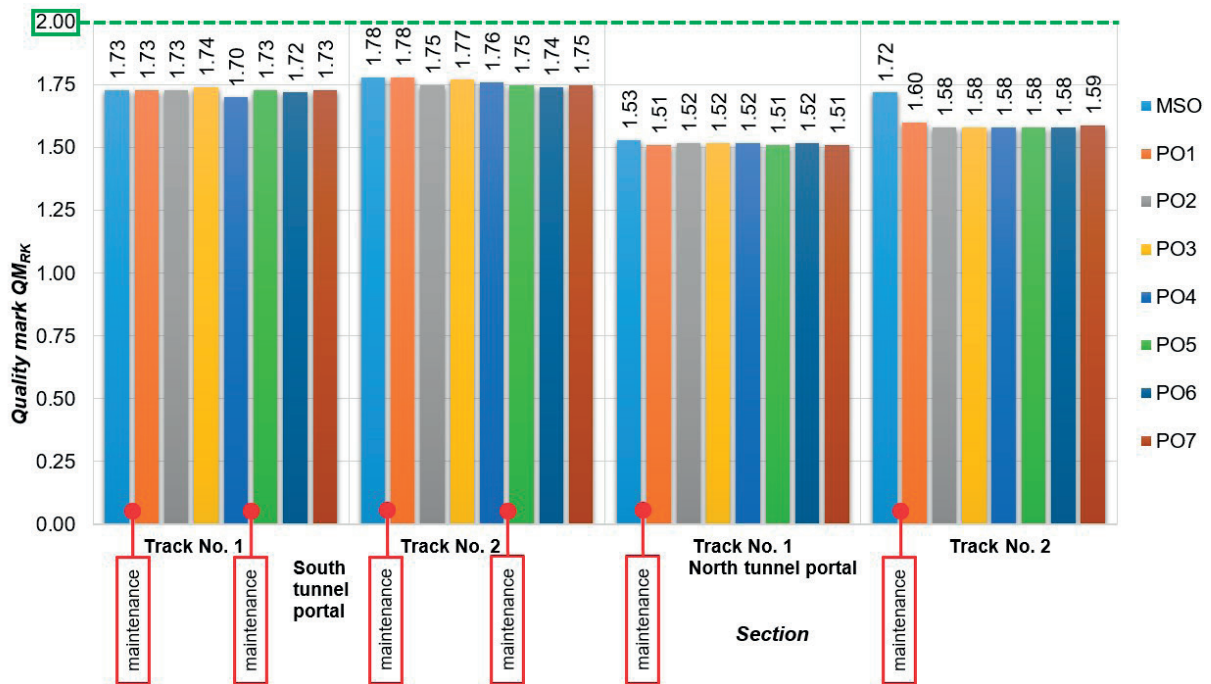
Fig. 4 Quality marks of the geometric quantity rail gauge tolerance in respective monitored sections - measurements carried out by measuring trolley KRABTM-Light

The quality marks of rail gauge tolerance QM_{RK} in all the sections and measurements are in the interval of values $0 < QM \leq 2$, which indicates that the state of track geometry is satisfactory (Fig. 4). Higher values of quality marks QM_{RK} in the sections 1.1 and 2.1 result from higher share of ballasted track sections compared to the sections 1.2 and 2.2 with prevailing better quality ballastless track (also securing higher durability of rail position). The values of QM_{RK} obtained by monitoring carried out during operation (measurements PO1 to PO7) present the rail gauge as a parameter with permanently satisfying quality development.

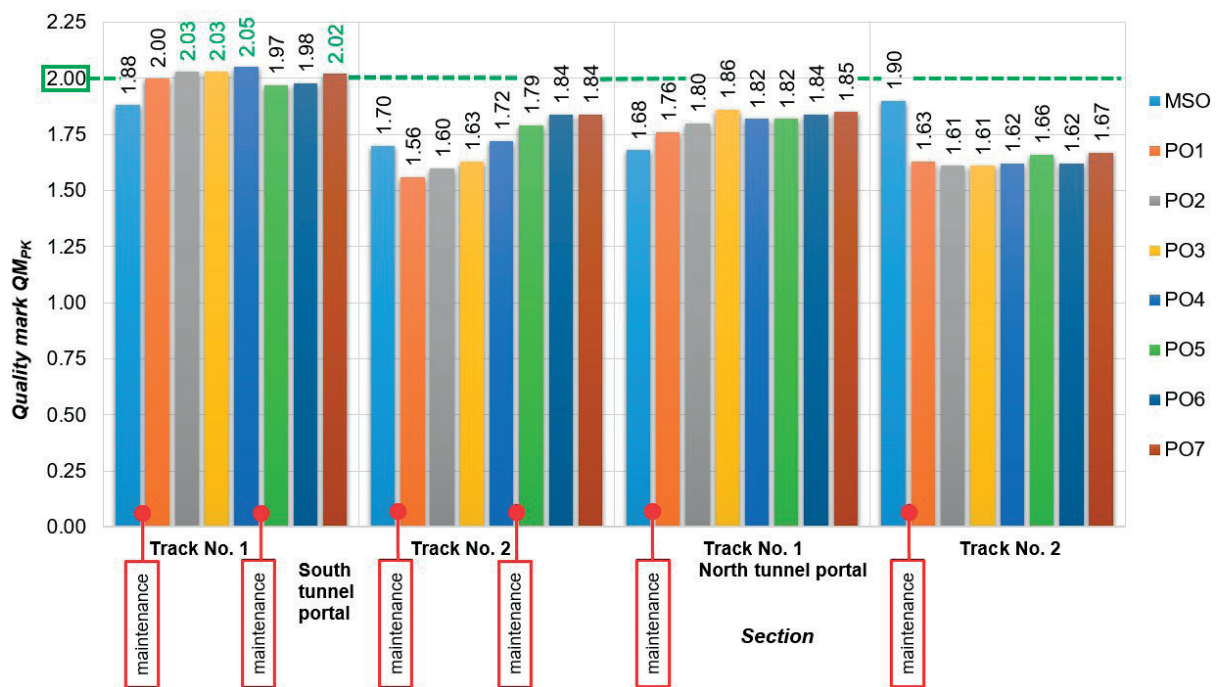
Fig. 5 Quality marks of the geometric quantity rail superelevation in respective monitored sections - measurements carried out by measuring trolley KRABTM-Light

The quality marks of superelevation QM_{PK} are in the interval of values $0 < QM \leq 2$ in all the sections and $2 < QM \leq 3$ in measurements PO2, PO3, PO4 and PO7 in the section 1.1. After repair interventions (after PO4 measurement) the values moved into the interval $0 < QM \leq 2$. The trend of quality increase in this section proven by measurements PO5 and PO6, is indicated as stopped by measurement PO7: the quality mark QM_{PK} is in the interval $2 < QM \leq 3$ (Fig. 5).

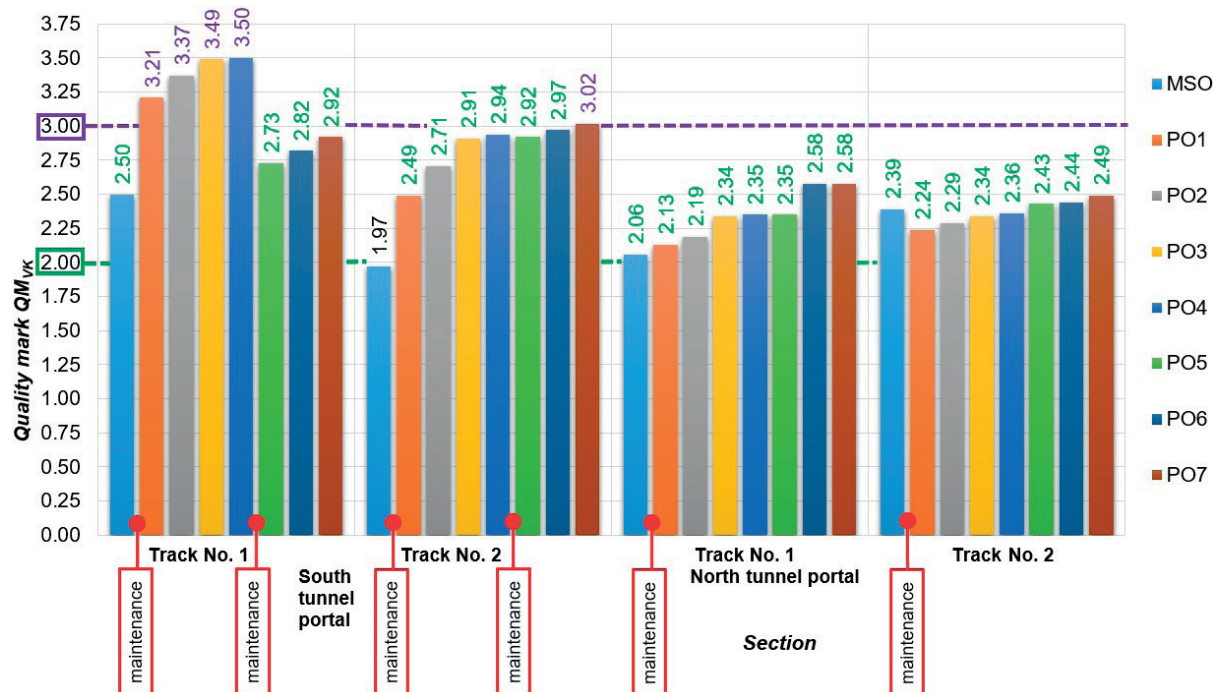
Fig. 6 Quality marks of geometric quantity rail top level of the right rail in respective monitored sections – measurement carried out by the measuring trolley KRABTM-Light

The quality mark with the worst development according to the measurements carried out so far seems to be the quality mark of the top level of the right (after calculation also of the left) rail QM_{VK} (Fig. 6).

The errors of the parameter of the top level of rails are the most frequently occurring defects, which is also confirmed by

evaluation of measurements by the track recording car of ZSR. With the exception of measurement MSO in the section 2.1, in all the measurements of monitored sections the determined values were $2 < QM \leq 3$ and in the measurements PO1, PO2, PO3 and PO4 in the section 1.1 the values were $3 < QM < 4$ which indicates the necessity to carry out the repair of track geometry until the nearest inspection. By the repair intervention carried out in sections 1.1 and 2.1, before measurement PO5, the values of QM_{VK} decreased. The measurements PO5 and PO6 placed these values into the interval $2 < QM \leq 3$. In the measurement PO7 QM_{VK} reached values in the interval $3 < QM < 4$, in the section 2.1. The tendency of quality mark deterioration in the section 1.1 predicts the determination of QM_{VK} value within the interval $2 < QM \leq 3$ in the near future.

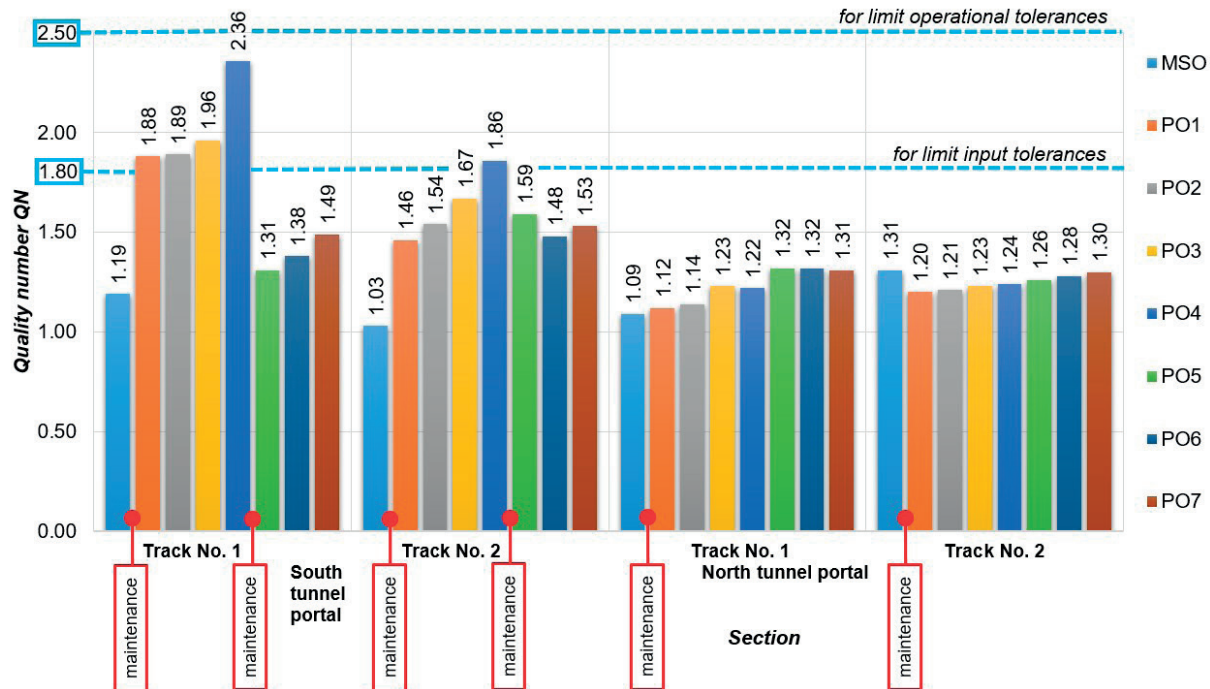
Fig. 7 Overall quality number in respective monitored sections – measurement carried out by measuring trolley *KRABTM-Light*

Within PO1, PO2, PO3 and PO4 measurements, further continuous quality deterioration of sections 1.1. and 2.1 was determined, as indicated by the overall quality number. The repair interventions, carried out in November 2014 by the railway infrastructure manager with the aim to remove the local errors of the parameter VK (top level of rail) as a priority, decreased significantly the values of quality numbers of respective sections, from the value 2.36 (PO4 measurement) to the value 1.31 (PO5) in the section 1.1 and from the value 1.86 (PO4) to the value 1.59 (PO5) in the section 2.1. The tendency of results of measurements PO5, PO6 and PO7 indicates certain increase and thus quality deterioration of sections 1.1 and 2.1. In the sections 1.2 and 2.2, the quality deterioration (QN increase) is slight only.

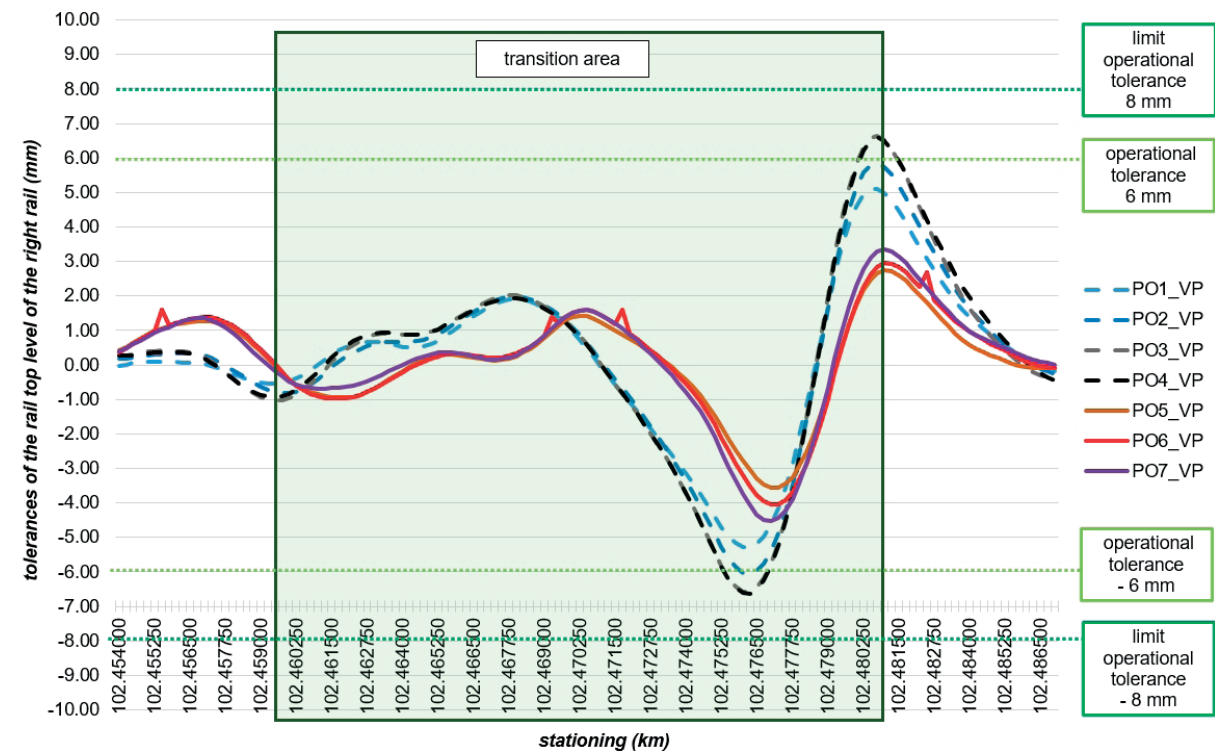
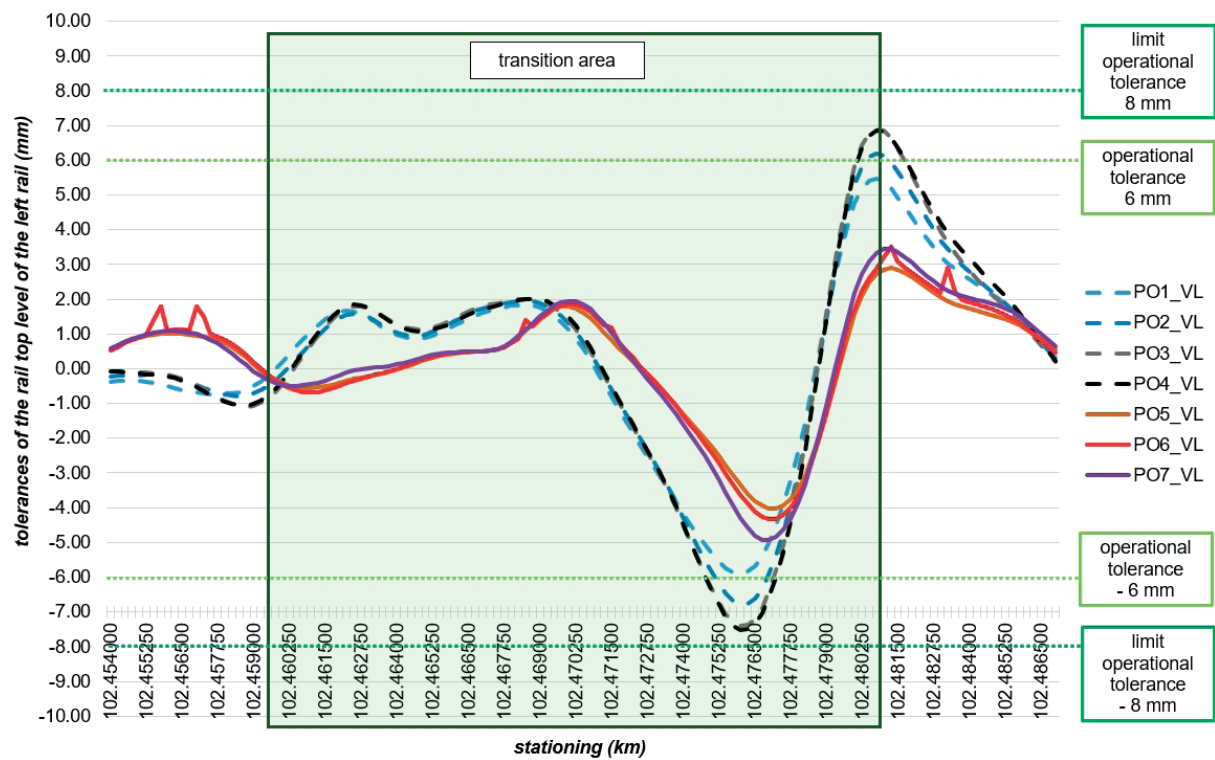
The tolerances of the top level of the right (after calculation also of the left) rail in the transition area of the section 1.1 (Figs. 8 and 9) detect the parameter errors on the level of exceeded operational tolerance defined by values ± 6 mm in the fourth operational measurement for the right rail, or in the third and

fourth operational measurement (upper limit + 6 mm) and in the second and fourth operational measurement (lower limit – 6 mm) for the left rail. The parameter error on the level of exceeded operational tolerance can be confirmed by errors detected by the measuring car of ZSR in individual measurements carried out within regular measurements in compliance with regulations for rail diagnostics. The completed repair of the track geometry in the transition area decreased the tolerance values but the places with limit tolerance values remained the same (contact of transition area with ballastless track and the start of the ballastless track structure).

Fig. 8 Tolerance of the top level of the right rail in the transition area of the section 1.1 (km 102.460 500 - km 102.480 500)

Fig. 9 Tolerance of the top level of the left rail in the transition area of the section 1.1 (km 102.460 500 - km 102.480 500)

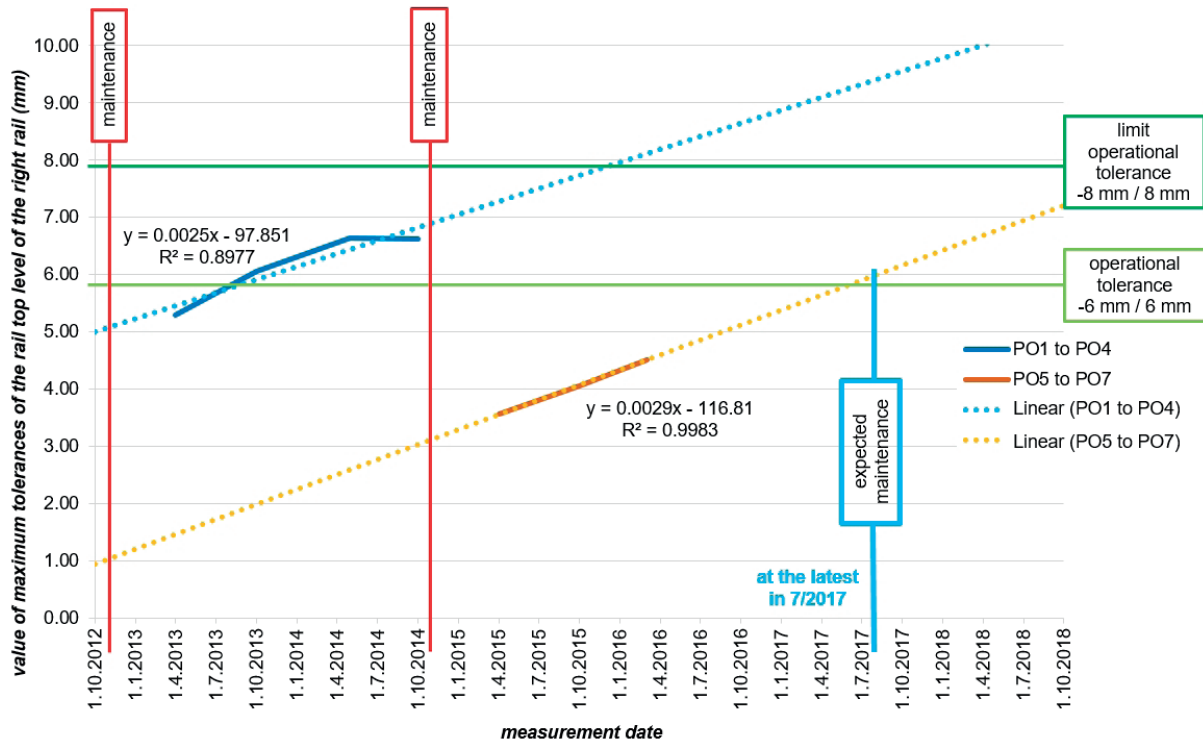
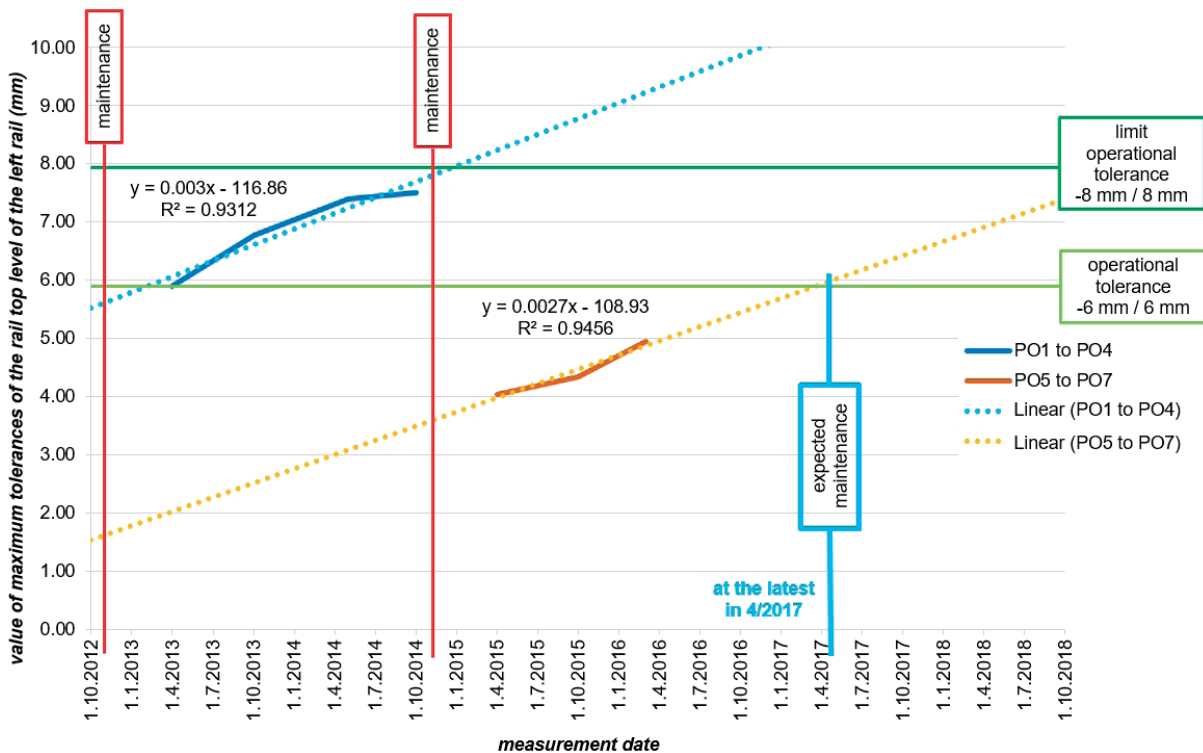
From the point of view of further quality development and subsequent maintenance planning, there was observed a tendency of development of maximum tolerances of both rails (Figs. 10 and 11) with the prediction of reaching the tolerance of the top level of

Fig. 10 Measurements PO1 to PO7 and the developmental tendency of maximum tolerances of the right rail in the transition area of the section 1.1 and its vicinity (km 102.454 000 - km 102.487 000)

Fig. 11 Measurements PO1 to PO7 and the developmental tendency of maximum tolerances of the left rail in the transition area of the section 1.1 and its vicinity (km 102.454 000 - km 102.487 000)

the right (left) rail on the level of exceeded operational tolerance. The developmental tendency shows that the absolute value of maximum tolerance of the top level of right rail will reach the level of operational tolerance at the latest in July 2017, the absolute value of the maximum tolerance of top level of left rail will reach the level of operational tolerance probably earlier – at the latest in April 2017, and these levels of exceeded operational tolerances should be detected within the second measuring campaign of the measuring car ZSR (in summer 2017). After detection of these tolerances, the infrastructure manager is supposed to plan and, as soon as possible, also to carry out the repair of track geometry in the respective section.
