Marek Patek - Augustin Sladek - Milos Mician *

DESTRUCTIVE TESTING OF THE WELD JOINTS ON SPLIT SLEEVE FOR BRANCH CONNECTIONS REPAIRS

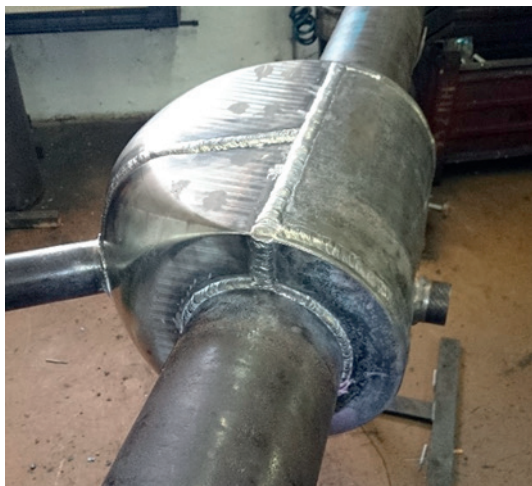
Weld joint analysis has been performed on the split sleeve for branch connections repairs (Fig. 1). Split sleeve consists of cylinder part and sphere-like part, which has to ensure safe installation of the sleeve to the repaired branch connection. Such type of split sleeve is joined together by butt welds and to the repaired pipes it is connected by circumferential fillet welds.

Fig. 1 Split sleeve for branch connection repairs

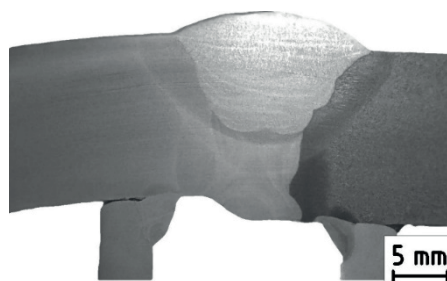
Macrostructural analysis of the split sleeve weld joints was performed in terms of the EN ISO 17639 standard. Four characteristic welds were selected to analysis. Macrographs of the butt weld joints are shown in Fig. 2 and 3. Unacceptable defects were not detected neither on the macrographs of the butt joint between cylindrical and sphere-like part (Fig. 2) nor in the macrograph of weld joint between sphere-like segments of the sleeve (Fig. 3). Some imperfections might be observed such as linear misalignment or excessive penetration. Dimensions of these imperfections are within the allowed range according to standards (ISO 5817-B). In the lower part of the Fig. 2 and 3 the sealant carriers can be seen, which serve to carry a sealants that isolates the places of welding from places where leaking gas is present. Large size of the root opening can be seen between the sealant carrier and wall of the sleeve in macrograph shown in Fig. 3. Weld joint between the sealant carrier and split sleeve wall are only supplementary and after the sleeve is welded onto the pipeline, it has no function. Such kind of defect might be consider as acceptable for the functionality of the split sleeve. Macrostructural evaluation of the weld between the cylindrical and sphere-like part (Fig. 2) shows significant heterogeneity of the joint, which might be a sign of inappropriate microstructure and also mechanical properties of the base metal.

Fig. 2 Macrograph of butt weld joint between cylindrical (left) and sphere-like (right) part of the sleeve

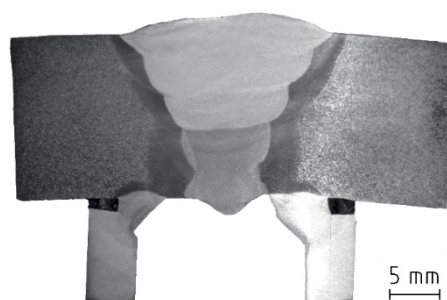
Fig. 3 Macrograph of butt weld joint between sphere-like parts of the sleeve

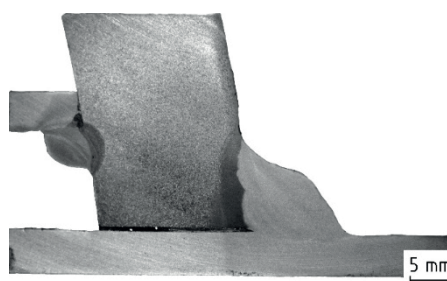
Typical macrographs of the girth fillet welds are shown in Fig. 4 and 5. Fillet welds do not show the presence of unacceptable defects similarly to the butt welds. Base metal and heat affected zone on the side of the sphere-like part also pointed out different character of macrostructure (Fig. 4) that confirms weld joint heterogeneity.

Fig. 4 Macrograph of fillet weld joint between sphere-like part of the sleeve and pipe

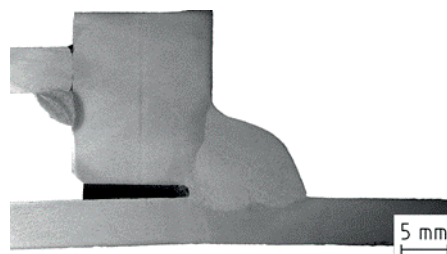
Fig. 5 Macrograph of fillet weld joint between cylindrical part of the sleeve and pipe

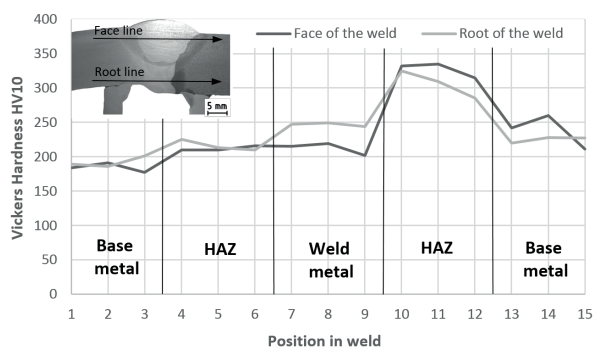
ISO 9015-1 standard. Significant increase of Vickers hardness can be seen in heat affected zone (HAZ) of the weld on the sphere-like side of weld joint (Fig. 6 - 8). In these areas hardness reaches values higher than 300 HV and in some cases it almost reached maximal allowed value for this type of material (380 HV without heat treatment according to EN ISO 15614-1 standard). Hardness of weld joint on the side of cylindrical part of the sleeve did not significantly increase in HAZ (Fig. 6, 8 and 9).

Fig. 6 Hardness of butt weld joint between cylindrical and sphere-like part of the sleeve

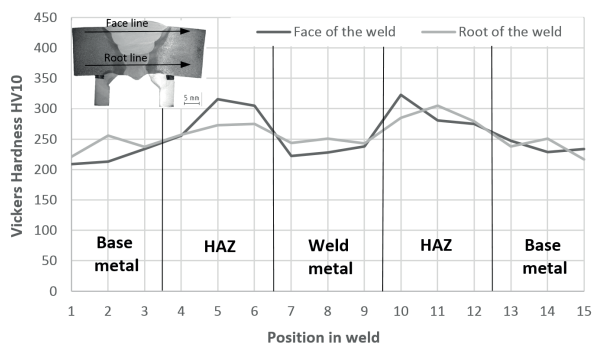
Fig. 7 Hardness of butt weld joint between sphere-like parts of the sleeve

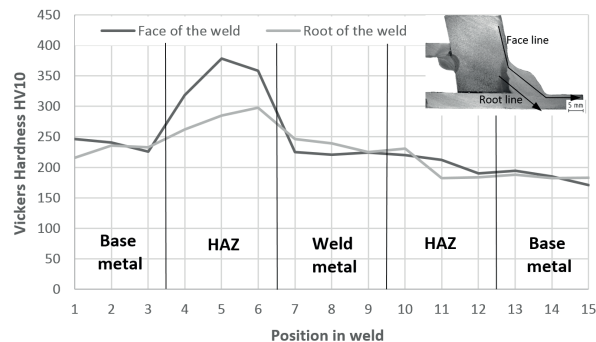
Fig. 8 Hardness of fillet weld joint between sphere-like part of the sleeve and pipe

Higher carbon level leads to significant increase of the hardness (up to 378 HV), especially in fillet welds with increased heat transfer to the wall of the sphere-like part of the sleeve. Welding and cooling conditions then lead to increased cooling rate in HAZ of the fillet weld on the sleeve side and increasing of the Vickers hardness. This effect together with material structure sensitive to hard and brittle phase formation may cause exceeding of the hardness tolerance.

To prevent similar behavior of the weld joints, there should be performed measurement of chemical composition before machining of the semi-product and/or full annealing of steel block or manufactured part should be applied. Even when some insufficient material properties can be present, repairing

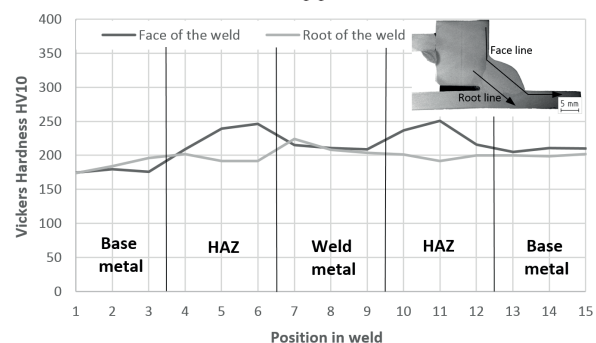
Fig. 9 Hardness of fillet weld joint between cylindrical part of the sleeve and pipe

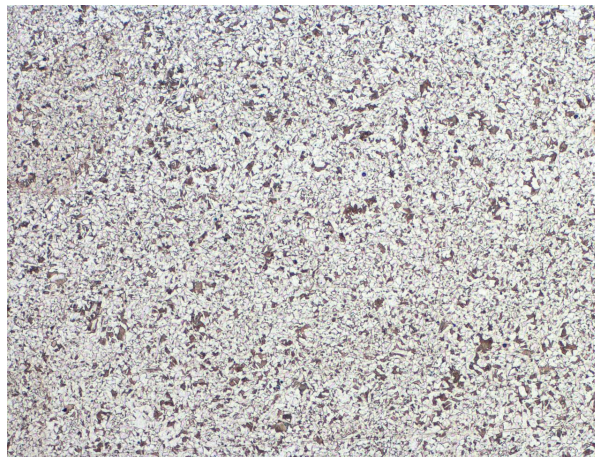
Microstructure analysis was performed in order to verify microstructure of the sphere-like part of the split sleeve. Characteristic microstructure of sphere-like part of the sleeve is shown in Fig. 10. Microstructure is formed by large perlite grains surrounded by ferritic envelopes. Base metal microstructure of the cylindrical part of the split sleeve (Fig. 11) is fine-grained ferritic-pearlitic and corresponds with S355 grade steel quality.

Fig. 11 Microstructure of the cylindrical part of the sleeve, etch. 5 % Nital
