Josef Vican – Jozef Gocal – Jozef Jost *

FATIGUE RESISTANCE OF TYPICAL FATIGUE PRONE RIVETED STEEL RAILWAY BRIDGE STRUCTURAL DETAIL

Department of Structures and Bridges, Faculty of Civil Engineering, University of Zilina, Slovakia E-mail: josef.vican@fstav.uniza.sk

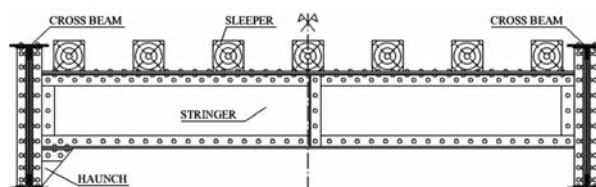
Fig. 2 Arrangement of a typical stringer to cross-beam connection with/without reinforcing haunches

Because of limited possibilities of the applied pulsating device as well as due to the economic aspect, the common static scheme of real stringers as a simply supported beam (supported by cross-beams), loaded by reactions from sleepers (see Fig. 2), could not be applied. Therefore, a cantilever loaded by one force at the free end was used as the static scheme for laboratory testing (see Fig. 3). Six specimens were manufactured of steel S235 in all. All specimens consisted of the web from steel plate of $P 10 \times 390 - 1115$ and flanges made of two angles $L 80 \times 80 \times 8 - 995$ mm connected to the web by means of rivets with diameters of 22 mm. Stringer was connected to the hot rolled cross-beam of IPE 700 by means of two angles $L 80 \times 80 \times 8 - 692$ mm using 16 bolts of $M 24 - 8.8$ in the case of specimens of type I and II. Three specimens were reinforced by triangular haunches at the connection to cross-beam (Fig. 3b) and other three specimens were manufactured without the haunches (Fig. 3a).

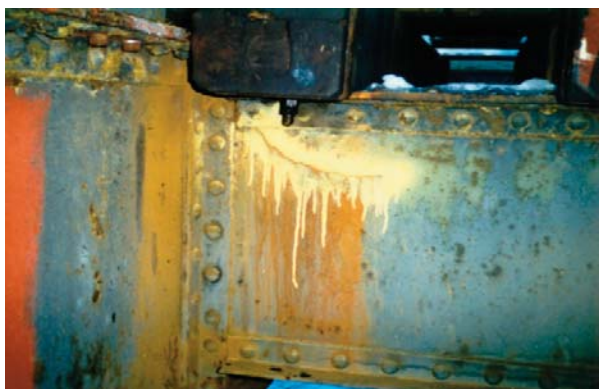
case of railway bridges with open bridge decks are typical details prone to fatigue cracks. Webs of stringer and cross-beam are only connected without flange mutual connecting, so that the joint is usually verified on the shear and normal forces only [7]. Due to connection arrangement and certain bending stiffness, the bending moment is arising and producing normal stresses causing the crack in the form given in Fig. 1.

Fig. 1 Example of fatigue crack in the investigated detail

Different form of the cracks in the real bridge stringer webs (see Fig. 1) and the ones in tested specimens (see Fig. 7) was caused due to discrepant stringer static system. While stringer in Fig. 1 seems to be quasi simple supported beam, the static system of the tested stringers is cantilever (see Figs. 4 and 5).

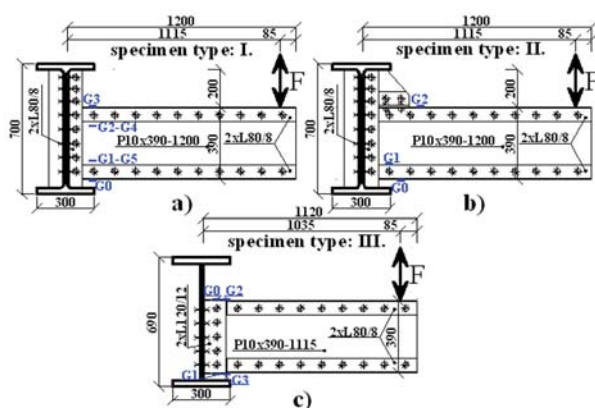
After testing the six aforesaid specimens, other five specimens of type III (see Fig. 3c) were obtained adjusting the previously tested stringers. The connecting angles were cut off and the new connecting angles $L 120 \times 120 \times 12 - 400$ mm were riveted to the free end of the specimens by means of 10 bolts $M24 - 8.8$. The new connecting angles were shortened compared to previous six specimens in order to situate measuring gauges above the first and below the last rivet, respectively, since the fatigue crack was supposed to develop from this point. Thus, eleven test specimens were tested altogether. One of the specimens was used for destructive tests to determine the material characteristics. The following material characteristics were obtained by testing – the yield strength $f_y = 244.92$ MPa and the ultimate strength $f_u = 360.77$ MPa.

Fig. 3 Configuration of laboratory specimens without haunch (I), reinforced by haunch (II) and new specimens without haunch (III) and specimen gauge arrangement

All the specimens were gradually subjected to fluctuating bending moment through the application of concentrated vertical load situated at the distance 1 115 mm from the supporting cross-beam (see Fig. 3), in the case of specimen type I and II and 1 035 mm, in the case of specimen type III, respectively. For all specimens, the loading force was floating between positive and negative limit values (see Fig. 3). At the start of fatigue test, each specimen was loaded statically at the maximum and minimum values of the loads that would be applied during the fatigue test. In the case of specimens with reinforcing triangular haunches the absolute values of maximum (positive) and minimum (negative) loading forces were different, i.e. the normal stresses in the observed points of the stringer web (see Fig. 3a) oscillated around the mean stress different from zero. In the case of specimens without haunches the absolute values of maximum (positive) and minimum (negative) loading forces were the same, i.e. the normal stresses in the observed points of the stringer web (see Fig. 3b) oscillated around the mean stress close to zero.

Normal stresses in the stringer web were measured by means of gauges LY11-6/120 manufactured by Hottinger-Baldwin Messtechnik [6]. Location of gauges is shown in Fig. 3. Measured data was recorded by measuring equipment Spider 8, controlled by computer software Catman. Fatigue test arrangement is shown in Fig. 5.

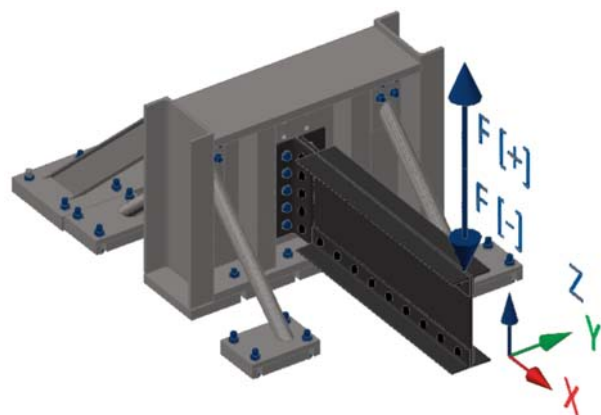
Fig. 4 Configuration of a laboratory specimen and the pulsating forces

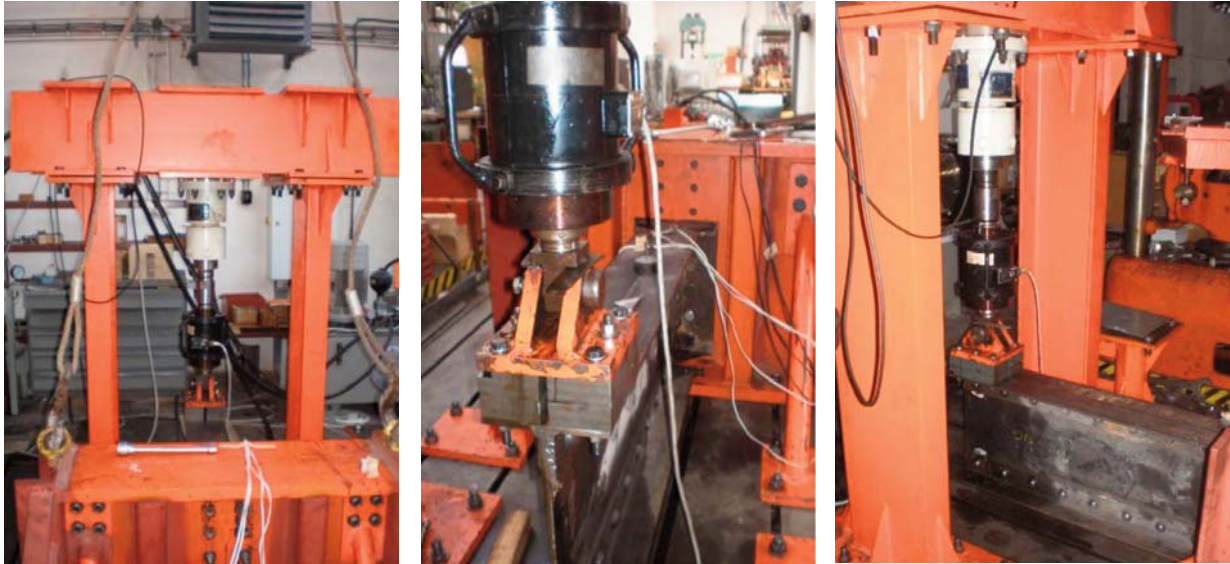
Fig. 5 Illustration photos from fatigue tests

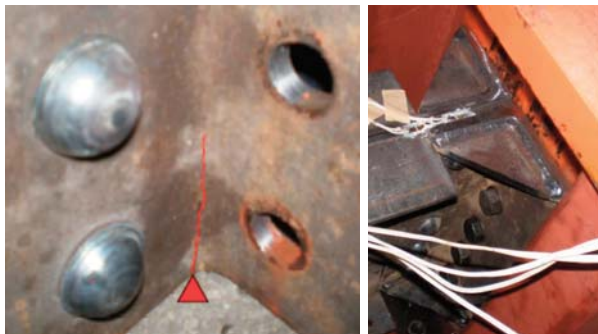
resent the results of the last tests in 2010. As it was mentioned above, eleven specimens altogether were experimentally investigated, but one specimen failed due to cracks in connecting angle, so that its result had to be rejected. In order to avoid this type of failure, the remaining four specimens were reinforced by means of triangular sheets welded between angle flanges according to Fig. 6.

Fig. 6 Failure of specimen due to crack in the angle and reinforcement of this detail

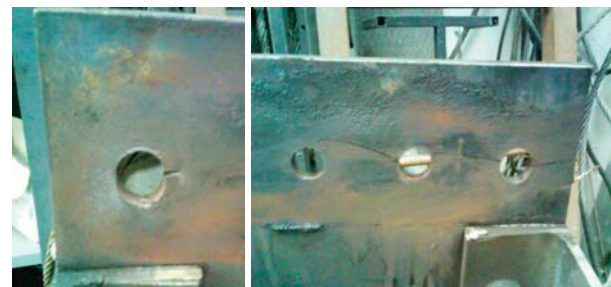
Typical failure of the investigated detail is presented in Fig. 7. Picture on the left side shows the out-of-roundness of the hole diameter due to material cyclic plasticity after which the beam global deflection is rapidly growing. The picture on the right side shows the classic type of fatigue failure in the form of crack starting from the rivet hole.

Fig. 7 Types of detail fatigue failures

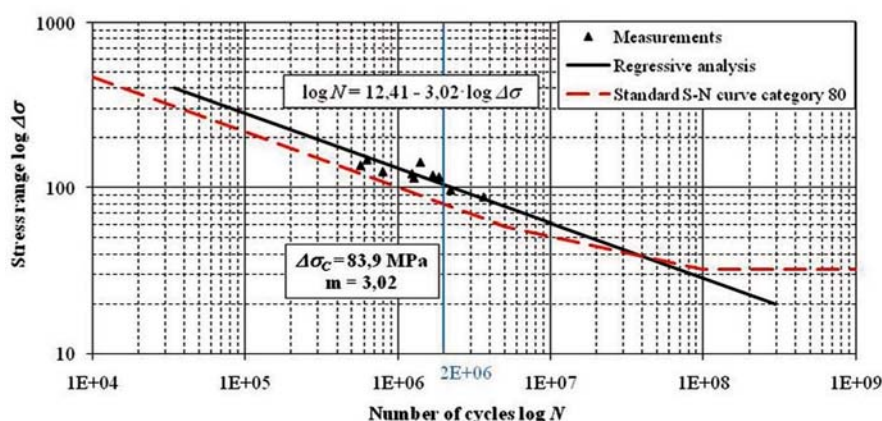
These results were subjected to linear regressive analysis (see Fig. 8) according to the Appendix L in STN 73 1401[5], in which $\log \Delta\sigma$ represents an independent variable and $\log N$ represents a dependent variable with normal probability distribution. Based on the regressive analysis results, the fatigue resistance of investigated detail corresponding to 2×10^6 cycles is $\Delta\sigma_C = 83.9$ MPa.

Fig. 8 Results of fatigue tests

Therefore, the detail can be classified to the category 80 with characteristic fatigue strength $\Delta\sigma_C = 80$ MPa in accordance with [1].
