## ANALYSIS OF THE IMPACT OF MICROCLIMATE IN A ROOF SPACE ON A GOTHIC TRUSS CONSTRUCTION

**Keywords:** Historical truss, timber construction, relative air humidity, air temperature, absolute moisture of wood.

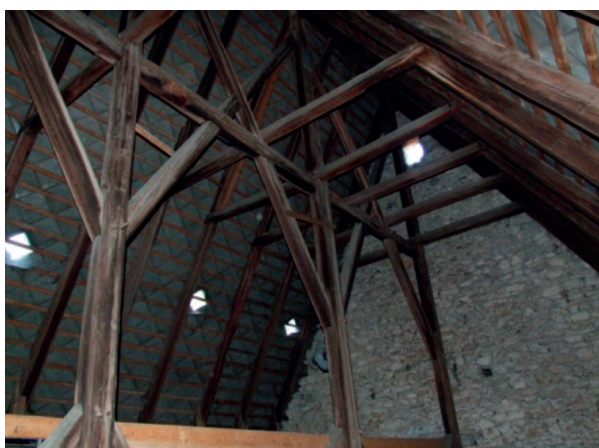
Fig. 2 View into the truss space

The Roman-Catholic church of the Most Holy Body of Christ was built as a stand-alone building, situated from the north to the west, in the middle of a fenced area in the historical centre of the village of Bela-Dulice (see Fig. 1). It probably arose in the first half of the 14th century. It has two separated truss structures, over the nave and the sanctuary. The truss over the nave was a subject of our investigation [2]. The steep truss over the nave has a rafter construction with collar beams, it is longitudinally bound with a central framed trestle (see Fig. 2), and it is dated from 1409d. It has 10 bonds, where 4 are full with 2 intermediate ones among them. In full bonds, central posts intersect collar beams; they are lapped over with rafters in the top. Symmetrical struts stabilize the post and join it with a tie beam. Rafters are mortised into the ends of tie beams. Tall oblique struts are used as a lateral reinforce. All joints are made using treenails. Central standing trestle is composed of a frame consisting of a sill beam, 4 posts which are, approximately in 3/5, divided with horizontal struts. Symmetrical bottom struts stabilize the posts in longitudinal direction, like in transversal one. Diagonal struts serve as a bracing for the entire framed structure. There are 3 larger openings in the roof space: the passage opening in the parting gable between the trusses over the sanctuary, and a smaller one in the upper part over the roof ridge of the sanctuary. Additional openings are: an entrance into the tower, a continuous slot between roofing and a profiled cornice – Fig. 3. The truss was renovated more times in the past; about 60% of original wall plates were replaced in 2011. Approximately 80% of the truss construction preserved its originality up to the present days.

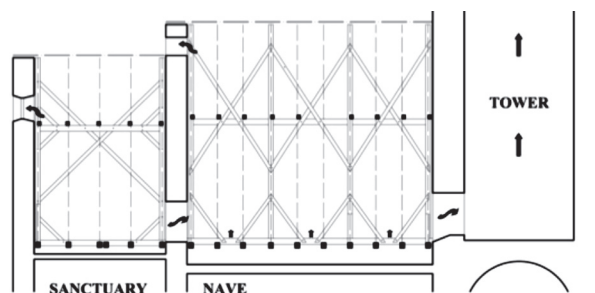
Fig. 3 The dispositional scheme of vents in the investigated truss; right - the truss cross-section, left - the truss longitudinal section

The examined pitched roof has a slope of  $59^{\circ}64'$  [5] with gable walls. The roof deck comprises sheet copper roofing used in strips; the joints of particular strips have standing seams. As the roof space is open towards the outside - it has openings as in the lower so in the upper part of the roof deck, in the top of the gable wall, passage openings in the tower gable wall and in the truss gable wall over the sanctuary - the roof can be considered as a ventilated double-cladding pitched roof.

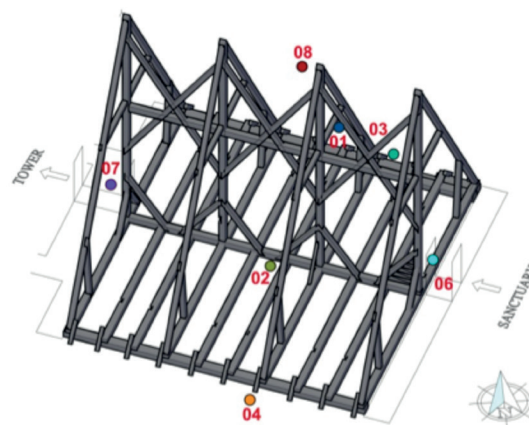
Fig. 4 The dispositional scheme of sensors VI used as a measuring system

To enter reliable and real data into the airflow simulation, and to detect an actual as well as a long-term impact of microclimate in a roof space on the moisture accumulation in timber elements, the measuring system with two types of sensors for a particular space was designed. Particular temperature and relative air humidity sensors, and also sensors for scanning the temperature and absolute moisture of timber elements are found on spots where there is a precondition of airflow. Their disposition is symmetrical in relation to the roof ridge, i.e. they are disposed evenly on the western and southern side in the roof space. Some sensors are located in the lowest roof part, exactly in the exterior under the gutter cornice (sensor 01 and 02). Additional sensors have their positions in the exterior near the opening in the eastern

gable wall, in openings in gable walls leading into trusses over the sanctuary (06) and into the tower (07). Other sensors are found in the roof space - in the middle of the object under the roof ridge (08), and in the midpoint of the roof plane length (03 and 04) - see the scheme in Fig. 4.

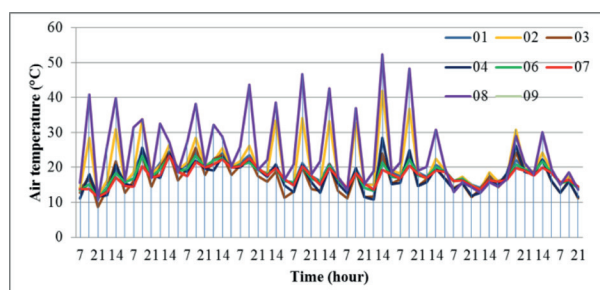
Fig. 5 The course of air temperatures recorded at 7:00, 14:00 and 21:00 o'clock - spring season 2012 (18.5.2012 - 5.6.2012)

Temperatures and relative air humidity are monitored with sensors at 15-minutes intervals. For calculations, data gathered at 7:00, 14:00 and 21:00 o'clock within summer time, and at 8:00, 15:00 and 22:00 o'clock during winter time was considered - Fig. 5 and Fig. 7. Average day temperatures and relative air humidity are calculated using obtained data - Fig. 6 and Fig. 8. All evaluated data from sensors, as in spring so in autumn season, reached temperature maximums at 14:00 o'clock - Table 1. Most sensors recorded temperature minimums at 7:00 o'clock; and all sensors in autumn season. As to complete evaluation, sensor No. 8 (located closely to the roof ridge) recorded the highest temperatures at 7:00, 14:00 and also at 21:00 o'clock. Relative air humidity goes to minimum in these spots. The roof ridge has no ventilation, thus there isn't any obvious airflow. There is sheet copper roofing used in strips on wooden slabs. The sensor No.07, found in the gable wall opening running into the tower, registered temperature minimums at 14:00 o'clock. At the same time, temperatures that were monitored with this sensor showed the smallest differences.

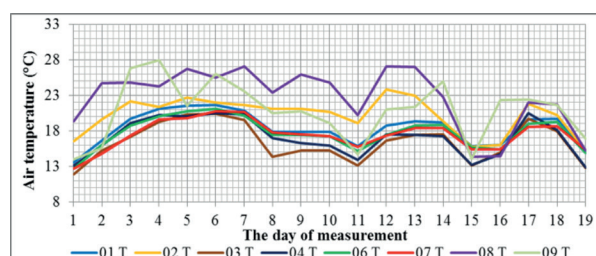
Fig. 6 Average day temperatures - spring season 2012 (18.5.2012 - 5.6.2012)

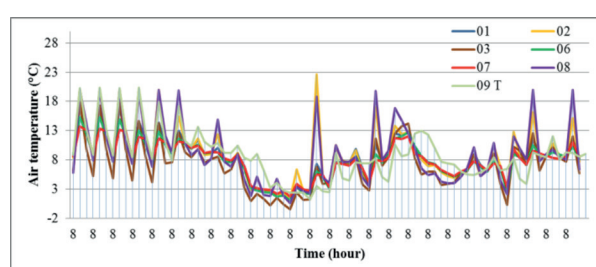
Fig. 7 The course of air temperatures recorded at 7:00, 14:00 and 21:00 o'clock - autumn season 2012 (18.10.2012 - 13.11.2012)

In most cases, temperature minimum was recorded with sensor No. 04, position of which is in the exterior on the northern side of a building, and with sensor No. 03 located near eaves in the exterior on the northern side of the building. Lowest temperatures in both seasons were found out using the outdoor sensor on the northern side of a building under the gutter cornice. Sensors No. 08 (under the roof ridge) and No. 02 (under roofing on the southern side of building) monitored considerable temperature fluctuations. It is these spots in the truss that air overheating occurs, which is caused by the effect of sunrays during the day.

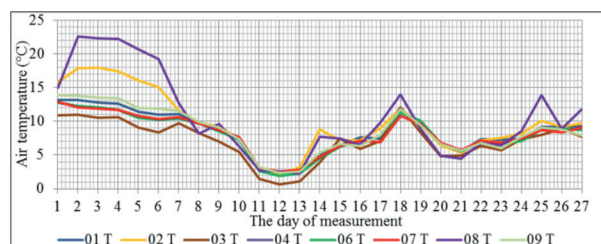
Fig. 8 Average day temperatures - autumn season 2012 (18.10.2012 - 13.11.2012)

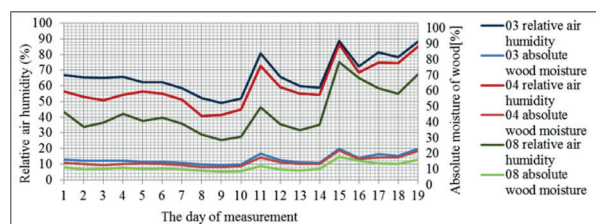
Fig. 9 The dependence of relative air humidity and absolute moisture of wood - calculated values, spring season 2012 (18.5. - 5.6.2012)

In accordance with calculations, absolute moisture of timber during the spring period in 2012 (see Fig. 9) fluctuated from 9.5 to 19.8%. The highest values of moisture (average moisture of 13.2%) are related to the timber elements on the northern truss side near eaves; the lowest ones (average moisture of 8.23%) regards the elements under the roof ridge. The highest values of moisture do not go over the critical limit which is optimal for arising such conditions that could cause damage of timber, e.g. ligniperdous insects, dry rot etc. [3].

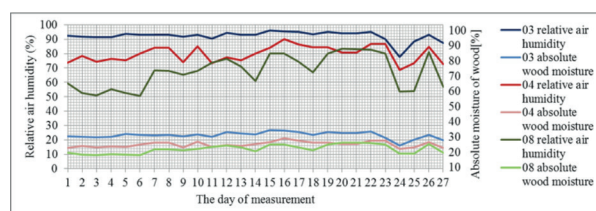
Fig. 10 The dependence of relative air humidity and absolute moisture of wood - calculated values, autumn season 2012 (18.10. - 13.11.2012)

Absolute moisture values during the autumn period in 2012 (see Fig. 10) ranged between 10 - 27%. Generally, relative air humidity is higher than in the spring and therefore moisture of timber elements is noticeably higher. The highest values of moisture (average 23.22%) were found out in timber elements on the northern side of the truss structure near eaves; the lowest ones (average 13.61%) concerned the timber elements under the roof ridge. In the view of the fact that moisture of timber elements exceeds critical values for the activity of ligniperdous pests, and the time during which the effect of higher relative air humidity is much longer, there is a high risk of occurring biotic damage of timber components.

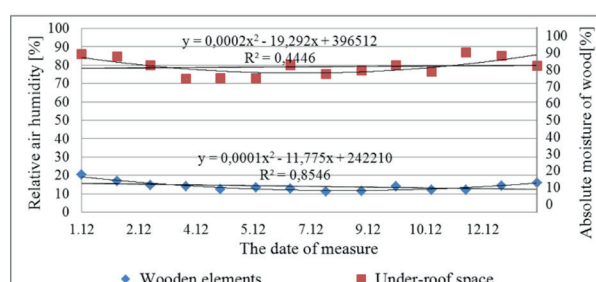
Fig. 11 Behaviour of relative air humidity in the roof space and values of absolute moisture, measured in timber elements of the fourth bond - the village of Bela-Dulice [8]

Values of moisture in timber components were confronted with the values that were obtained by direct measurements with the device Greisinger. Measured relative air humidity in the roof space reached the values of outdoor air characteristics. Year-long measurements regarding moisture in timber components of the fourth bond indicated that average values of absolute moisture of wood exceeded 20% only in one case - in January. Next month average moisture was 17%, and after that time values of moisture did not go over 13%. As late as in winter season the values were higher than 16% - see Fig. 11.

Calculated values were compared with values of absolute moisture of timber elements that were measured with the hand-device within experimental measurements using resistant hygrometer Greisinger. Measured absolute moisture of wood moved on lower level, in critical seasons it did not overrun critical values of absolute moisture of wood. On the basis of data confrontation it is possible to suppose that under the influence of venting in specific spots or areas in the truss space, there is a local change of conditions in microclimate, which can be seen as a change of moisture in particular timber elements.
