ENSURING OPERATIONAL RELIABILITY OF OVERPASS ON "ALMATY-KAPSHAGAI" HIGHWAY SECTION IN KAZAKHSTAN

The article presents results of the overpass condition survey, technical survey, static tests and assessment of the structure operational reliability, a double-decker overpass on Almaty-Kapshagai highway section in Kazakhstan.

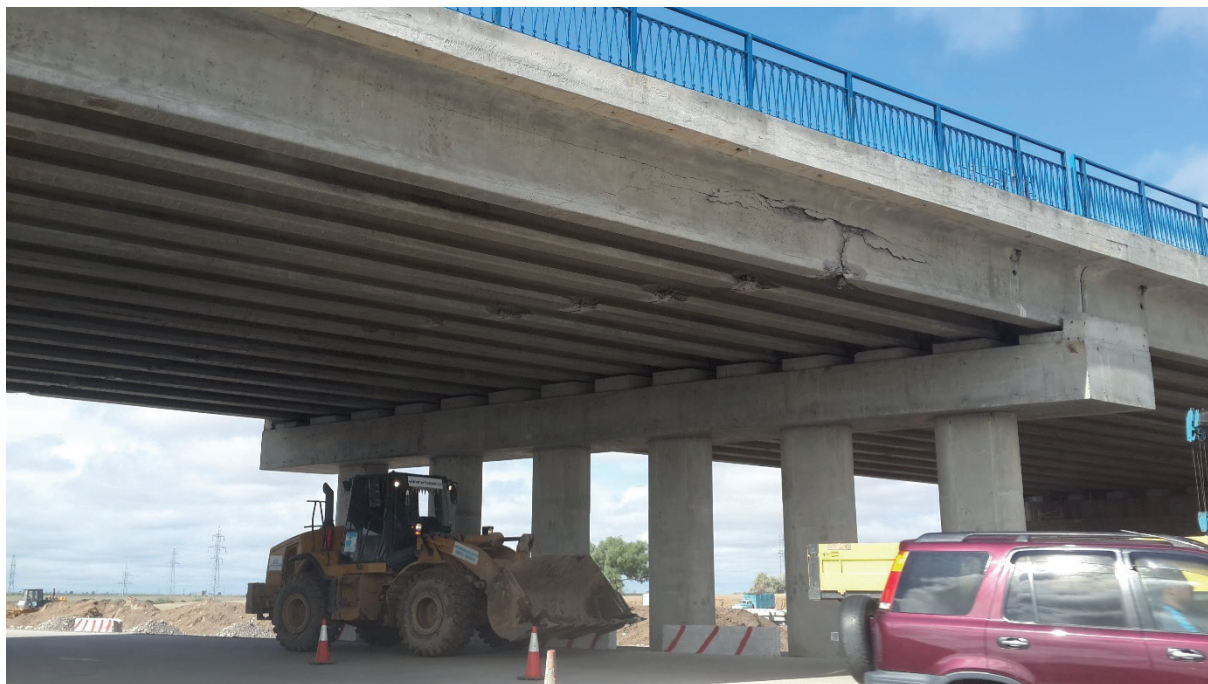
Figure 1 General view of the overpass from Kapshagai before repair

superstructure No. 1 were damaged as a result of vehicle impact.

Figure 1 shows a general view of the road overpass before repair and Figure 2 shows the repaired superstructure No. 1 [1].

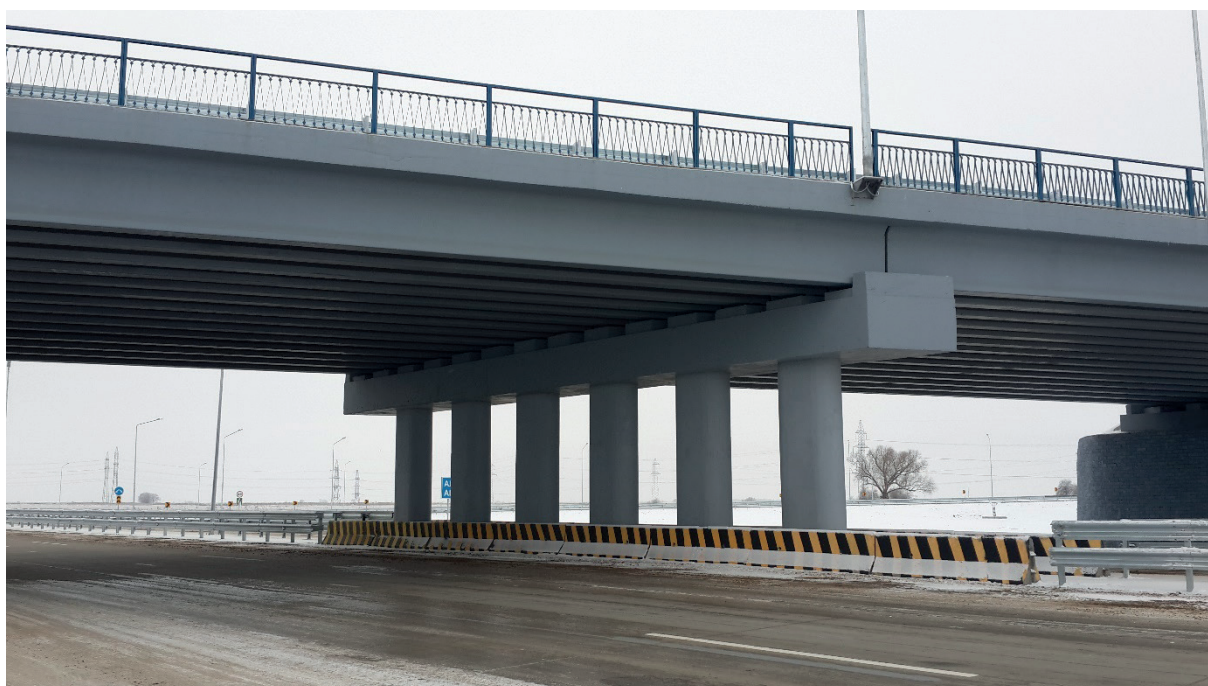
Figure 2 General view of the repaired superstructure No. 1 from Almaty

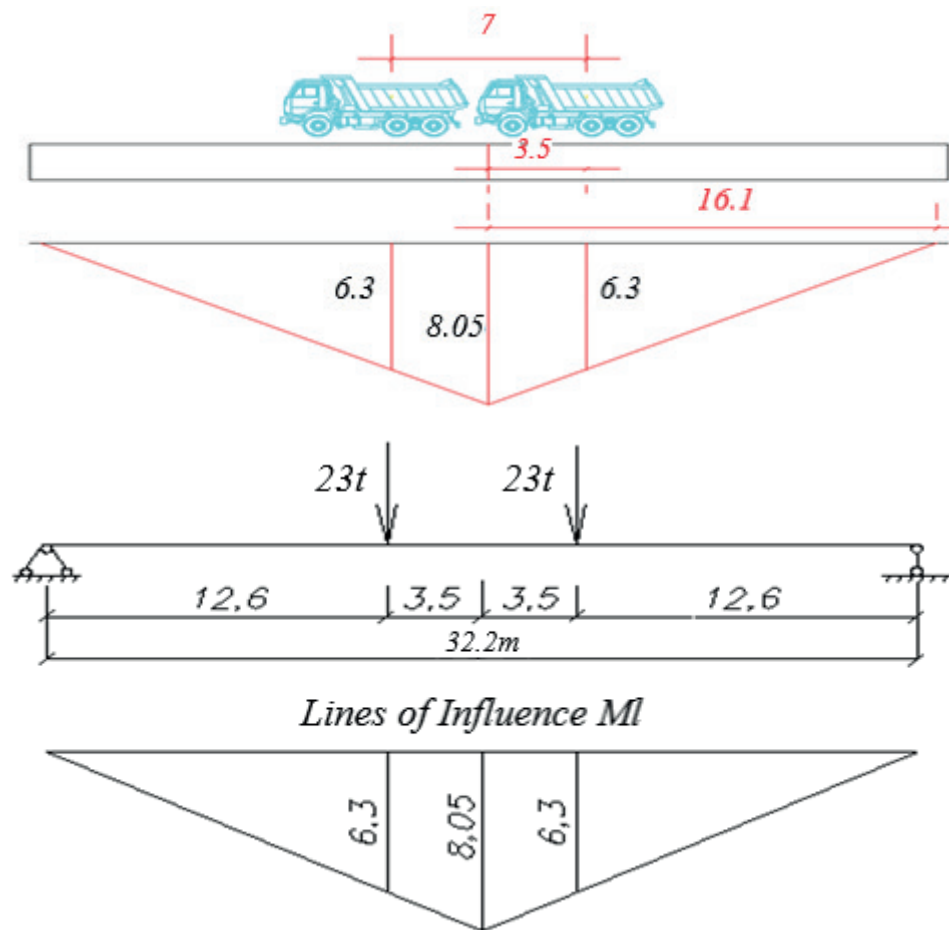
Figure 3 The influence line of the bending moment in the middle of the beam span and the position of the test load on the superstructure

Here is the test load calculation. The influence line of the bending moment in the middle of the beam span

and the position of the test load on the superstructure are shown in Figure 3.

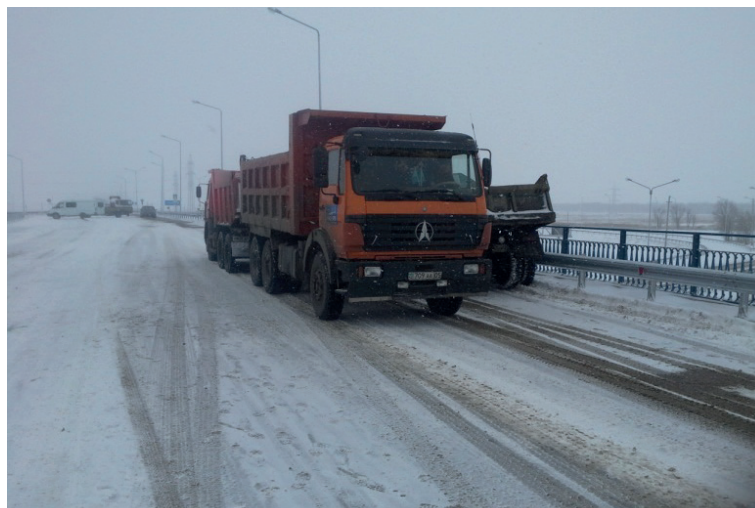
Figure 4 Vehicles are located at the roadway safety fence of superstructure No. 1 from Kapshagai at the first stage of testing

Table 4 shows the transverse location factor (TLF) values from the action of the test load when the last row of trucks is located at a distance of 1.5 m from the roadway safety fence and in the middle of the superstructure (Figures 4, 5 and 6).

The analysis of the transverse location factor values showed that at the accepted position of the test load at the first, second and third stages of the tests, the maximum load was on beams No. 1, No. 14 and No. 7, respectively.

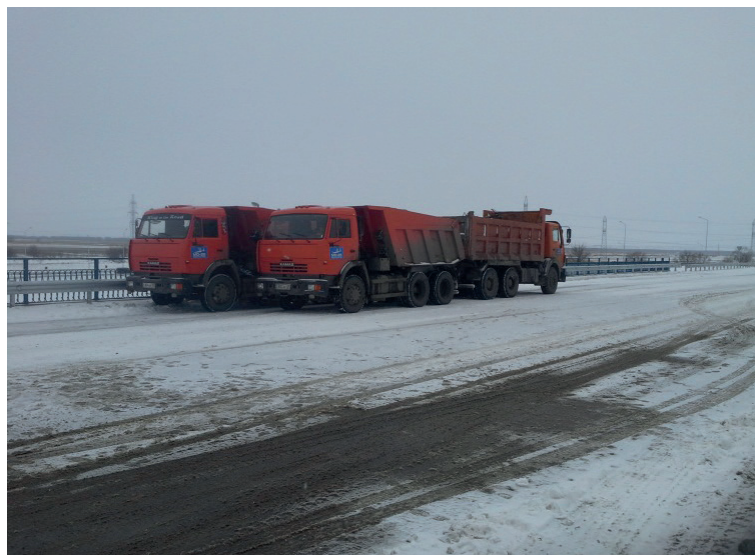
Figure 5 Vehicles are located at the roadway safety fence technical of superstructure No. 1 from Almaty at the second stage of testing

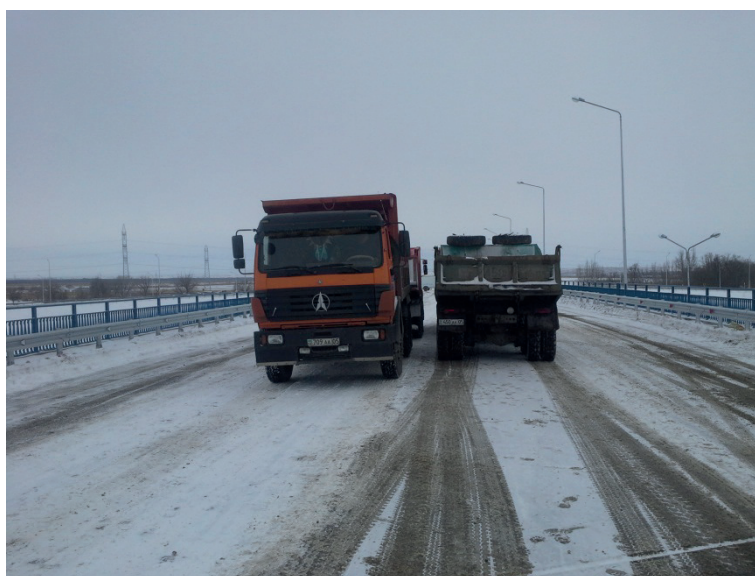
Figure 6 Vehicles are located at the longitudinal axis of superstructure No. 1 at the third stage of testing

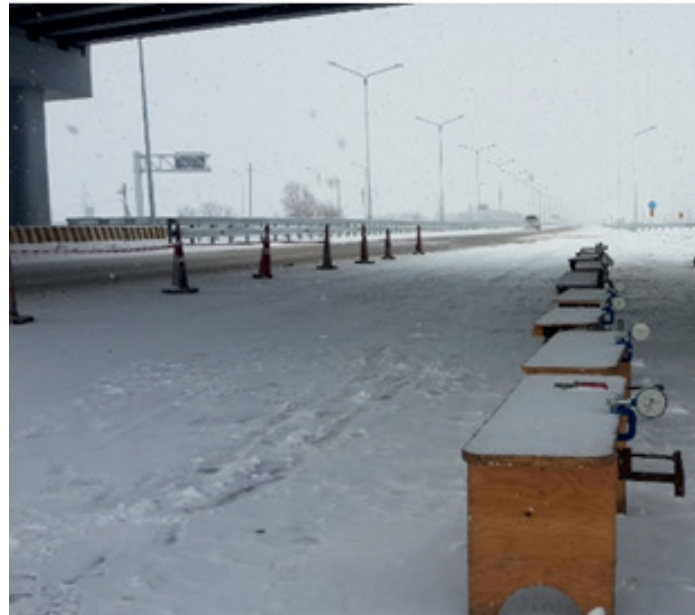
Figure 7 Location of deflection gauges under each of the fourteen beams in the middle of the superstructure No. 1

Figure 7 shows the deflection gauges' location under fourteen beams in the middle of the superstructure No. 1.

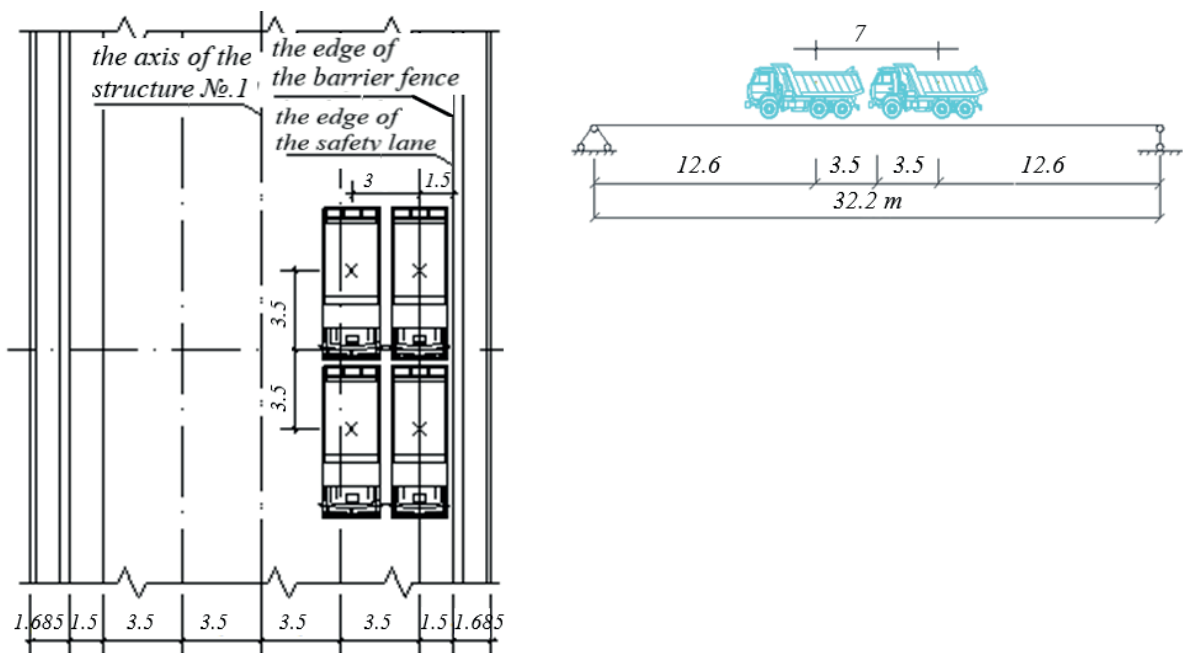
Figure 9 The second stage of the static tests on superstructure No. 1

Four vehicles were installed in stages on superstructure No. 1 at the first (Figure 8) and second (Figure 9) stages of the static tests. Meanwhile, the roll axis of the last vehicle was located at a distance of 1.5 m from the roadway fence. The distances between the vehicles in overpass transverse and longitudinal directions were 3.0 m and 7.0 m, respectively.

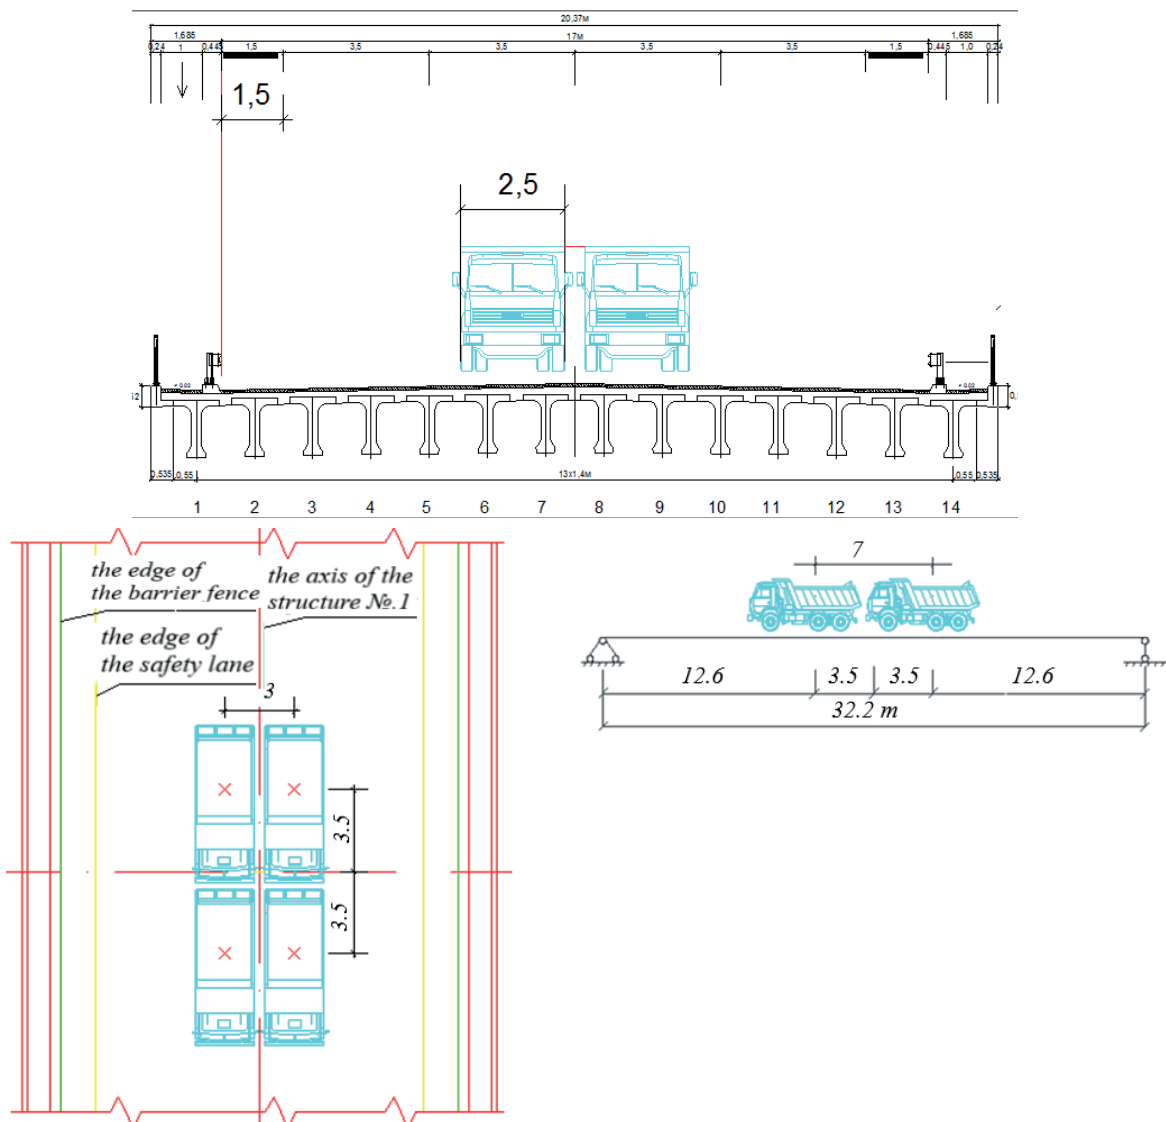
Figure 10 The third stage of the static tests on superstructure No. 1

Four trucks - two vehicles in one row were also installed on superstructure No. 1 at the third stage of testing. The axes of each vehicle row were separated from the roadway longitudinal axis at a distance of 1.5 m. The distances between vehicles in the overpass transverse and longitudinal directions were 3.0 m and 7.0 m, respectively (Figure 10).

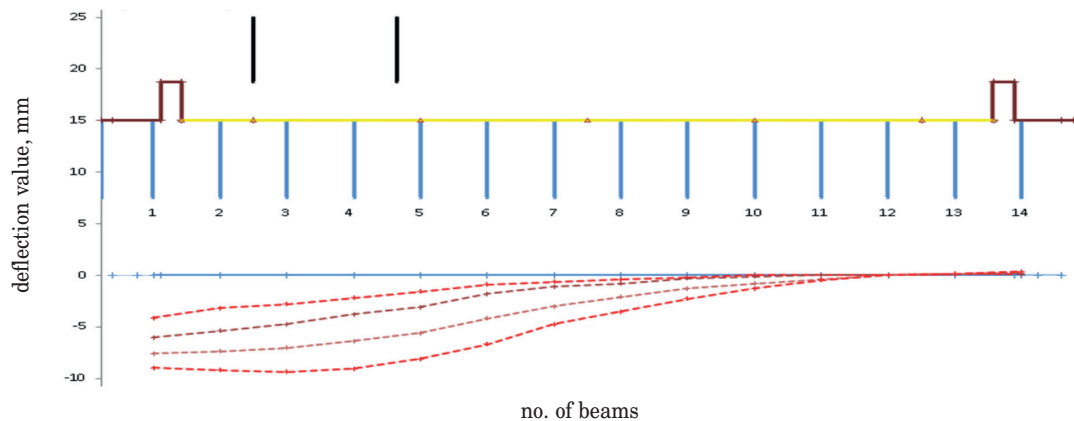
Figure 11 Loading and unloading stages, the superstructure transverse profile and outline of the beam deflections during the loading and unloading at the first stage

At the first stage of testing, the maximum deflection value has been recorded in beam No. 3, which was $f = 9.36 \text{ mm}$.

The values analysis of the deflection increments during the loading and unloading at the first, second and third stages of the static tests testified to the elastic behavior of the VTK-33u beams of a length of 33.0 m.

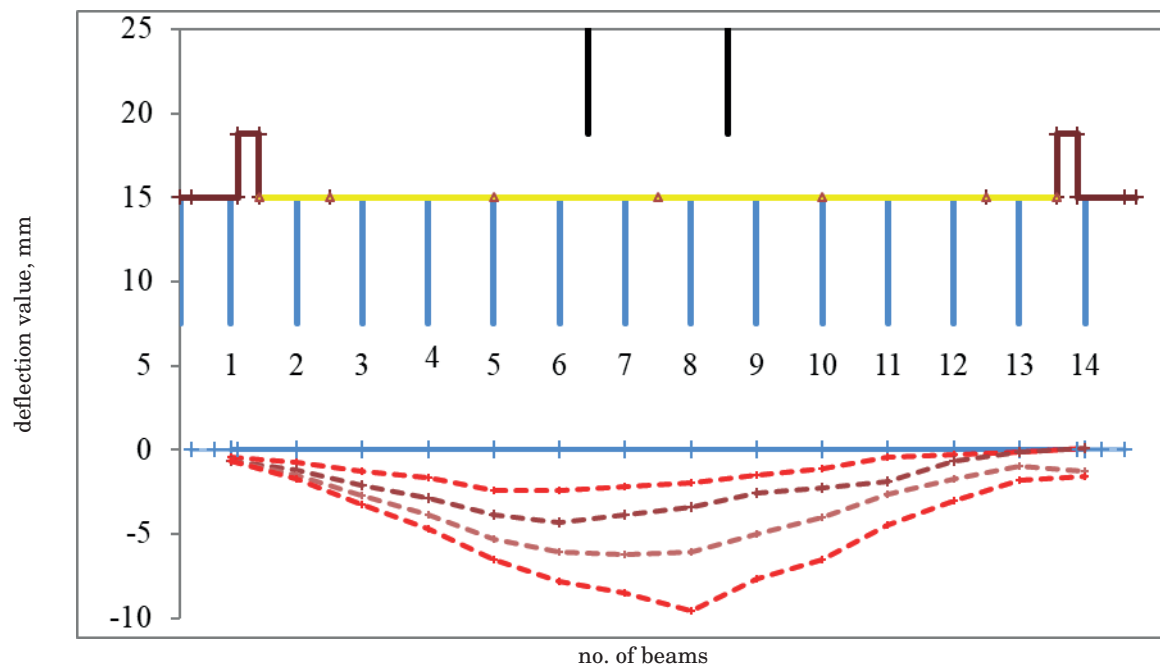
Figure 13 Loading and unloading stages, the superstructure transverse profile and outline of the beam deflections during the loading and unloading at the third stage

At the third stage of testing, the maximum deflection value has been recorded in beam No. 8, which had

a value equal to $f = 9.54 \text{ mm}$.
