ROAD ACCIDENT ANALYSIS AND SAFETY AUDIT: A CASE STUDY OF MDR 132

Road accident and road safety are the key global concerns and problem for emerging nations like India. It has been attempted to examine the accidents that happened on Major District Road (MDR) 132 (Nuh to Hodal), India in the last five years. The primary objective of this study was to perform the Road Safety Audit for identification of accident-prone areas based on Accident Severity Index (ASI) and provide some improvement measures in order to lower the frequency and severity of accidents. Identified accident prone locations (blackspots) were ranked according to the ASI index. The distribution of accidents based on various parameters were also discussed. Site visit of critical sections of the road to observe road deficiencies were made and safety recommendations, along with the risk associated with them and priority as per IRC: SP: 88-2019, were suggested.

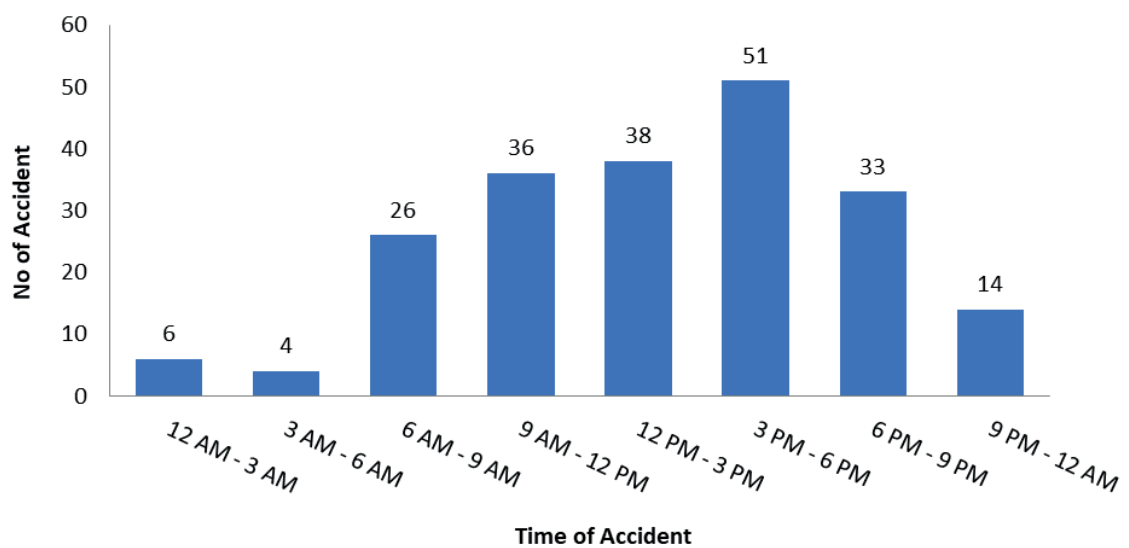
Figure 3 Time-wise distribution of accidents

Figure 3 shows pattern of accident severity according to the time of day. The figure indicates that more severe accidents occurred between 3 PM and 6 PM and then between 12 AM and 3 PM, while during the time between 3 AM and 6 AM least accidents occurred.

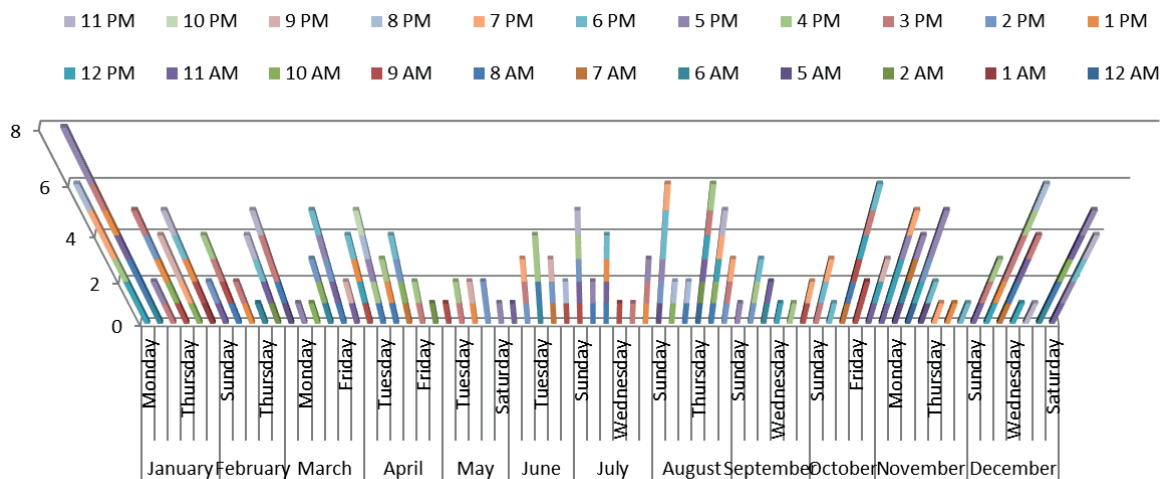
Figure 4 Distribution of accidents according to time, day and month

Figure 4 presents the combined graph showing the relation between the number of accidents and time, day and month.

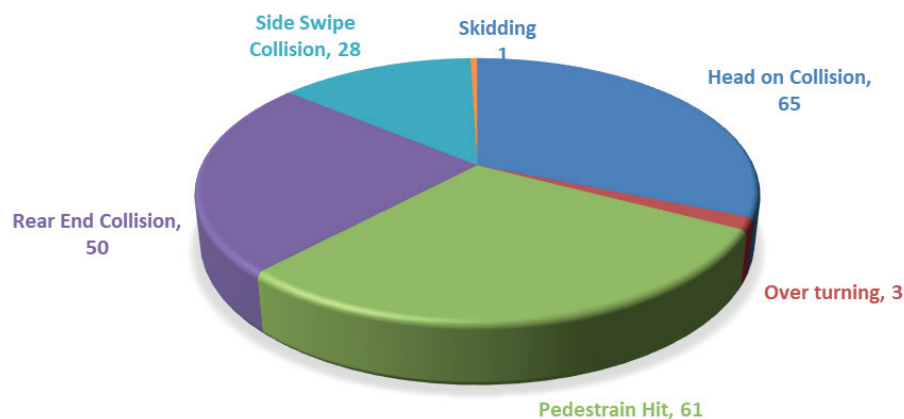
Figure 5 Distribution of accidents according to their nature

According to an FIR assessment of the previous five years, the head-on collision accidents accounted for 65 accidents, rear end collision accidents accounted for 50 accidents and skidding was the cause of just one accident as per records in FIRs (see Figure 5).

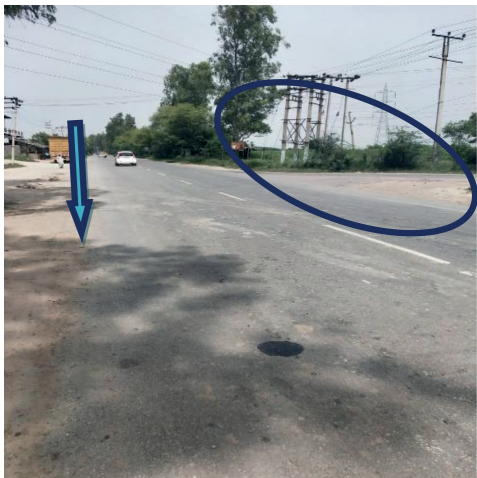
<ul style="list-style-type: none"> Pavement edge marking missing. Speed breaker and its marking missing at entry of junction Speed breaker sign missing on the entry of junction. Information Sign Missing in all directions. 	<ul style="list-style-type: none"> Pavement edge marking should be provided towards both edges. Provide speed breaker sign board before intersection in all the incoming directions to alert the drivers Provide light reflecting tape/paint on all such poles. Provision of cat eyes at the entry of junction on both carriageways. Provide information sign in all directions to guide the road user. 	Risk: High Priority: Highly desirable

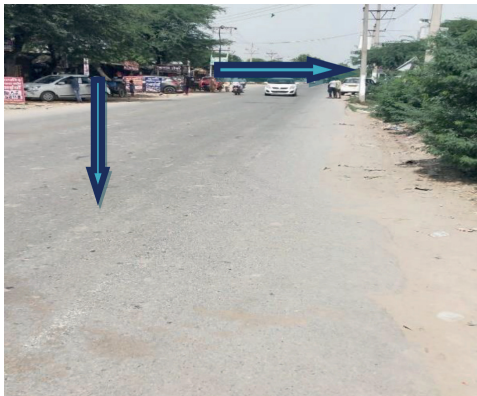
<ul style="list-style-type: none"> Pavement edge marking missing. Electrical poles laying on main carriage way obstructing the traffic without marking. 	<ul style="list-style-type: none"> Road marking should be painted properly on the road. The electric pole should be removed from the carriageway to avoid safety hazards. At least the retro-reflective tape should be pasted on both sides of the pole. 	Risk: High Priority: Highly desirable

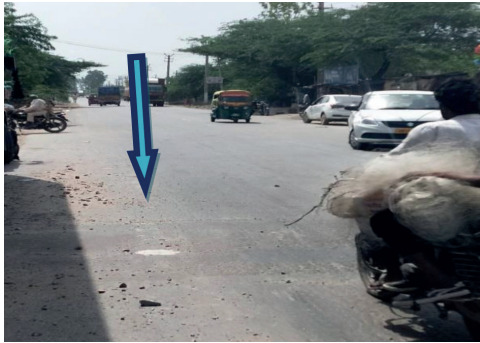
<ul style="list-style-type: none"> Road marking/Speed breaker marking is missing, which can cause visibility problems for road users at night-time as it can lead to the road crashes. 	<ul style="list-style-type: none"> Provide speed breaker along with the sign board before the intersection to alert the drivers. Pavement edge marking should be provided. 	Risk: High Priority: Highly desirable

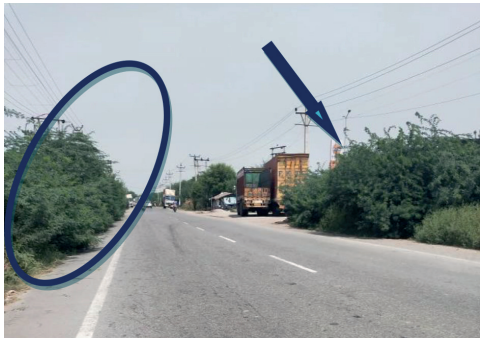
<ul style="list-style-type: none"> The shoulders are covered under vegetation. 	<ul style="list-style-type: none"> The tree branches have come on the carriageway at very low height require pruning along with removal of weeds/ plants from roadside. 	Risk: Medium Priority: Desirable

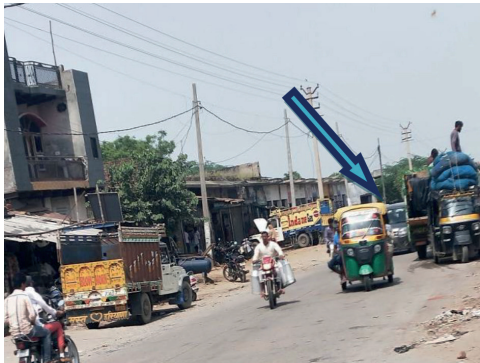
<ul style="list-style-type: none"> The information and direction signages are not provided 	<ul style="list-style-type: none"> To warn residents of habitation, a standard village signboard should be installed (as per IRC-67,99). Speed Limit signboard should be provided. 	Risk: High Priority: Highly Desirable

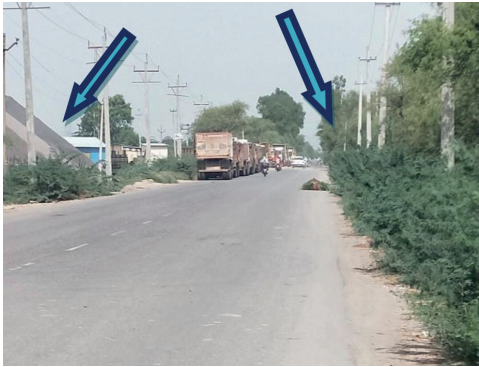
<ul style="list-style-type: none"> Road side green areas and trees abutting are not properly maintained. Retro-reflective tape is missing on the electric pole. 	<ul style="list-style-type: none"> Formation land along with footpath should be free from vegetation/weeds. Retro-reflective tape should be provided on both sides of the electric poles placed close to the carriageway as per IRC-35 	Risk: High Priority: Highly desirable

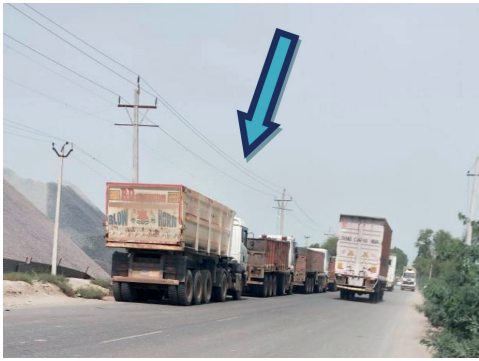
<ul style="list-style-type: none"> Truck drivers are parking their trucks in no parking zone approx. 1 km near Ujina mixture plant. 	<ul style="list-style-type: none"> Unauthorized parking on the carriageway must be removed 	Risk: Medium Priority: Desirable

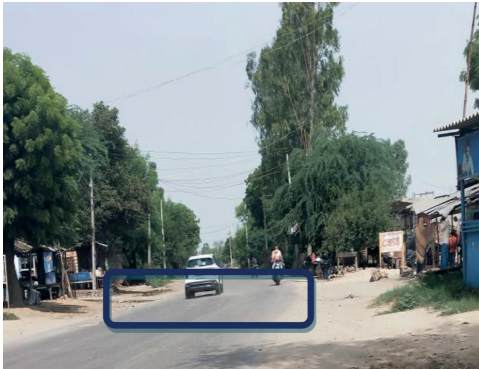
<ul style="list-style-type: none"> Speed hump is not visible. It can lead to road crashes. 	<ul style="list-style-type: none"> All marking should be reinstalled and maintained properly and kept clean of dust at all times for the proper visibility. 	Risk: High Priority: Highly desirable
