# EXPERIMENTAL STUDYING THE BELT CONVEYOR ROLLER WEAR DEPENDENCE ON THE INTENSITY OF TECHNOLOGICAL DUST ACCUMULATION IN OPEN PIT MINING

The paper presents the research on revealing the causes of belt conveyors downtime at open-pit mining operations. By results of researches it is established that the reasons of the above mentioned problems are technological dust formed at crushing of mineral ore, further loading and unloading, and also at transporting by conveyors. Dense dust-air mixture settling on the rotating mechanisms of conveyors, gets into the bearing units and on the surfaces of friction gears, which accelerates the process of wear of parts several times.

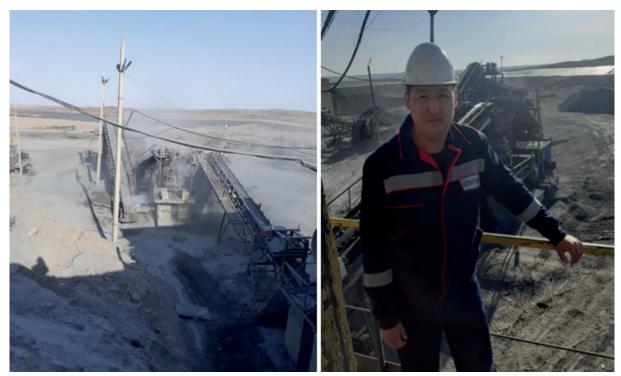
Figure 1 Cyclic-flow transport of the crushing and screening complex of the «BAST» mining and processing plant [9]

Figure 1 shows images of cyclic-flow transport of the crushing and sorting complex of the mining and processing plant of "BAST" taken during the experiments.

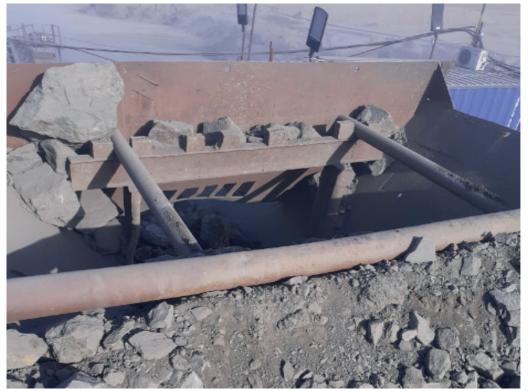
Figure 3 Receiving hopper of the coarse lump crusher of the Maksut mine (position 6 of Figure 2) [9]

Figure 3 shows the receiving hopper of the lump crusher located in the ore stockpile (position 6 of Figure 2), which is the beginning of the mineral ore crushing process. In front of the hopper there is an open area (ramp) for maneuvering the front-end loader, which delivers ore from the ore stockpile and doses ore to the

The receiving hopper has sorting grates that prevent the ingress of oversized pieces with the length of more than  $500\,\mathrm{mm}$ .

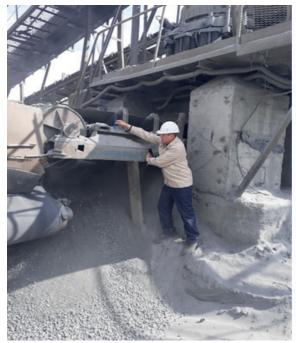
Figure 5 Measuring technological dust in the CSC section

for sampling and measuring the settling dust at the CSC section marked with points T1 to T5 were installed. For the above period, every shift (the shift duration is 11 hours) measurements of dust accumulation were carried out in the most dusty areas of the CSC (Figure 5).

Measurements of settled dust were made using a measuring ruler, the measurement results were noted in the "Register of Research and Experiments" during the inter-shift shutdown of the equipment. In the most dusty areas of the CSC in Figure 4 marked with points T1 to T5, technological dust was sampled and placed in plastic bags indicating the time, date and place of sampling (Figure 6).
