## THE VIBRODIAGNOSTICS OF DAMAGED GEARS OF PLANETARY GEARBOXES

*This article deals with description of a diagnostic device used at the Department of Design and Machine Elements at the University of Zilina which has been built in order to measure, diagnose and evaluate gearbox faults by vibrodiagnostics. The article describes methods and damage creation process for tested gearboxes. Evaluation of different faults is also processed in this article as well as description of comparative measurements between real and artificially created pitting. Comparison of all measured data with SPM methods is also included.*

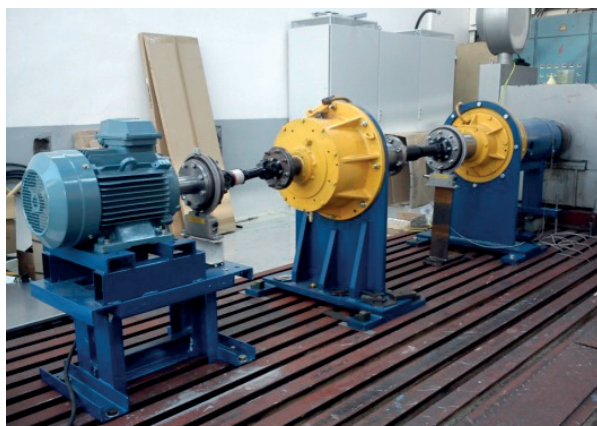
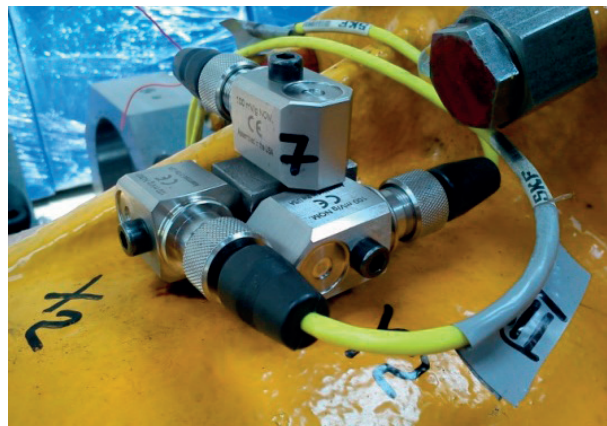
Fig. 1 The testing device used at the Department of Design and Machine Elements for diagnostics of planetary gearboxes' faults (left) and placement of vibration sensors (right)

The testing device consists of one 15 kW electromotor controlled by a phase shifter, two planetary gearboxes type A2000 mounted in series and also one dynamometer. Components

are coupled together by cardan shafts. The testing device is supplemented with noncontact sensors HBM T10F for RMP and torque measurement. Gearbox A 2000 is a planetary gearbox with two planetary gearings with involute spur gears [2].

The diagnostic apparatus was purchased from SKF and it contains six acceleration sensors with sensitivity of 100 mV/g, on-line diagnostic unit type IMx-S and one PC equipped with @plitude analyst software. Both frequency analysis and envelope method for signal processing are used to determine gearbox faults.

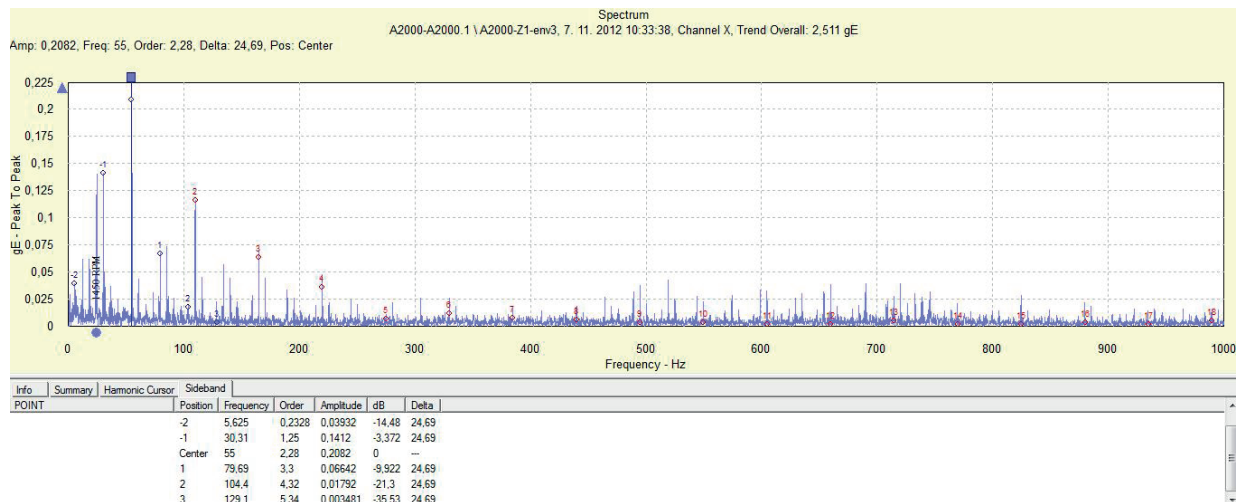
Fig. 2 The frequency spectrum of enveloped accelerations filter 3 for tooth of the sun gear damaged by the notch on its face area

The sun gear of the first planetary gearing was first to be damaged. First type of damage is represented by the notch on face area of one tooth. This damage was done with assumption of significant response within frequency spectrum. The damage can be seen in vibrations velocity spectrum by analysing sideband of gear mesh frequency of the first planetary gearing, because first amplitudes significantly surpassed magnitude of gear mesh frequency. Its effect was even more significant in enveloped

accelerations spectrum filter 3 (Fig. 2). Frequency 55 Hz of damaged sun gear dominated throughout spectrum and its harmonic frequencies showed up (marked as red). Sideband was created around gear frequency with the delta equal to RPM frequency 24.69 Hz of damaged gear (marked as blue). Sideband can be clearly seen in vicinity of its harmonic frequency [3].

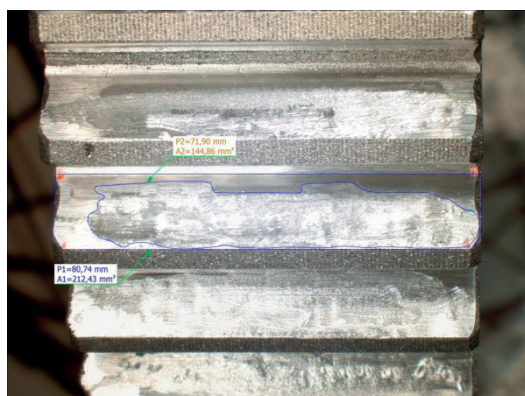
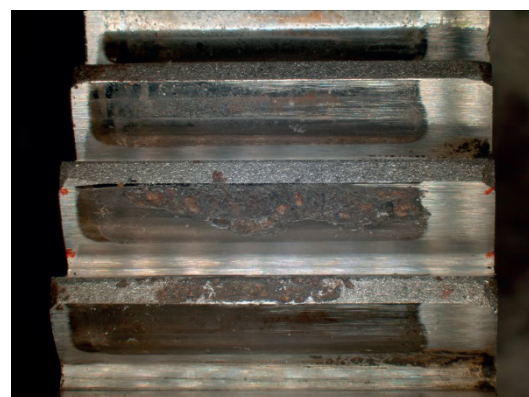
Fig. 3 Sun gear of planetary gearing damaged by artificially created pitting (left) and sun gear damaged by real pitting (right)

In order to compare all measured data, another experiment with artificially created pitting on half of gear's teeth (on the same face

area as damaged by the notch) took place (Fig. 3 left). Artificially damaged sun gear was replaced by another sun gear damaged by real pitting on half of gear's teeth (Fig. 3 right). After both spectra were measured and frequency spectra were compared, we came to the conclusion that artificially created pitting has very similar effect when compared to real pitting (Fig. 4). This comparison confirmed that measured data match reality and test method was suitable for this application as well [8] and [9].

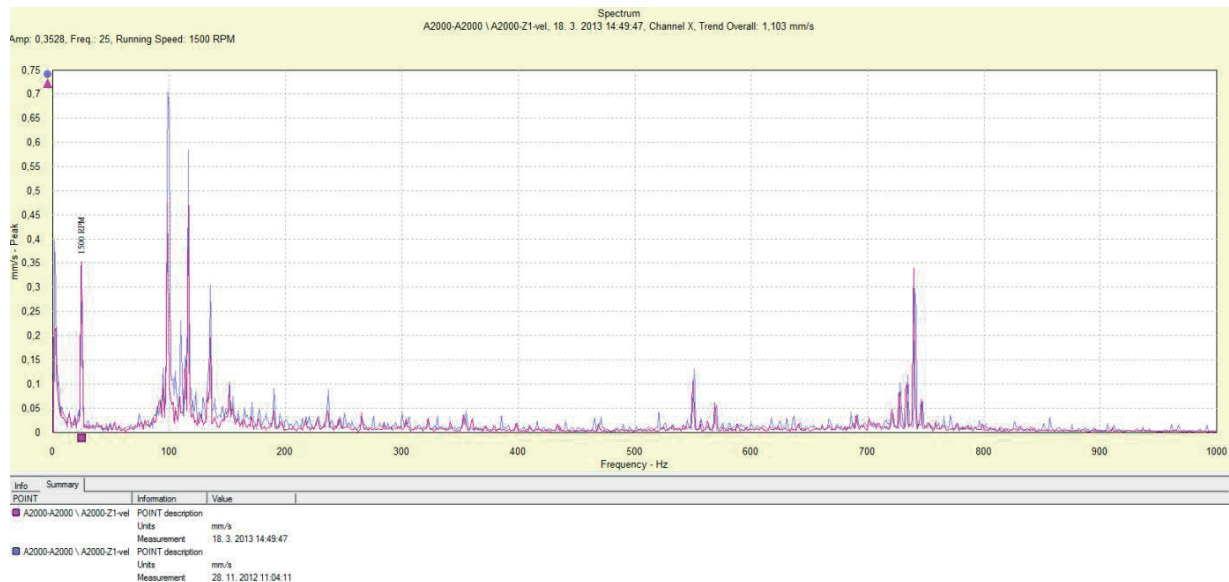
Fig. 4 The comparison of frequency spectra of gearbox with sun gear damaged by artificially created pitting on half of gear's teeth (blue) and sun gear damaged by real pitting (violet)

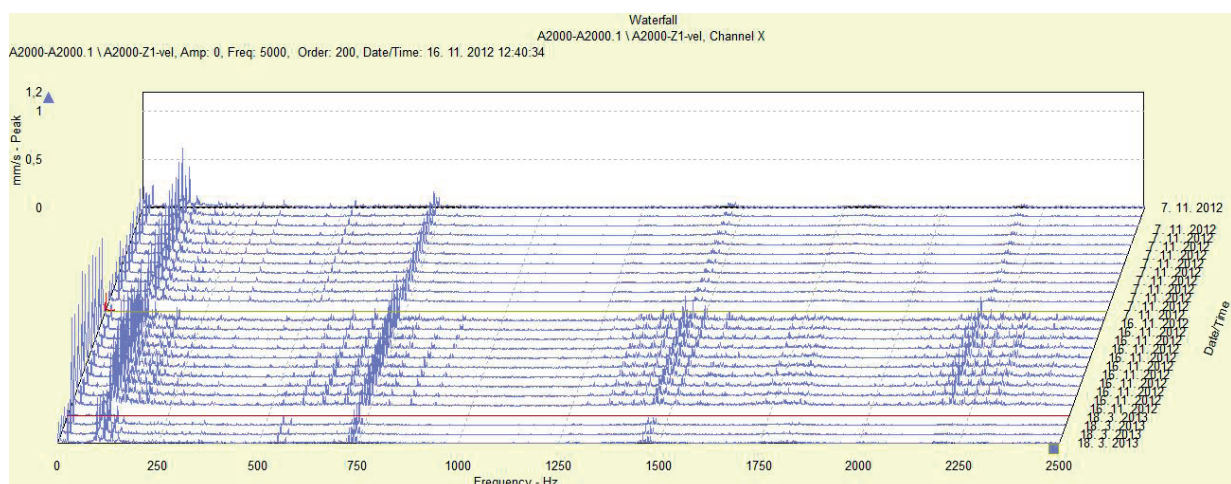
Fig. 5 Frequency spectrum of velocity of vibrations with differently damaged sun gears of first planetary gearing by pitting

Vibrations velocity frequency spectra with different pitting affected area of the sun gear of the first planetary gearing can be seen in Fig. 5. The upper part of spectra represents only one tooth damaged by pitting, middle part corresponds to all teeth damaged by pitting and lower part represents the gear damaged on half

of its teeth by real pitting. Straight lines between measurements reflect time when the testing device was offline.

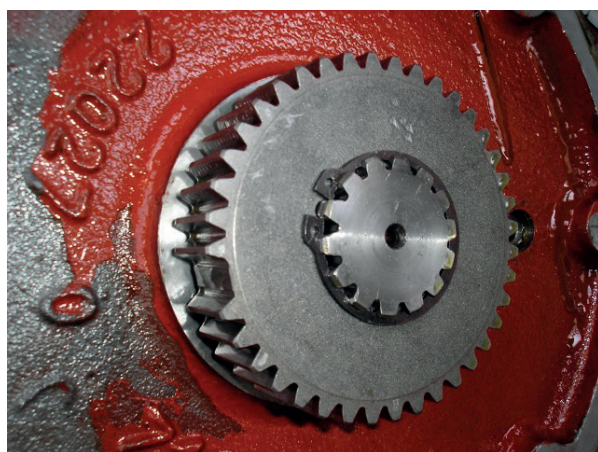
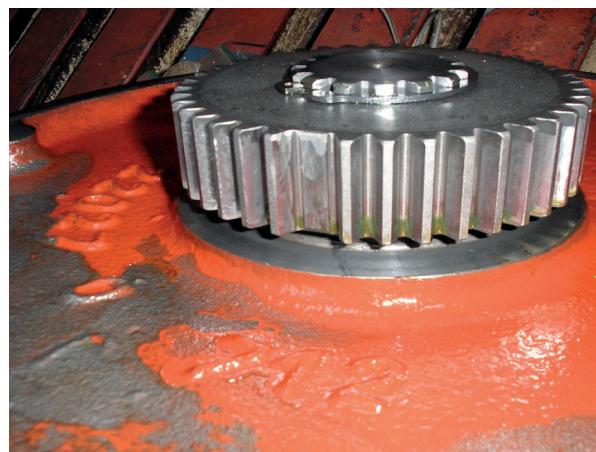
Fig. 6 Sun gear with one missing tooth

Another phase involved sun gear with one tooth partially broken and later with whole missing tooth. Measurements were made on gears which were previously damaged by pitting on half of their teeth (Fig. 6).

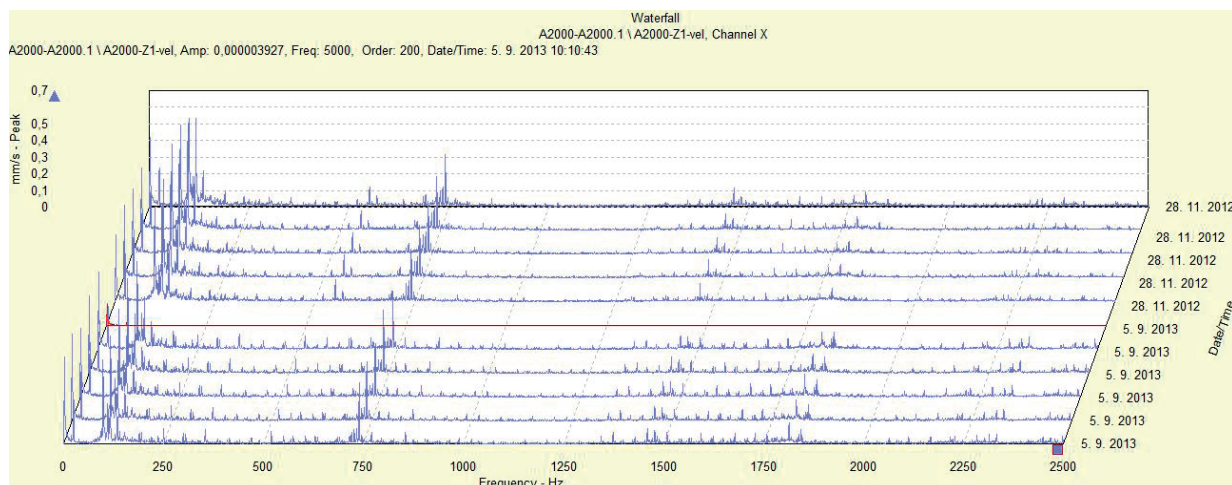
Fig. 7 The comparison of frequency spectra of vibrations for pitting created on half of teeth of sun gear (upper part) and for gear damaged by same pitting with one missing tooth (lower part)

There was no significant change in vibrations velocity spectrum (Fig. 7) compared to the sun gear damaged by pitting on half of its teeth [10]. Enveloped accelerations spectrum filter 3 – from 5 Hz to 1kHz (Fig. 8) also had similar characteristic compared to same sun gear with no missing teeth, but amplitude

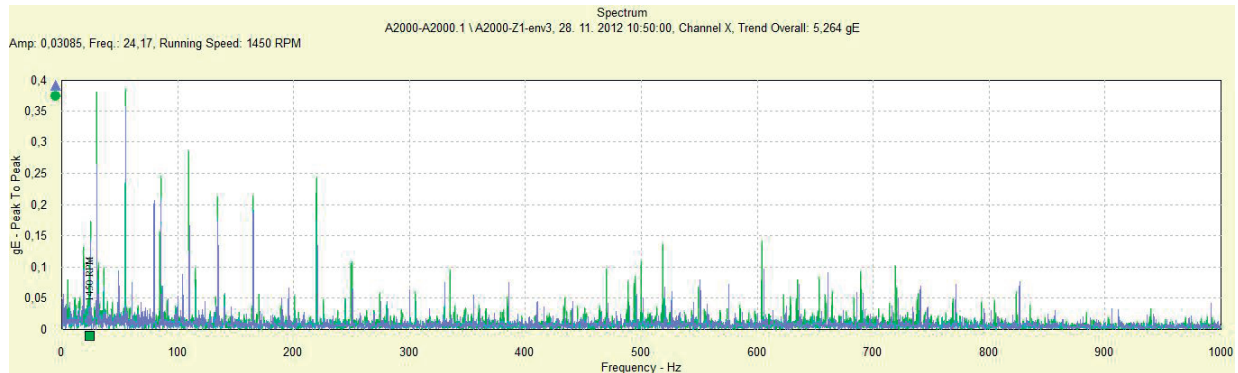
Fig. 8 The comparison of frequency spectra of enveloped acceleration filter 3 for pitting created on half of teeth of sun gear (blue) and for gear damaged by same pitting with one missing tooth (green)

of gear mesh frequency and its harmonic frequencies had higher values compared to pitting damaged sun gear.

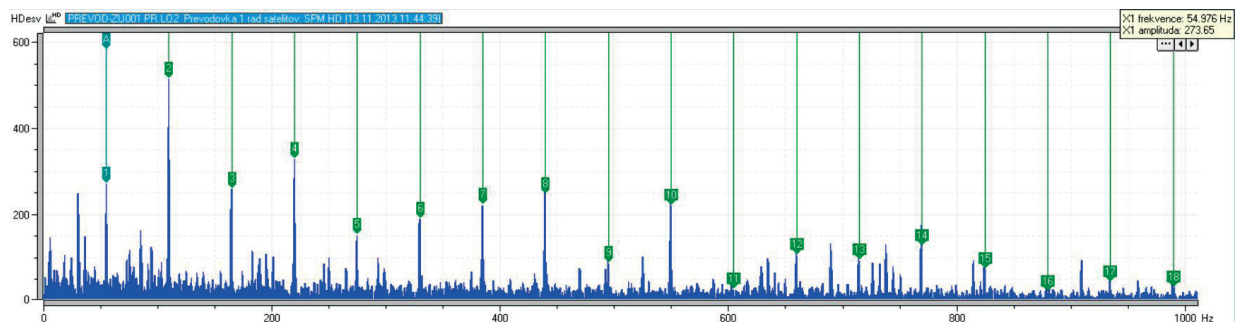
Fig. 9 Frequency spectrum measured by SPM HD method

Frequency spectrum measured by SPM HD method is shown in Fig. 9. Teeth frequency of damaged gear (54.976 Hz) and its harmonic frequencies within spectrum are marked by numbers. Figure 10 contains data measured by enveloped accelerations method filter 3 where teeth frequency (55 Hz) and its harmonic frequencies of damaged gear are also marked by numbers. Spectra

in both figures are very similar with small difference of amplitude magnitude for 6<sup>th</sup>, 7<sup>th</sup> and 8<sup>th</sup> harmonic frequency because these harmonic frequencies have much lower amplitudes with enveloped accelerations method.

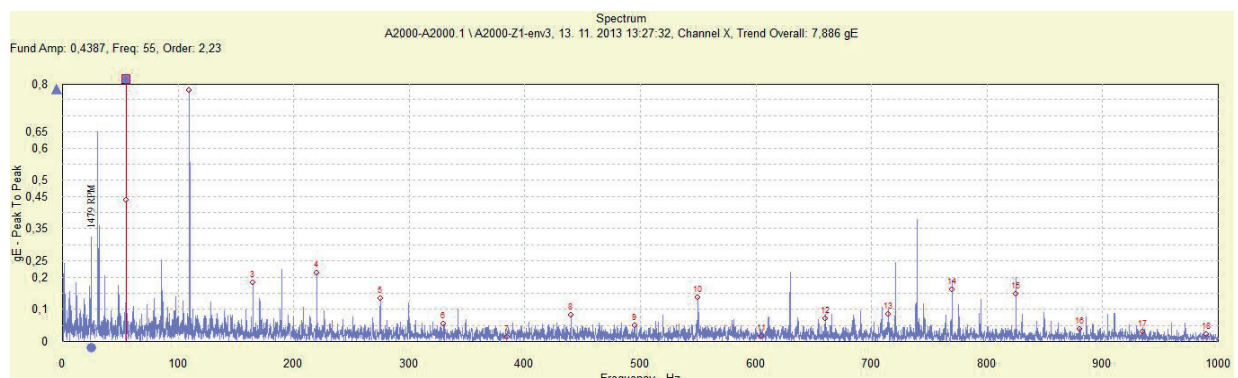
Fig. 10 Frequency spectrum measured by enveloped accelerations method (SKF)

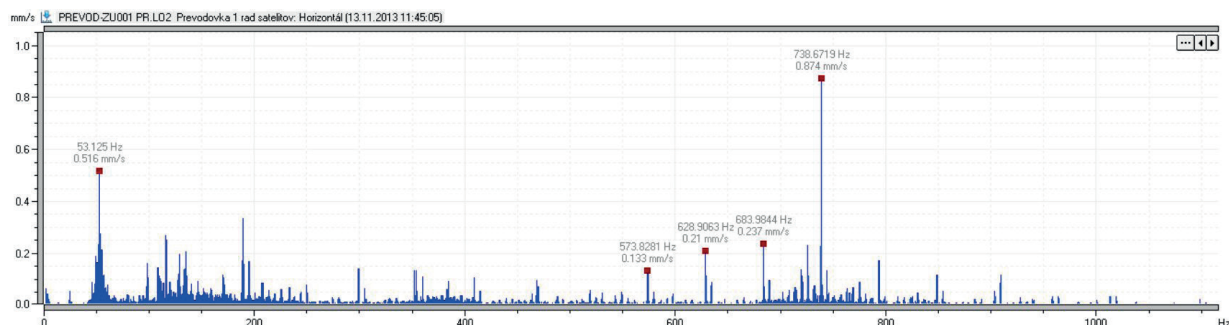
Fig. 11 Frequency spectrum of vibrations velocity measured by SPM Spectrum method

Vibrations velocity frequency spectrum obtained by SPM Spectrum method can be seen in Fig. 11. Spectrum's shape is very similar to SKF methods in direct comparison (Fig. 12), difference

is in amplitude magnitudes. Spectra in both figures highlighted amplitudes of sideband with the spacing of teeth frequency of damaged sun gear (55 Hz) and amplitude of sideband of gear mesh frequency of the first planetary gearing which has high value of amplitude dominating through whole spectrum.

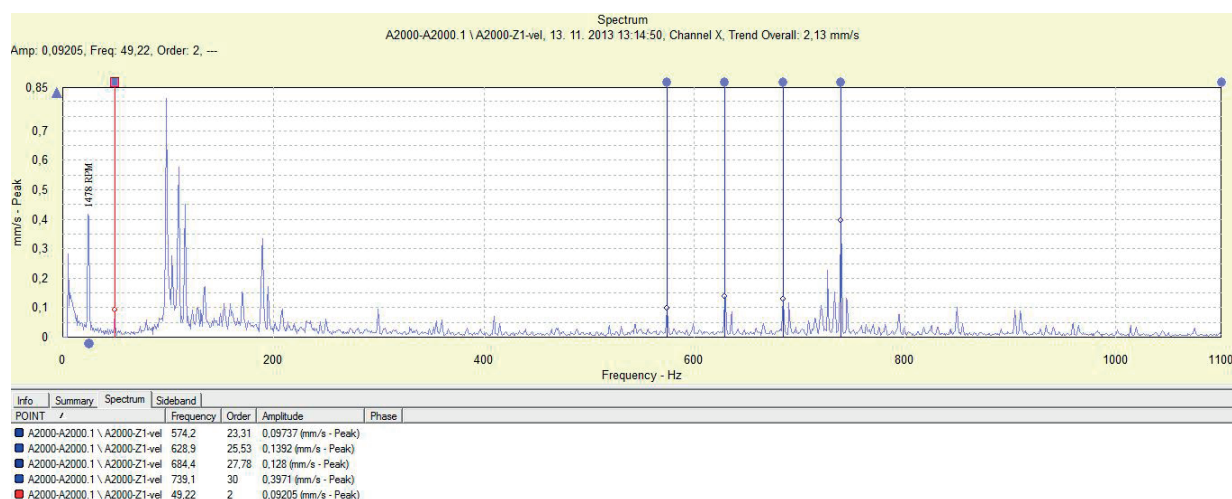
Fig. 12 Frequency spectrum of vibrations velocity measured by SKF diagnostic methods
